Baseline Channel Inventories of Pinabete Arroyo and No Name Arroyo
from 1998 and 2007 (Edited 2013)

**BASELINE CHANNEL INVENTORIES OF PINABETE ARROYO AND NO NAME ARROYO
FROM 1998 AND 2007 (EDITED 2013)**

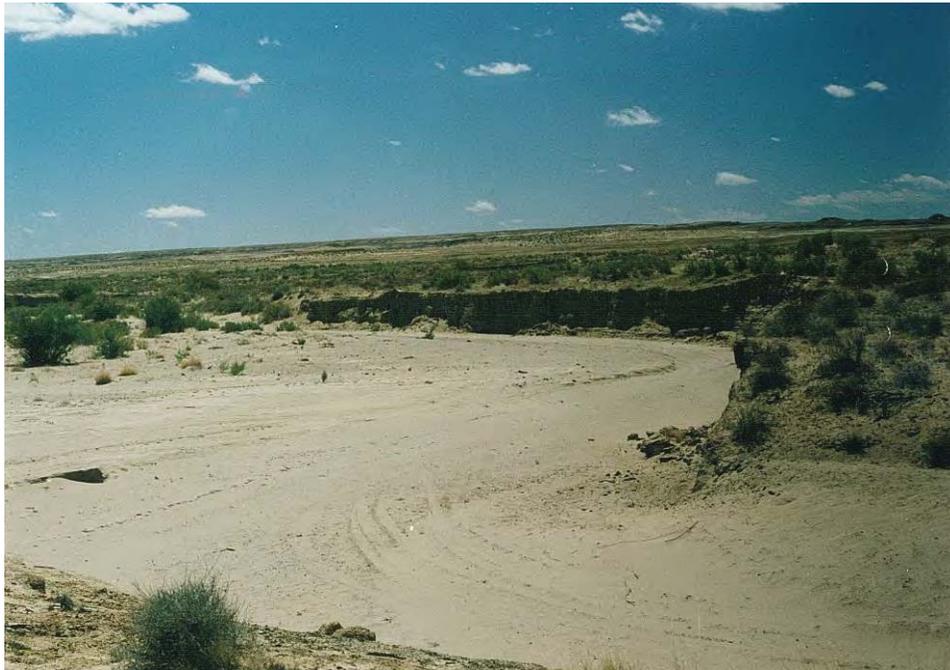
Figure 18.A-1 Pinabete Arroyo upstream of location P1, looking upstream

The value of Manning's roughness coefficient, n , was estimated to be 0.032 using the procedure for small channels described in Gray (1970). The estimated contribution to roughness from component conditions includes:

Channel materials,	0.022
Channel vegetation, negligible	0.000
Surface irregularities,	0.005
Variations in channel section,	0.005
Obstructions, and meandering,	0.000

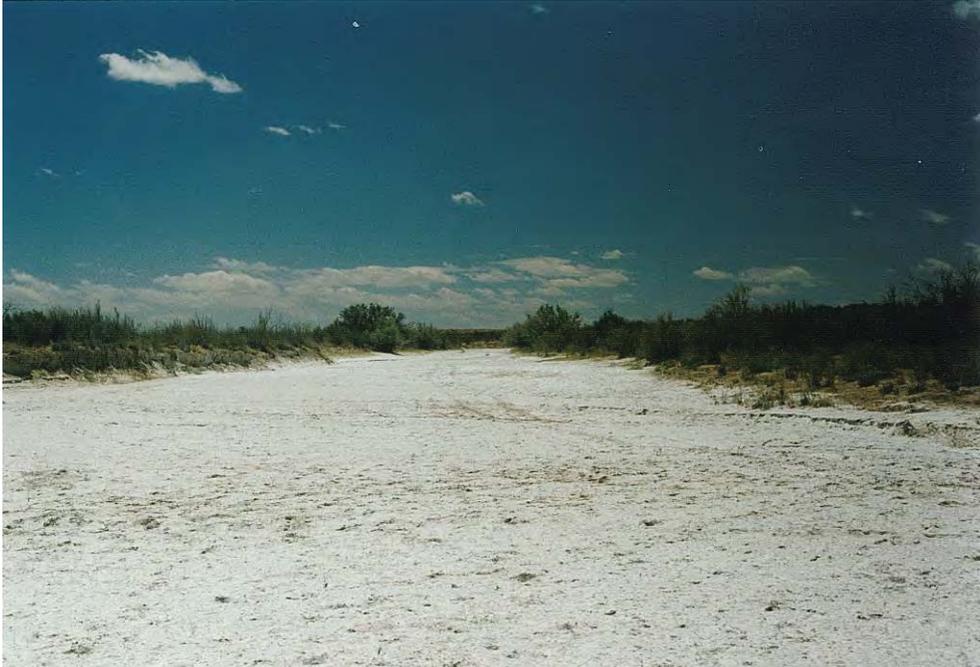
Figure 18.A-3 Pinabete Arroyo location P2, looking upstream

This location is approximately 7,700 feet down the channel from location P1. The channel at this location is trapezoidal but wider and shallower than P1 with a bottom width of 40 feet, a top width of 58 feet, and a depth of about 2.1 feet. The channel bottom is comprised of fine sand (SP) with sparse coal and rock fragments. The channel banks consist of sand with negligible fines (SW). Salt deposits occur on bed and bank materials due to evaporation of ground water seepage as shown in Figure 18.A-3. The rate of seepage is insufficient to cause surface flow. The No. 8 coal seam outcrop occurs near this cross section location as shown in Figure 18.A-4 and may be the source of seepage. No vegetation occurs on the channel bottom. Dense shrubs and forbs occur on the channel banks and overbanks. The channel slope at this location is about 0.51% and the valley slope about 0.6%.

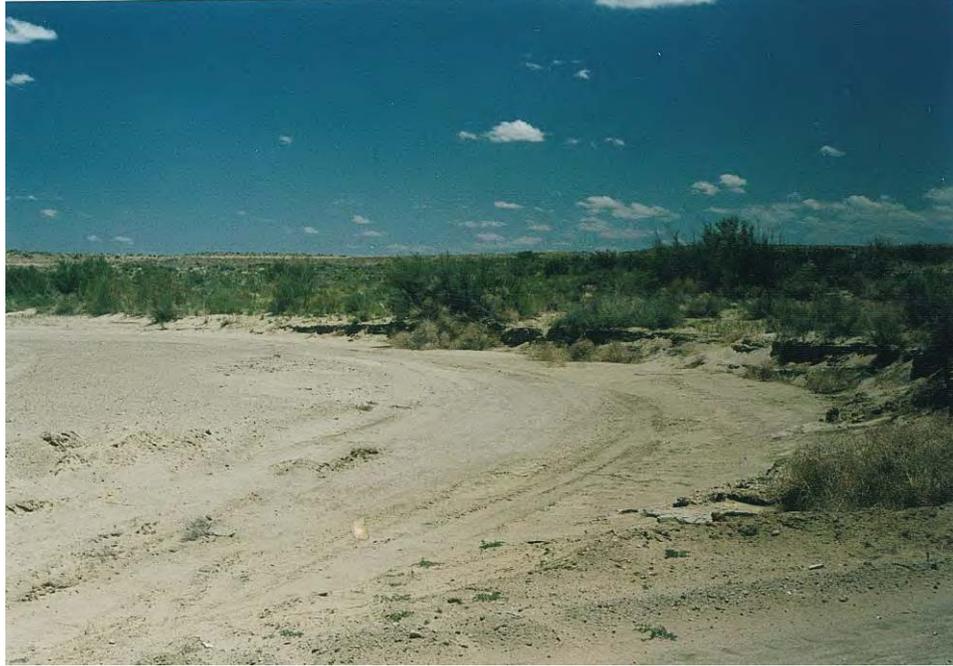
Figure 18.A-5 Pinabete Arroyo location P3, looking upstream

This location is approximately 5,530 feet down channel from location P2. This location is on a meander bend immediately upstream of the Burnham Road crossing as shown in Figure 18.A-5. The channel at this location is approximately trapezoidal with a 48-foot wide sand bar and the inside of the meander bend. The

bottom width is 24 feet and top width, excluding the sand bar, is 40 feet. The channel is about 2.8 feet deep. The channel bottom and sand bar are comprised of sand with gravel (SW), with a greater gravel fraction on the sand bar. The channel banks are comprised of sand with a higher fine fraction (SP) and are cohesive enough to form steep banks in places. The channel banks are sparsely vegetated and the sand bar and channel bottom are devoid of vegetation as shown in Figure 18.A-5. Shrubs occur on the overbanks. The channel slope at this location is about 0.51% and the valley slope about 0.7%

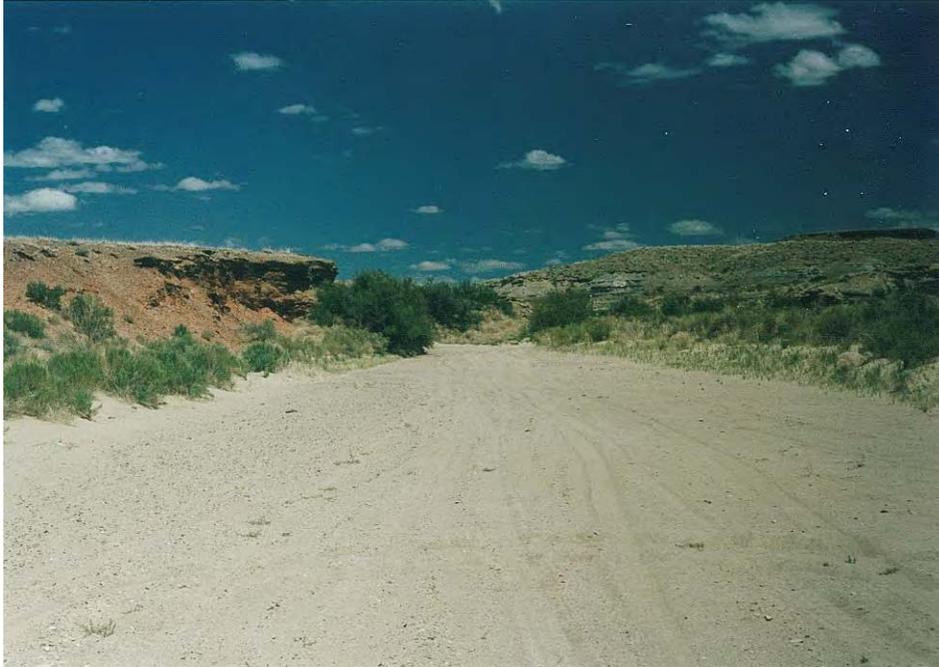
Figure 18.A-6 Pinabete Arroyo location P4, looking upstream

This location is at the road crossing to the dug alluvial well and monitoring well PA-1 and is approximately 5,750 feet down the channel from location P3. The channel at this location exhibits considerable meandering with bedrock outcrops common on the outside of meander bends. The channel at this location is approximately trapezoidal with a bottom width of 54 feet and top width of 65 feet. The channel is about 2.0 feet deep. The channel bed and banks are comprised of medium to coarse sand (SW), with a higher gravel fraction on the sand bars located on the inside of meander bends. The channel banks and overbanks are vegetated with grasses and shrubs while channel bottom is devoid of vegetation as shown in Figure 18.A-6. The channel slope at this location is about 0.51% and the valley slope about 0.9%

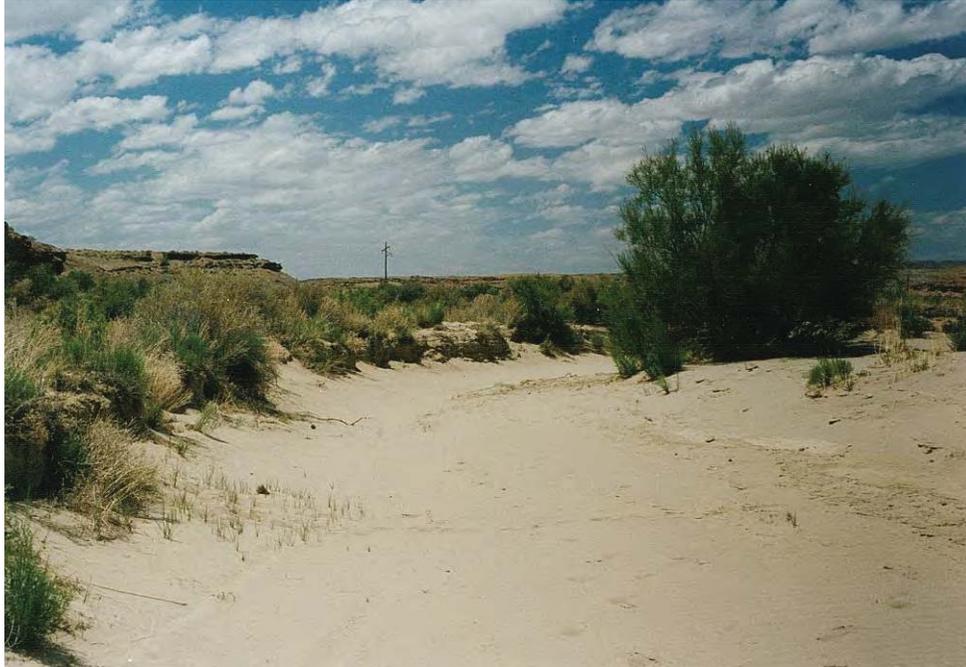
Figure 18.A-7 Pinabete Arroyo location P5, looking downstream

This location is approximately 6,600 feet down the channel from location P4. The channel at this location exhibits considerable meandering with steep cutbanks on the outside of meander bends. The channel at this location is slightly narrower than at location P4 with a bottom width of 33 feet. The channel is about 3.0 feet deep. The channel bends and banks on the inside of meander beds are comprised of medium sand (SW) with pebbles. The channel banks on the outside of meander bends are comprised of cohesive sand with fines (SP). The channel banks and overbanks are vegetated with grasses and shrubs while channel bottom is devoid of vegetation as shown in Figure 18.A-7. The channel slope at this location is about 0.51% and the valley slope about 1.2%.

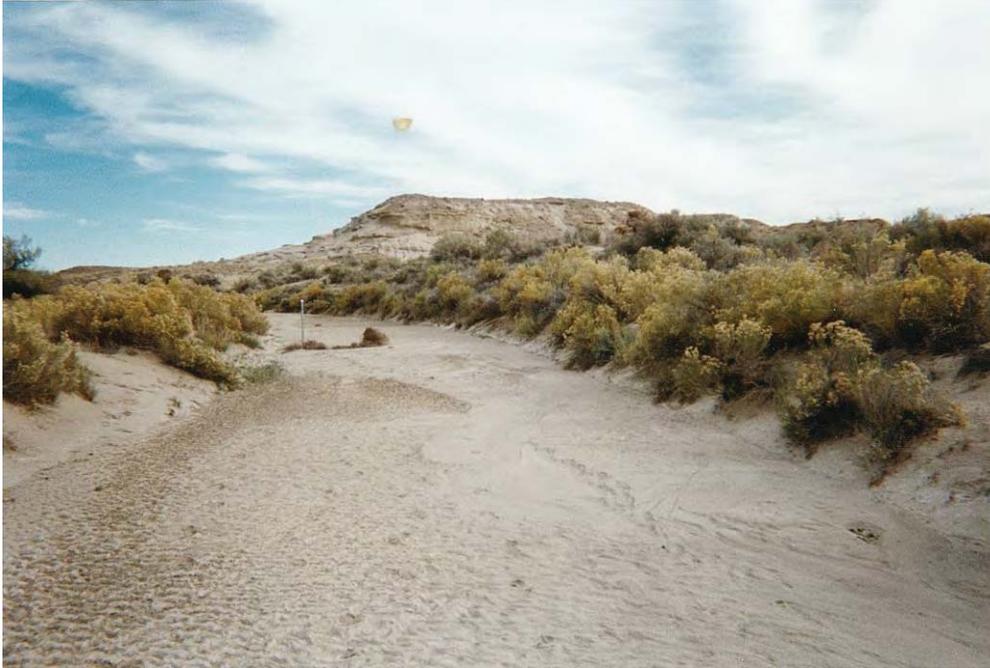
Figure 18-A.8 Pinabete Arroyo location P6, looking upstream

Manning roughness coefficient for the channel is estimated to be 0.032 using the procedure for small channels described in Gray (1970). The estimated contribution to roughness from component conditions includes:

Channel materials,	0.022
Channel vegetation, negligible	0.000
Surface irregularities,	0.005
Variations in channel section,	0.005
Obstructions, and meandering,	0.000

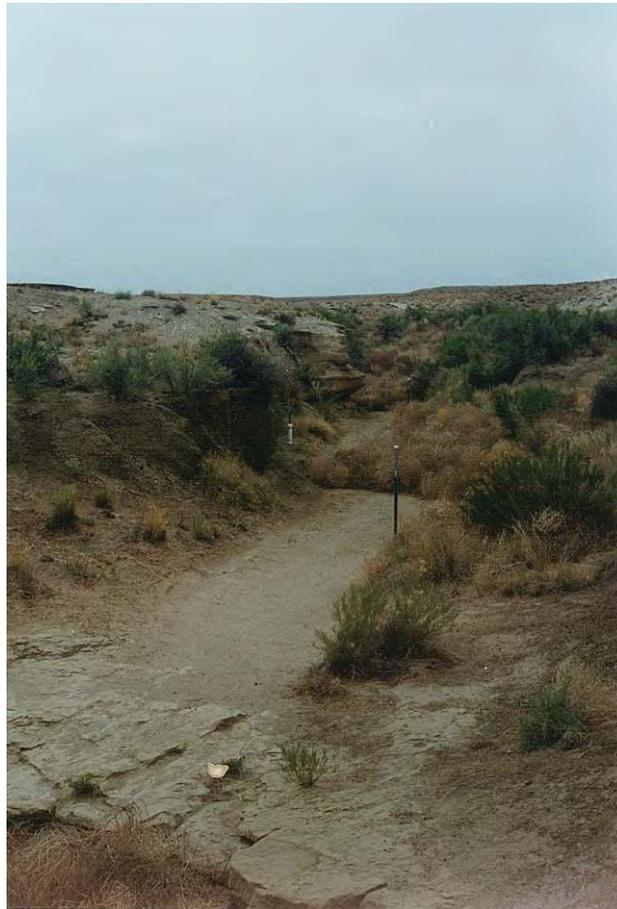
Figure 18.A-9 No Name Arroyo location NN-1, looking upstream

This location is at the No Name Arroyo downstream monitoring station which is downstream of the western permit boundary. The channel is incised and is approximately trapezoidal in shape with a bottom width of 12 to 15 feet, a top width of 35 to 50 feet and a depth of about 8 feet. Bottom materials are medium to coarse sand with rock fragments (SW). Bank materials are comprised of cohesive silt (MH). No vegetation is found on the channel bottom although the channel is at times partially filled with tumbleweeds as shown in Figure 18-A.9. Shrubs, grass and forbs occur on the channel overbank while the

channel banks are steep and support sparse vegetation. Sandstone bedrock outcrops in the channel just below the monitoring station as shown in Figure 18.A-9. The channel slope at this location is about 1.4% and the valley slope about 1.4%. Manning roughness coefficient for the channel is estimated to be about 0.037 using the procedure for small channels described in Gray (1970). The estimated contribution to roughness from component conditions includes:

Channel materials,	0.022
Channel vegetation, low	0.000
Surface irregularities,	0.010
Variations in channel section,	0.005
Obstructions, and meandering,	0.000

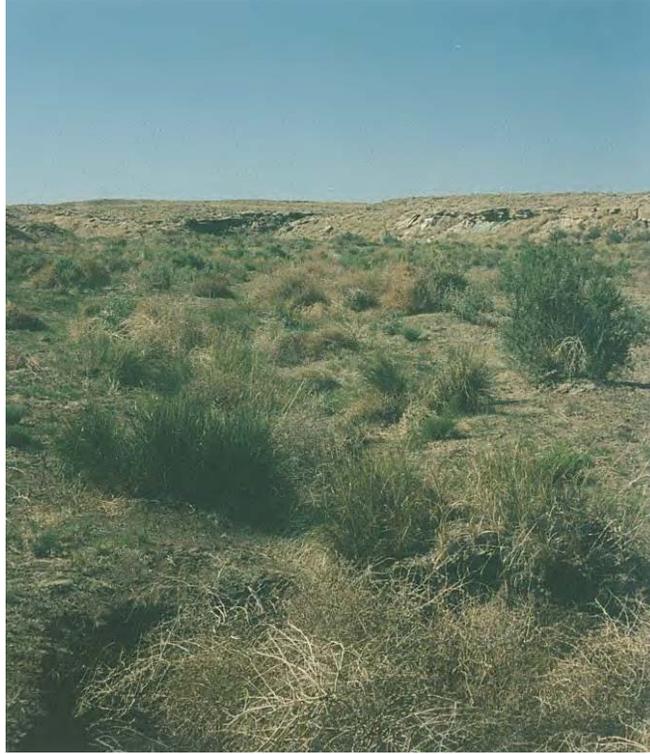
Figure 18.A-10 No Name Arroyo location NN-2, looking upstream

with a bottom width of about 5 feet, a top width 15 feet, and a depth of about 1 to 1.5 feet. Channel bed and bank materials are comprised cohesive silts (MH) with dense shrubs and grass as shown in Figure 18-A.10. A relatively broad, well-vegetated floodplain occurs on either side of the channel. Downstream of the head cut, the channel is deeply incised with near vertical banks that slough readily as seen in Figure 18-A.11. Bank materials are cohesive silts (MH). The channel bottom and banks are devoid of vegetation and the channel is partially filled with tumbleweeds as shown in Figure 18.A-11. The channel slope at this location is about 0.71% and the valley slope about 1.3%.

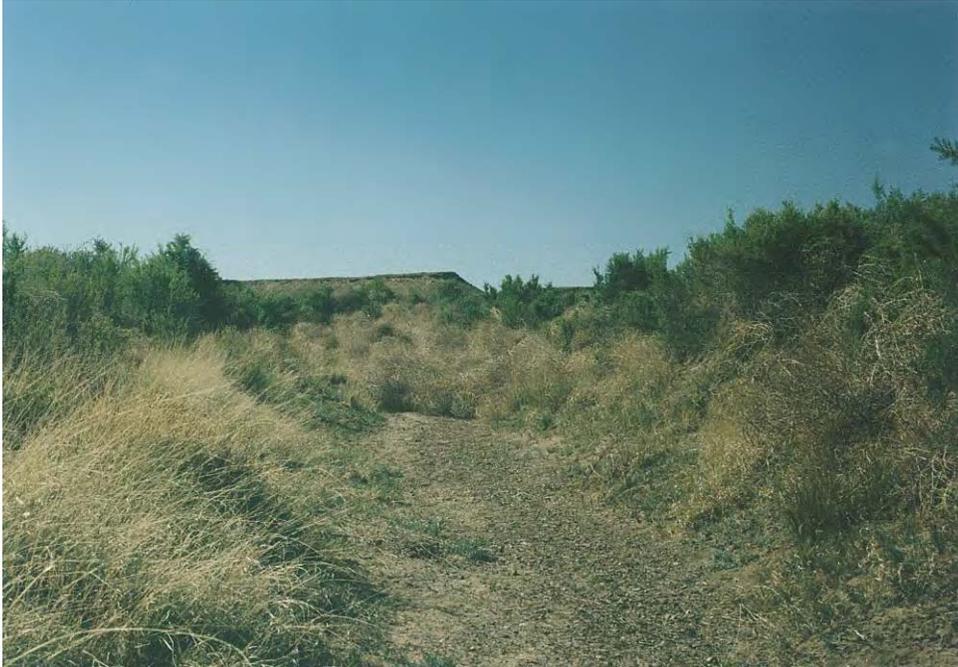
Figure 18.A-12 No Name Arroyo location NN-3, looking upstream

This location is approximately 3,100 feet upstream of the No Name Arroyo location NN-2. The channel is approximately trapezoidal in shape with a bottom width of 5 feet, a top width of approximately 20 feet, and a depth of about 5 feet. The channel bed is composed of medium sand with fine gravel and rock fragments (SP). The channel banks are composed of cohesive silty sand (SM). No vegetation is found on channel bottom but shrubs and grasses are abundant on the channel banks and overbanks as shown in Figure 18-A.12. The channel was partially filled with tumbleweeds as shown in Figure 18.A-12. The channel slope and valley slope at this location are both approximately 0.72%.

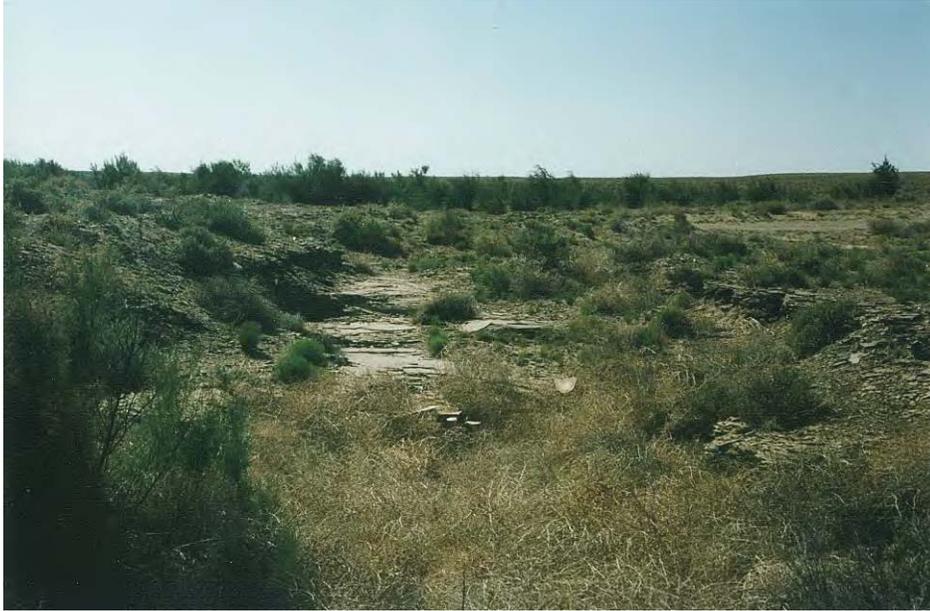
Figure 18.A-13 Spillway channel below No Name Impoundment, location NN-4, looking upstream

This location is immediately below the No Name impoundment approximately 3,350 feet upstream of the No Name Arroyo location NN-3. A channel section was not measured at this location because of the significant variation in channel conditions. The spillway overflow from the impoundment crosses the Burnham road on the south side and flows down a bedrock lined channel to the valley floor below the impoundment as shown in Figure 18-A.13. A very dense growth of shrubs and tamarisk is present in the valley below the impoundment with channel headcuts occurring at a number of places within the valley floor as shown in Figure 18.A-14. The valley floor soils consist of silt and very fine sand (MH). The valley slope just below the No Name impoundment is about 1.0%.

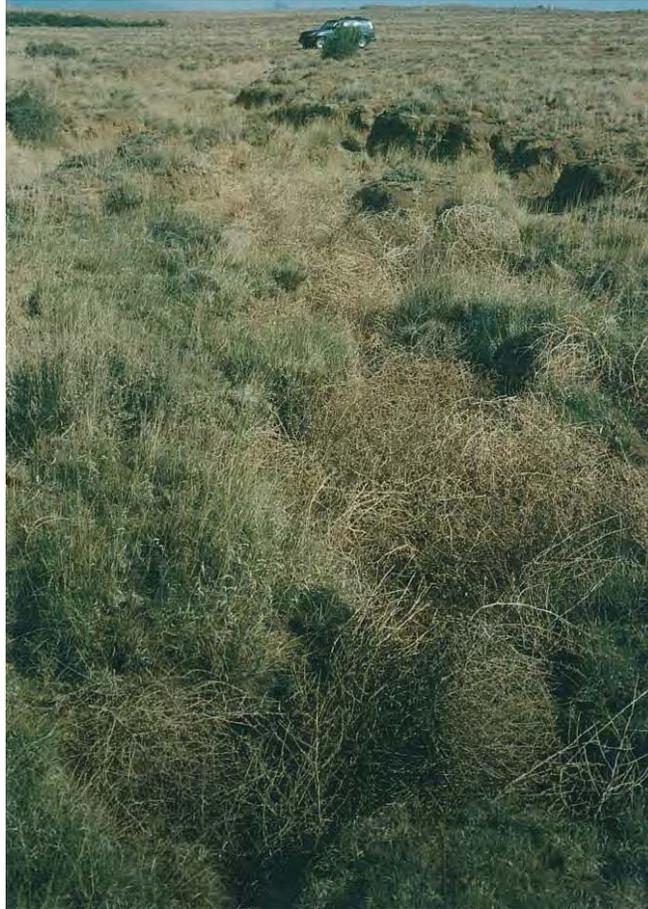
Figure 18.A-15 No Name Arroyo location NN-5, looking downstream

(MH). No vegetation is found on the near vertical banks where they occur but dense shrubs and grasses are abundant on the overbank but less dense on the channel bottom. The dimensions of the channel section were not measured at this location because of the widely varying sections. Tumbleweeds were found at numerous places within the channel as shown in Figure 18.A-15. The valley and channel slope at this location are about 0.78%.

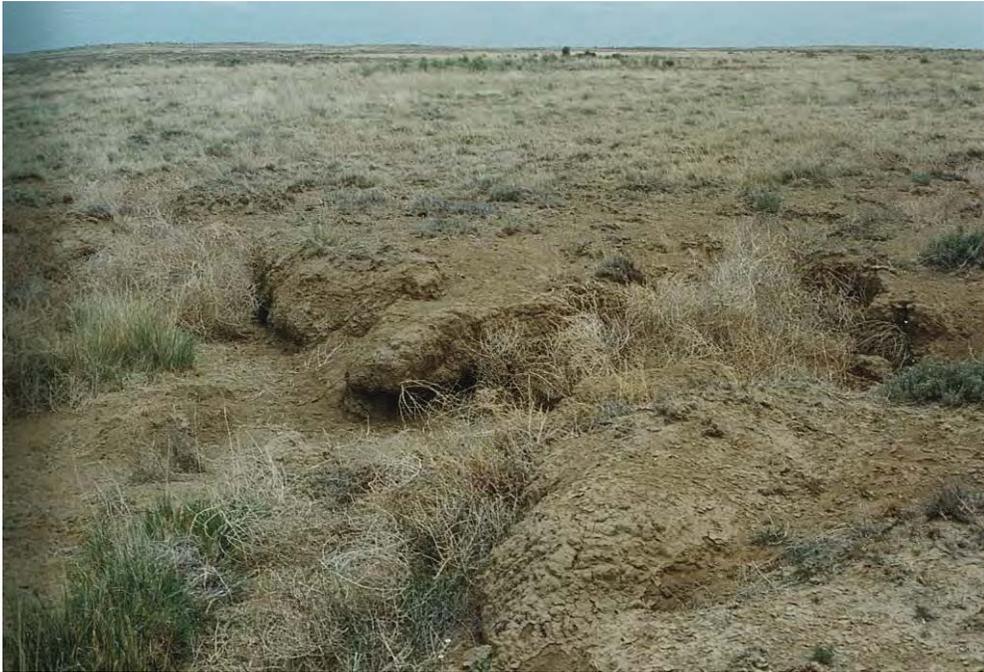
Figure 18.A-16 No Name location NN-6, looking upstream

This location is approximately 5,060 feet upstream of the location NN-5. The channel is incised about 2 feet and is irregular in shape as shown in Figure 18-A.16. Small channel headcuts and soil pipes were common around location NN-6. The channel above and below this location occurs intermittently within the valley bottom and is typically associated with channel incision with headcuts and soil pipes. Channel bed and bank materials consist of cohesive silts (MH). Vegetation in these areas is sparse due to the presence of limiting soil conditions. The density of vegetation is greatest in minor depressions where water and windblown soils accumulate but channel erosion or scouring does not occur. A channel section was not measured at this location because of the widely varying sections. Tumbleweeds were found at

numerous places within the channel as shown in Figure 18.A-16. The channel and valley slope at this location is about 0.82%.

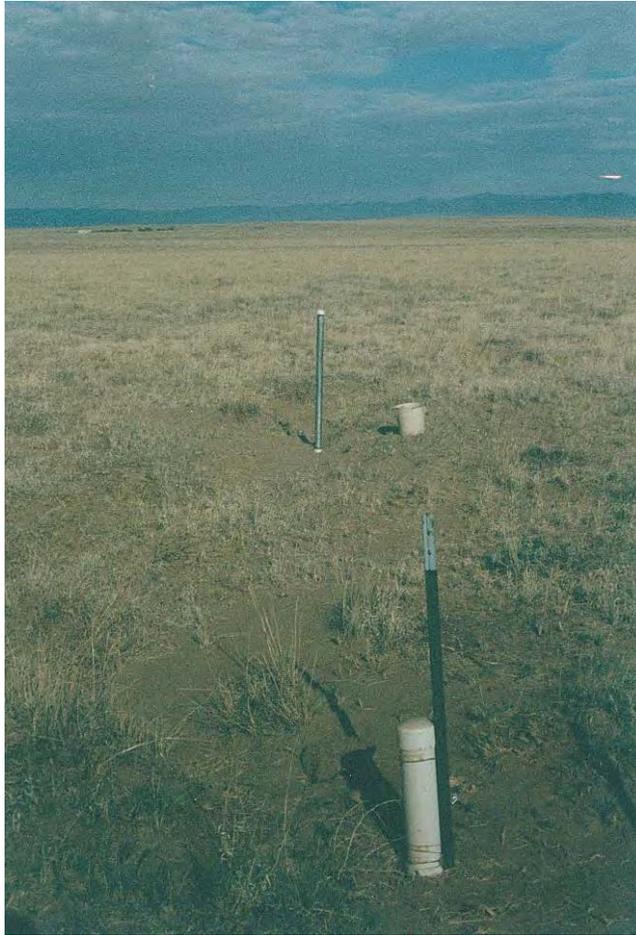
Figure 18.A-17 No Name Arroyo location NN-7, looking downstream

This location is at the upstream monitoring station on No Name Arroyo located just west of the eastern lease boundary approximately 400 feet upstream of location NN-6. The surface water monitoring station includes one stage crest gage and one single stage sampler. The channel is approximately parabolic in shape with a top width of less than 6 feet and a depth of less than 1 foot but varies along the channel. The channel does not extend upstream of this location and occurs intermittently downstream. Channel rills are found within the broad flat valley of No Name Arroyo both upstream and downstream of the eastern lease boundary. Channel cross-sections associated with the stage crest gage and sediment sampler are included on [Exhibit 18.A-3](#). Channel bed sediments at this location are fine sands (SM). Channel banks are comprised of cohesive silty sand (ML). Vegetation occurs on the channel bank and overbank but is very sparse on the channel bed as shown in Figure 18.A-17. The channel and valley slope at this location are about 0.82%. The Manning roughness coefficient for the channel is estimated to be about 0.055 using the procedure for small channels described in Gray (1970). The estimated contribution to roughness from component conditions includes:

Surface irregularities,	0.010
Variations in channel section,	0.015
Obstructions, and meandering,	0.000

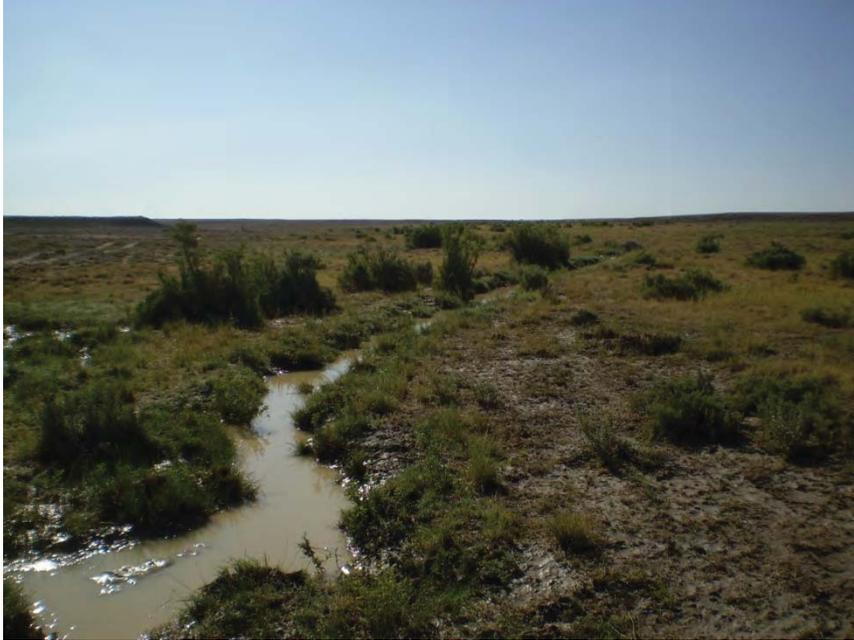
Figure 18.A-18 No Name Arroyo low flow channel upstream of Burnham Road

The area from NN-7 to approximately 500 feet downstream, the channel is incised at a depth of 2 to 4 feet and a width of 10 to 20 feet and has significant braiding. With the exception of the rare major storm events, flow is confined to the channel. The vegetation in the channel is consistent with the downstream section; however, the effective ground cover is approximately 50% in the channel resulting in an estimated Manning's n value of 0.035.

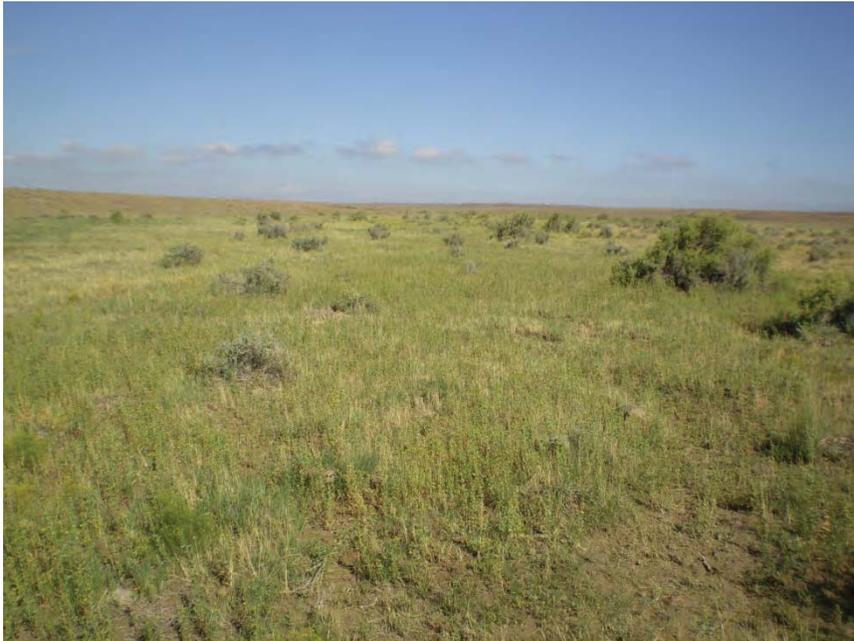
Figure 18.A-19 No Name Arroyo shallow concentrated flow area upstream of Burnham Road

Immediately upstream of Burnham Road is the other location where the No Name Arroyo characteristics deviate from the typical channel section described above. Burnham Road acts as a retention structure creating a ponding area on the upstream side of the road. No crossing culverts were found. The gradient of the road slopes downward from north to south with a small dip in the road just south of the effective ponding area before the gradient of the road starts in an upward slope. This dip in the road acts as an overflow location for the ponding area and corresponds to a sandstone outcrop that limits the erosion of the roadway. The ponding area has an effective ponding depth of approximately 4 to 6 feet before flow will inundate the overflow location. It is assumed this ponding area was intentionally created to serve as a cattle watering pond. The bottom of the ponding area is covered with clayey soil. There is little to no vegetation in the bottom of the ponding area; however, heavy brush is present on the upstream half of the pond overbanks. This heavy brush extends into and up the channel feeding the pond for approximately 500 feet creating an effective ground cover of almost 100% resulting in an estimated Manning's n value for this part of the channel of 0.15.

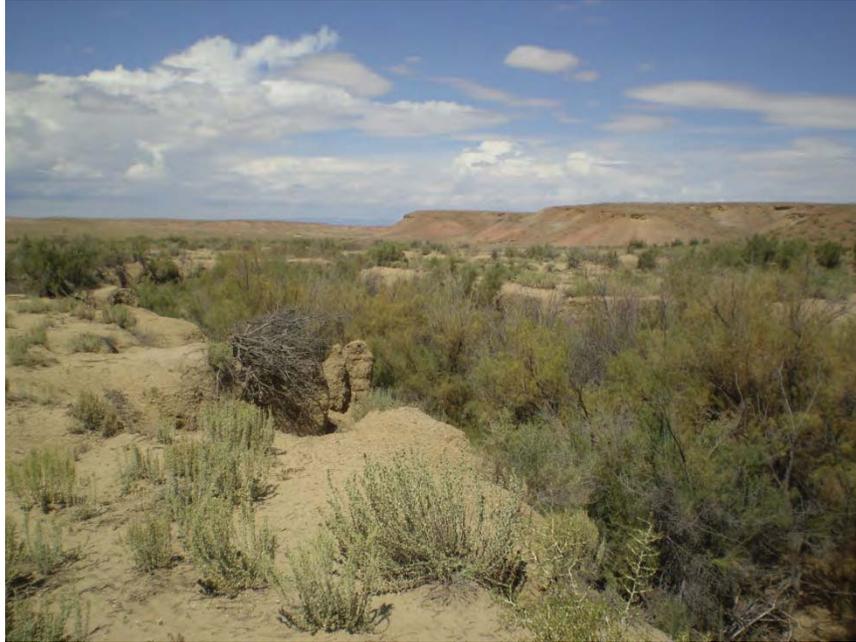
Figure 18.A-23 No Name Arroyo at approximately NN-4

From NN-4 to downstream approximately 1,000 feet, the channel is 10 to 12 feet deep and 10 to 20 feet wide. Vegetation in the channel is very thick constituting a ground cover of approximately 80%. Bends are more pronounced and frequent but do not exceed approximately 45 degrees. Due to the thick vegetation, the Manning's n value for this portion of the channel is estimated to be 0.10.

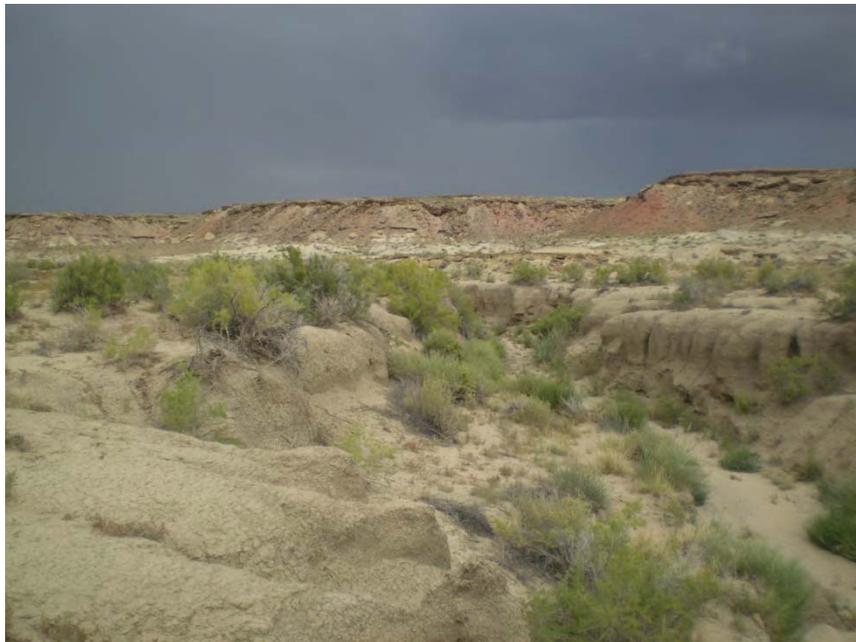
Figure 18.A-25 No Name Arroyo from NN-2 to NN-1

From NN-2 to NN-1, the channel banks are vertical or nearly vertical in most locations. In the locations where the channel banks are not vertical, they range to a side slope of approximately 3h:1v. The top edge

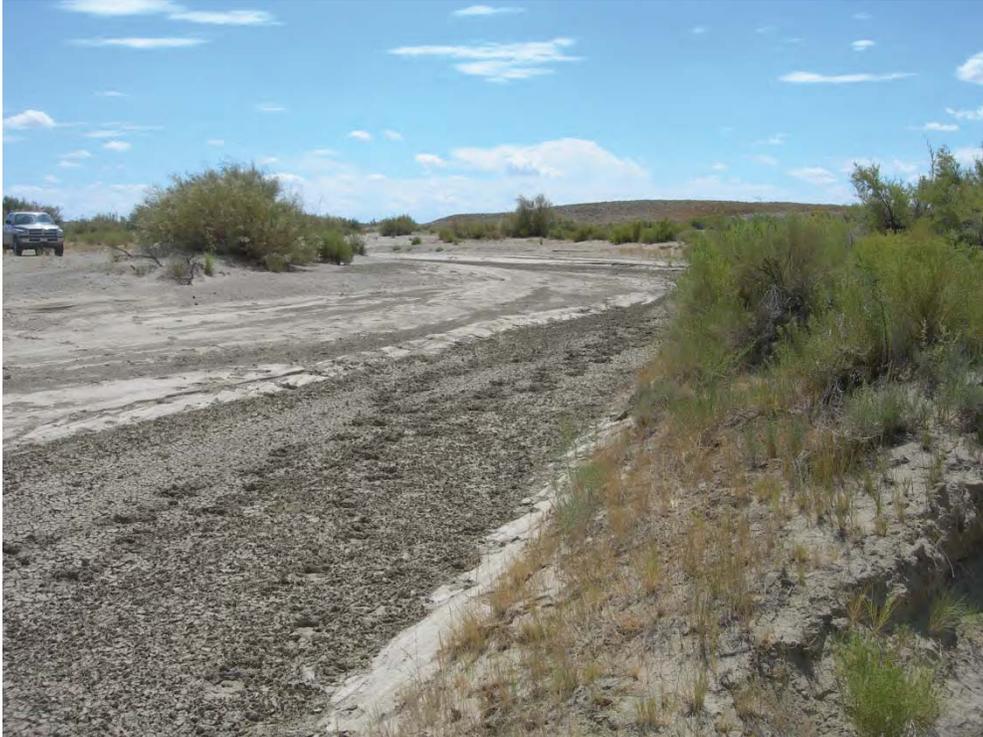
Figure 18.A-30 Pinabete Arroyo near confluence of main tributary channel from Drainage Basin 18

The URS team performed an overall reconnaissance of the area by driving through the project area from north to south over the watersheds of both the arroyos. The first basin explored was Drainage Basin 18. This drainage basin is located immediately downstream of Burnham Road and drains to the Pinabete Arroyo directly downstream of cross section P-3. A GPS receiver was used to mark the drainage features of the tributary channels within Drainage Basin 18.

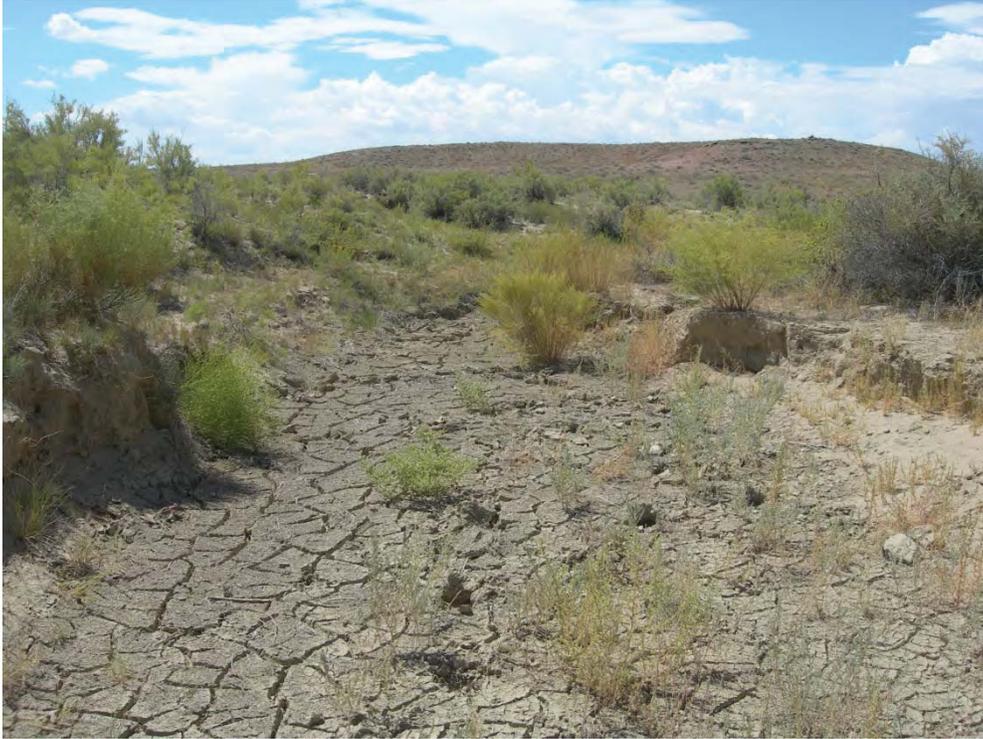
Figure 18.A-31 Main tributary channel from Drainage Basin 18 near confluence with Pinabete Arroyo

The tributary channels within Drainage Basin 18 are fairly flat and narrow, rectangular in shape, have a bottom width varying from less than 1 foot to over 10 feet, and side slopes from 1h:1v to 3h:1v. The main tributary channel within Drainage Basin 18 extends approximately 5,000 feet to the southwest from the confluence with the Pinabete Arroyo. The total length of all the tributary channels within the Drainage Basin 18 is 18,400 feet. The contributing drainage area is estimated to be 322 acres. The estimated drainage density is 60 feet per acre (ft/acre).

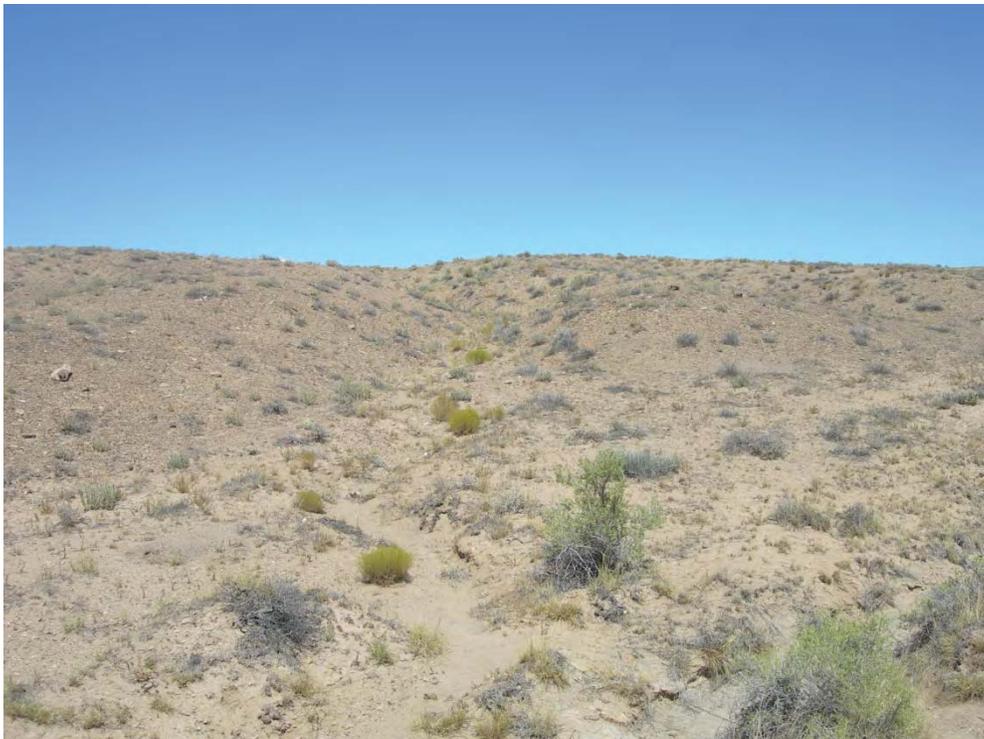
Figure 18.A-37 Typical upstream channel segment in Drainage Basin 28

On the third day, measurements of the lengths of the tributaries within Drainage Basin 28 were conducted. The tributaries within this basin have slopes varying from 2 to 20 percent, which is steeper than tributaries measured in the preceding basins. The tributaries are narrower in comparison to those within Drainage Basin 18. The tributary channels generally have a trapezoidal shape, a bottom width varying from 0.5 to 4 feet, and 1h:1v to 2h:1v side slopes. The main tributary channel extends approximately 1,080 feet to the confluence with the Pinabete Arroyo. The total length of all tributaries within Drainage Basin 28 is 2,350 feet. The contributing drainage area is approximately 16.8 acres. The estimated drainage density is 140 ft/acre.
