Review Reports - MSHA Sedimentation

REVIEW REPORT
Sedimentation Structure
N14-F
Kayenta Mine
Navajo County, Arizona
for
PEABODY COAL COMPANY

REPORT
Dam-Break Analysis
for
Sedimentation Structures J28-B, J28-C, J28-D, and J28-G
Kayenta Mine
Navajo County, Arizona
for
PEABODY COAL COMPANY

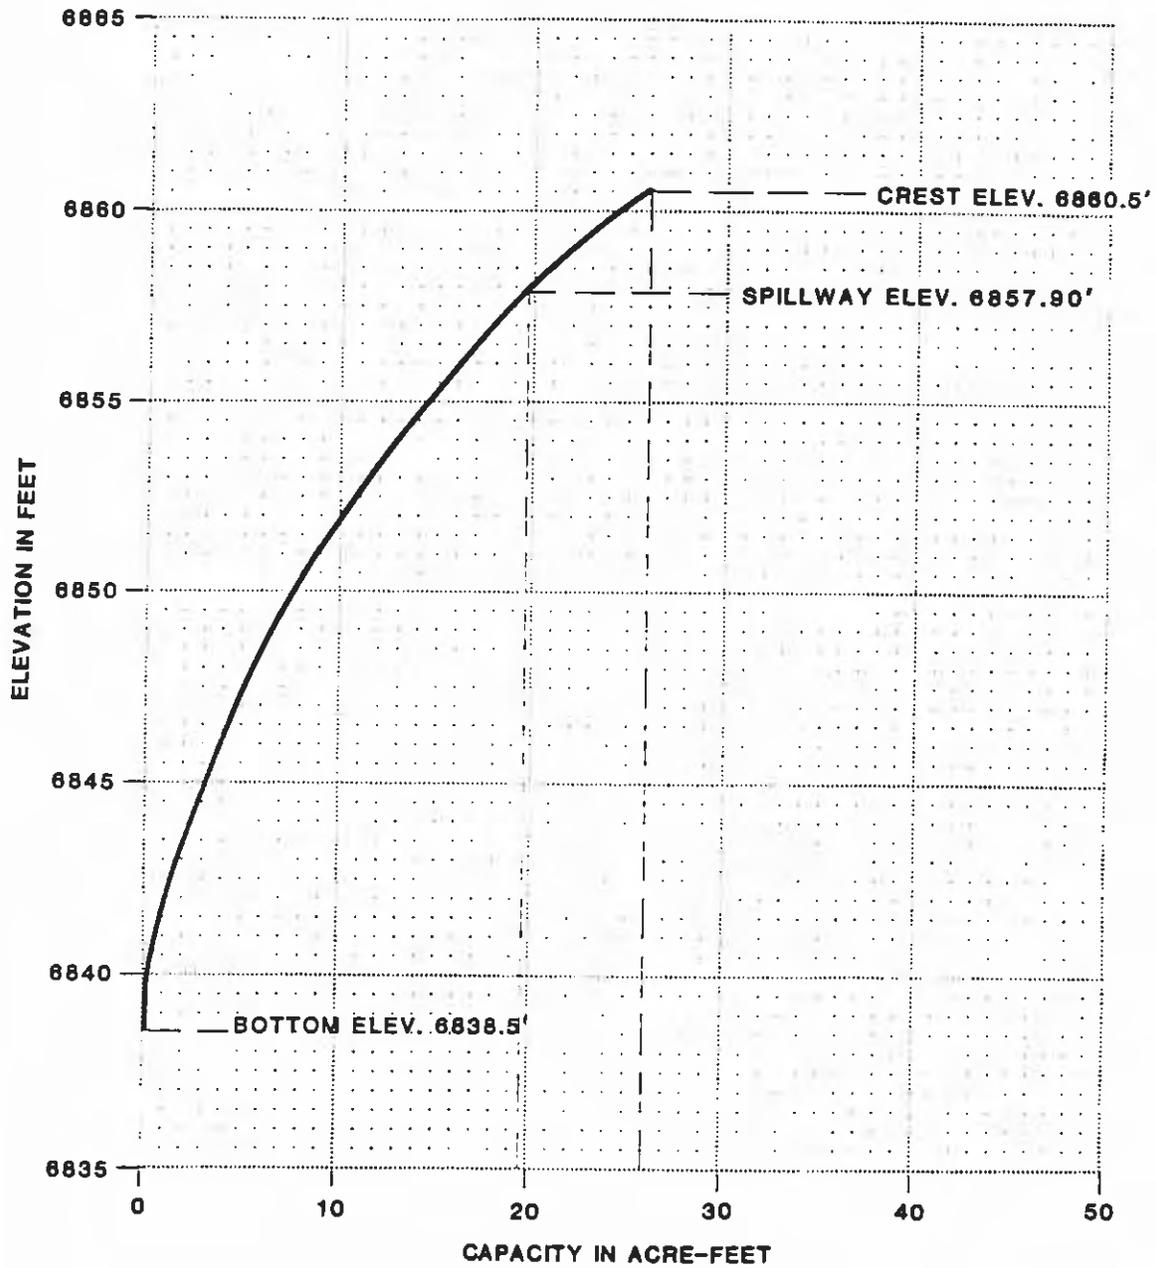
VOLUME-ELEVATION
CURVE
J28-B

The elevation-storage curves for Sedimentation Structures J28-B, J28-C, J28-D, and J28-G are shown in Figures 2, 3, 4, and 5, respectively. The elevation-storage and spillway rating curves for the J16-A and Reed Valley Dams are shown in Figures 6, 7, 8, and 9, respectively.

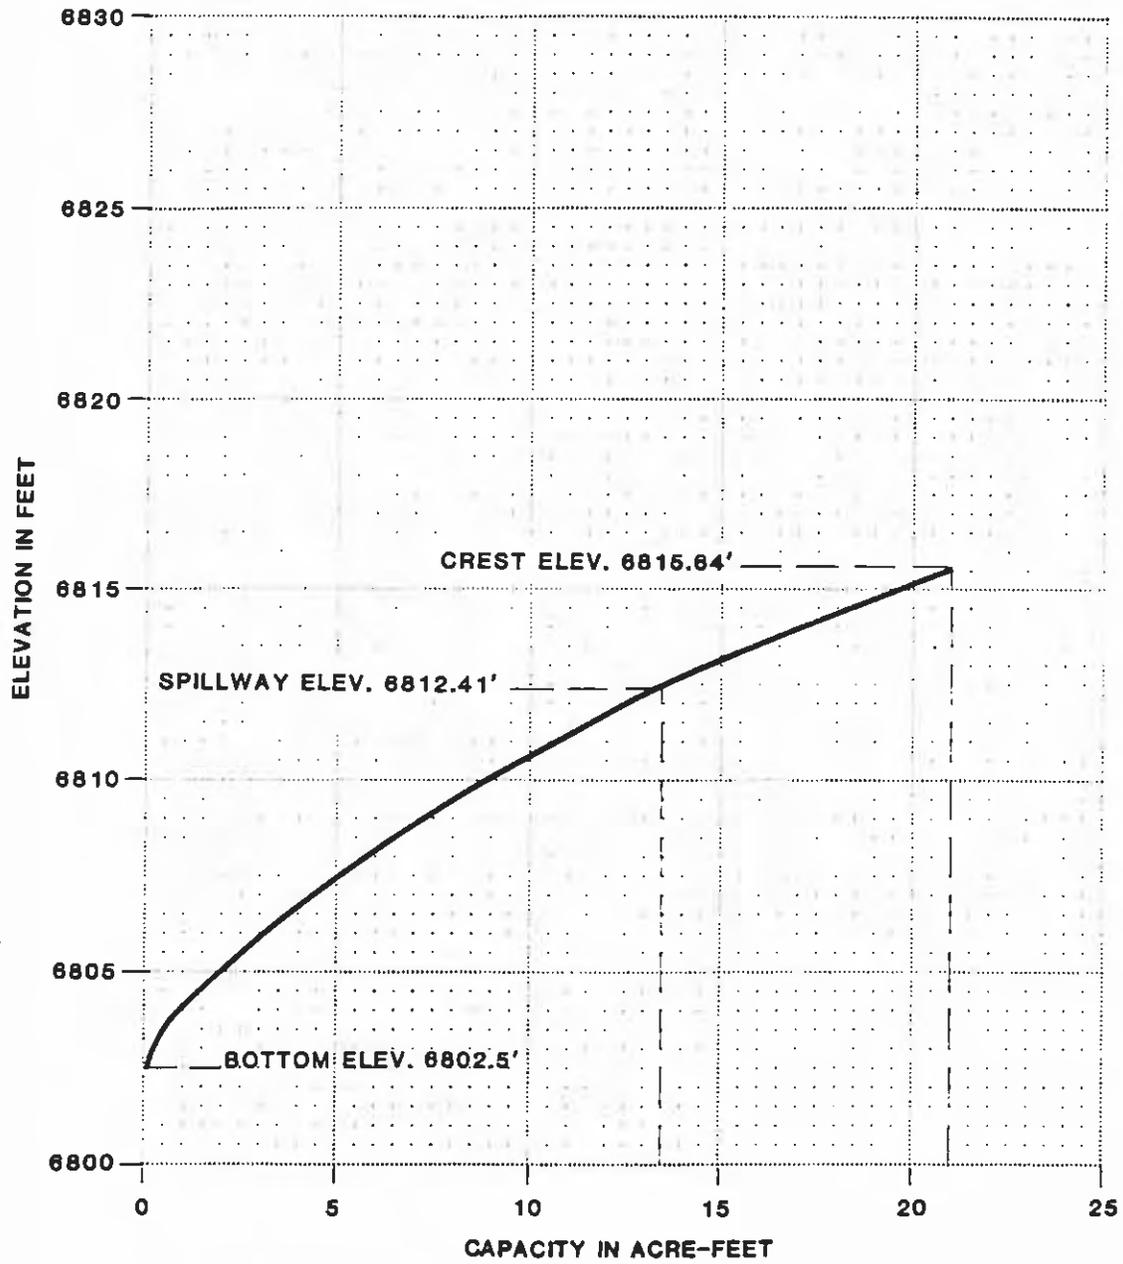
VOLUME-ELEVATION
CURVE
J28-C

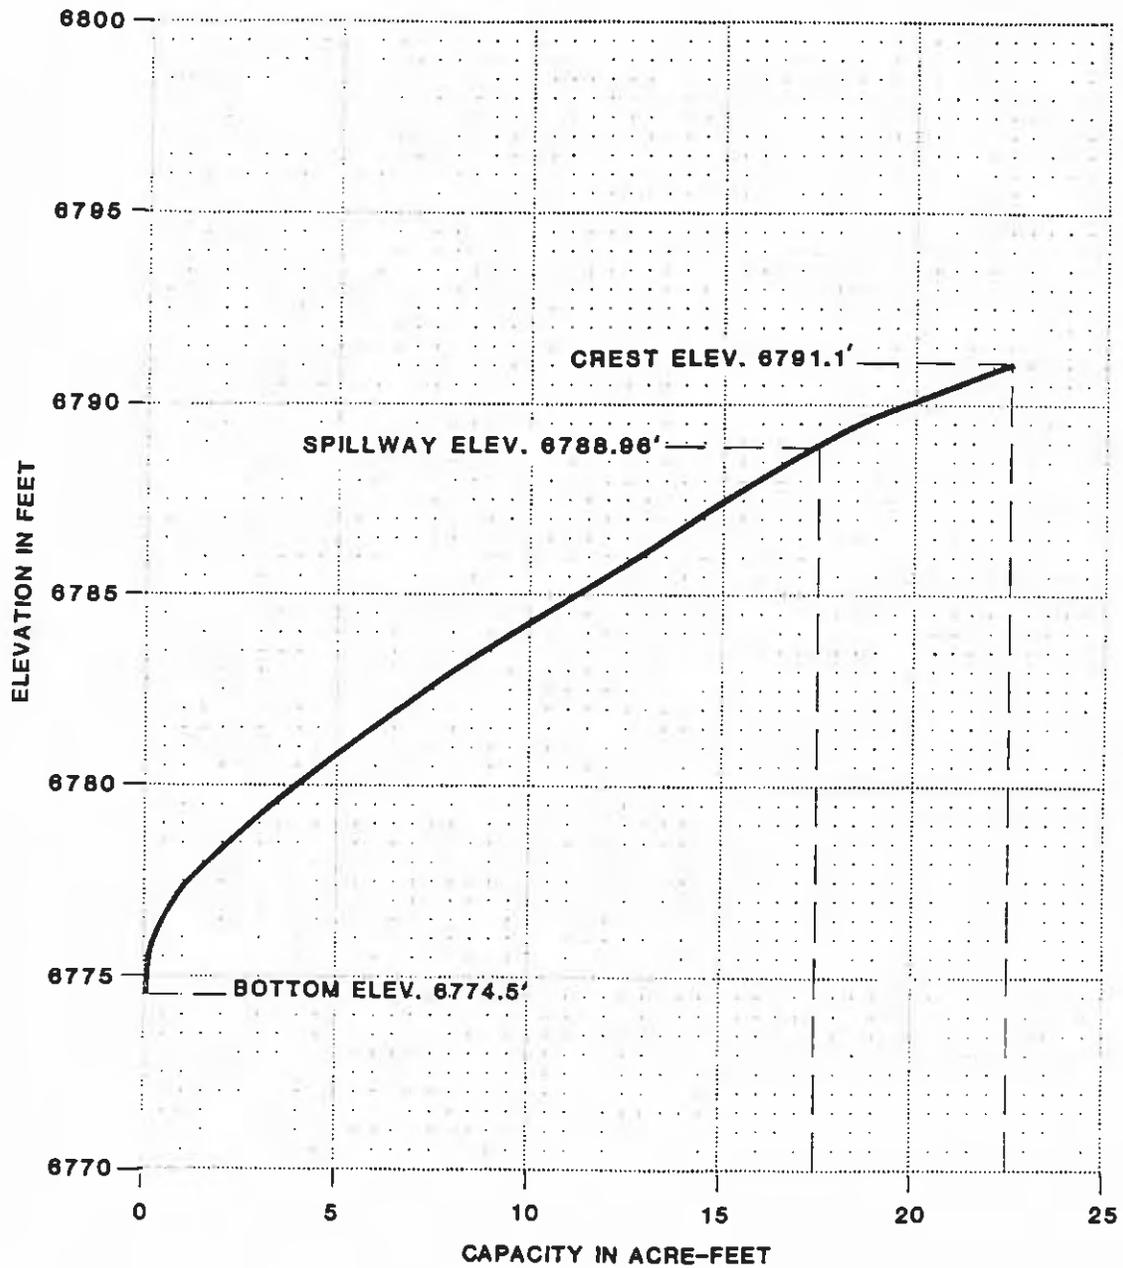
VOLUME-ELEVATION
CURVE
J28-D

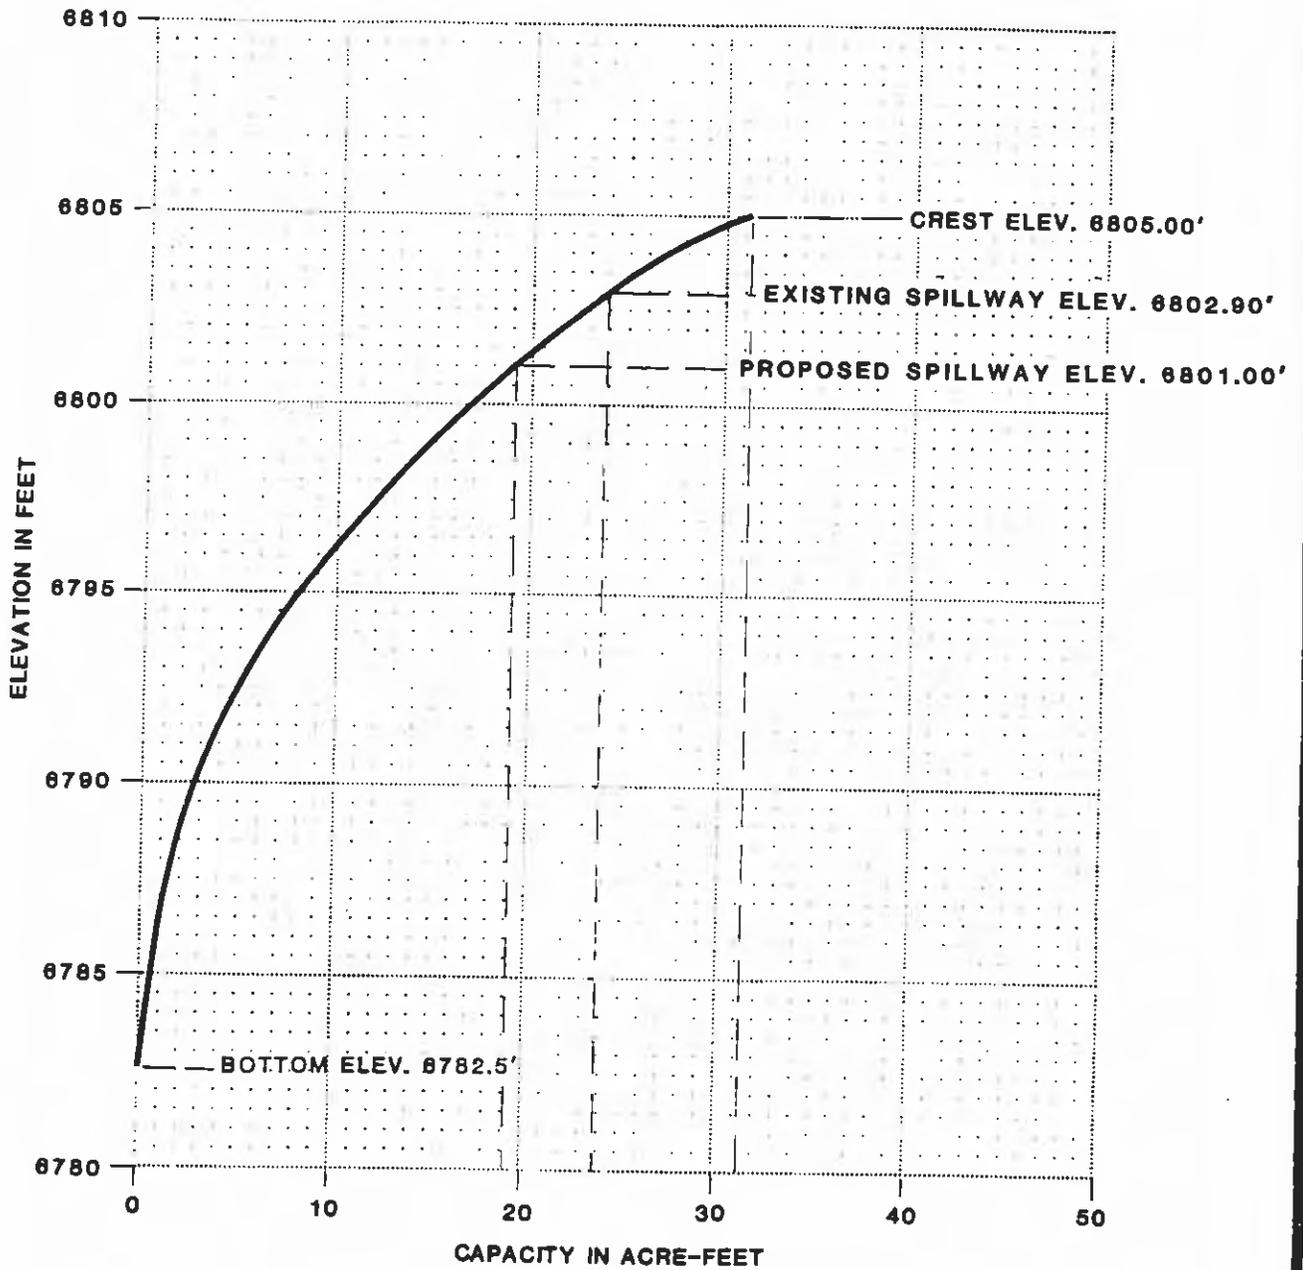
VOLUME-ELEVATION
 CURVE
 J28-G

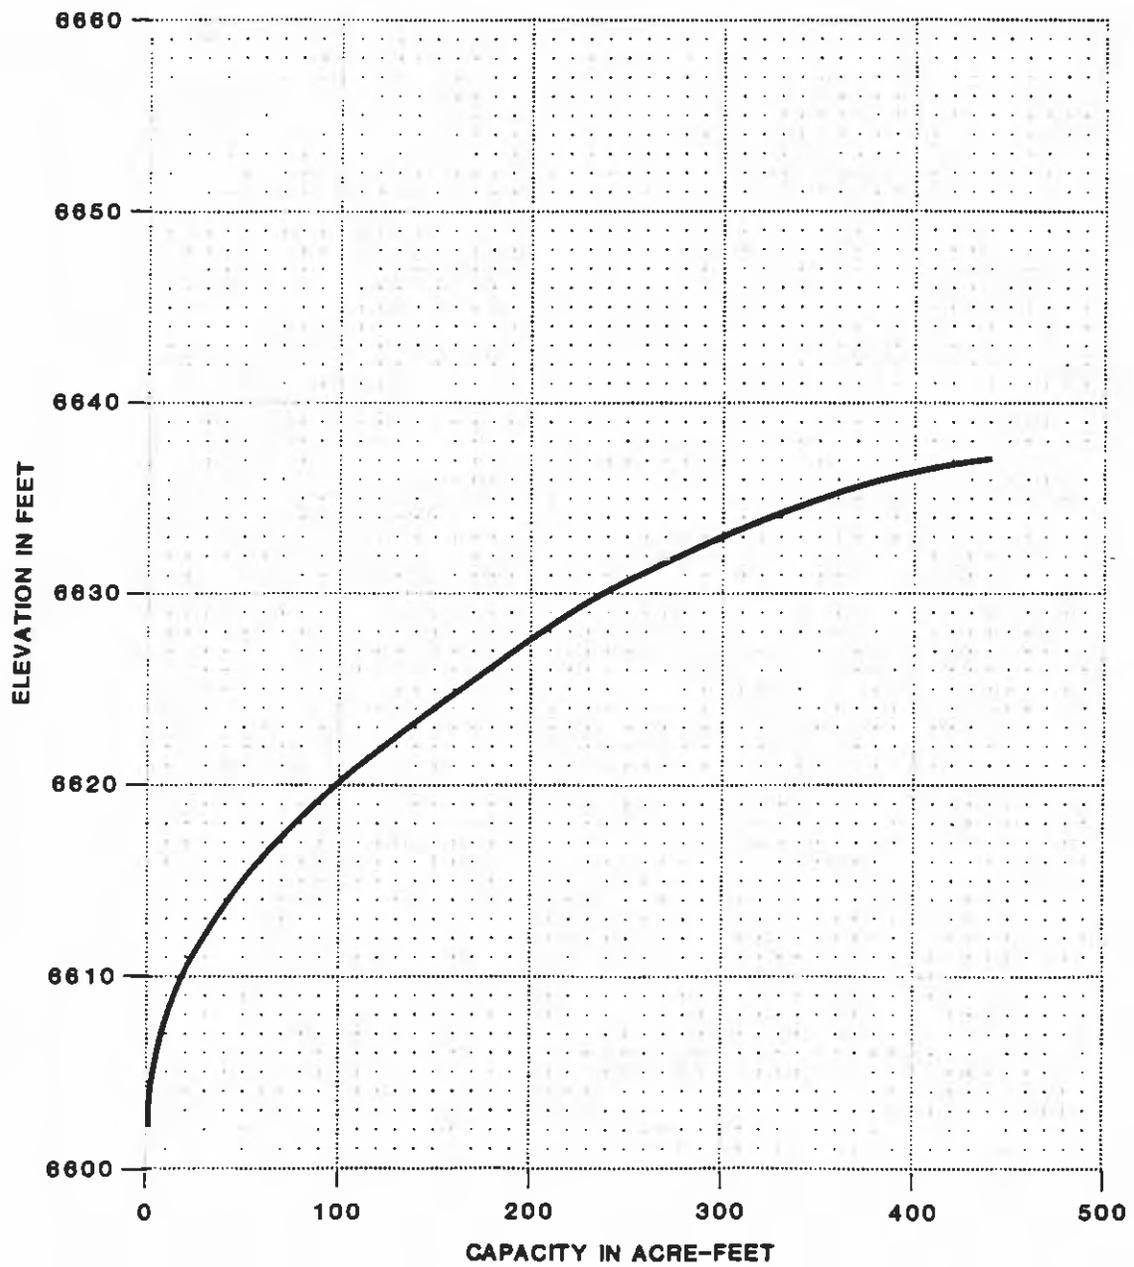
Figure 6

VOLUME-ELEVATION
CURVE
J16-A
RESERVOIR

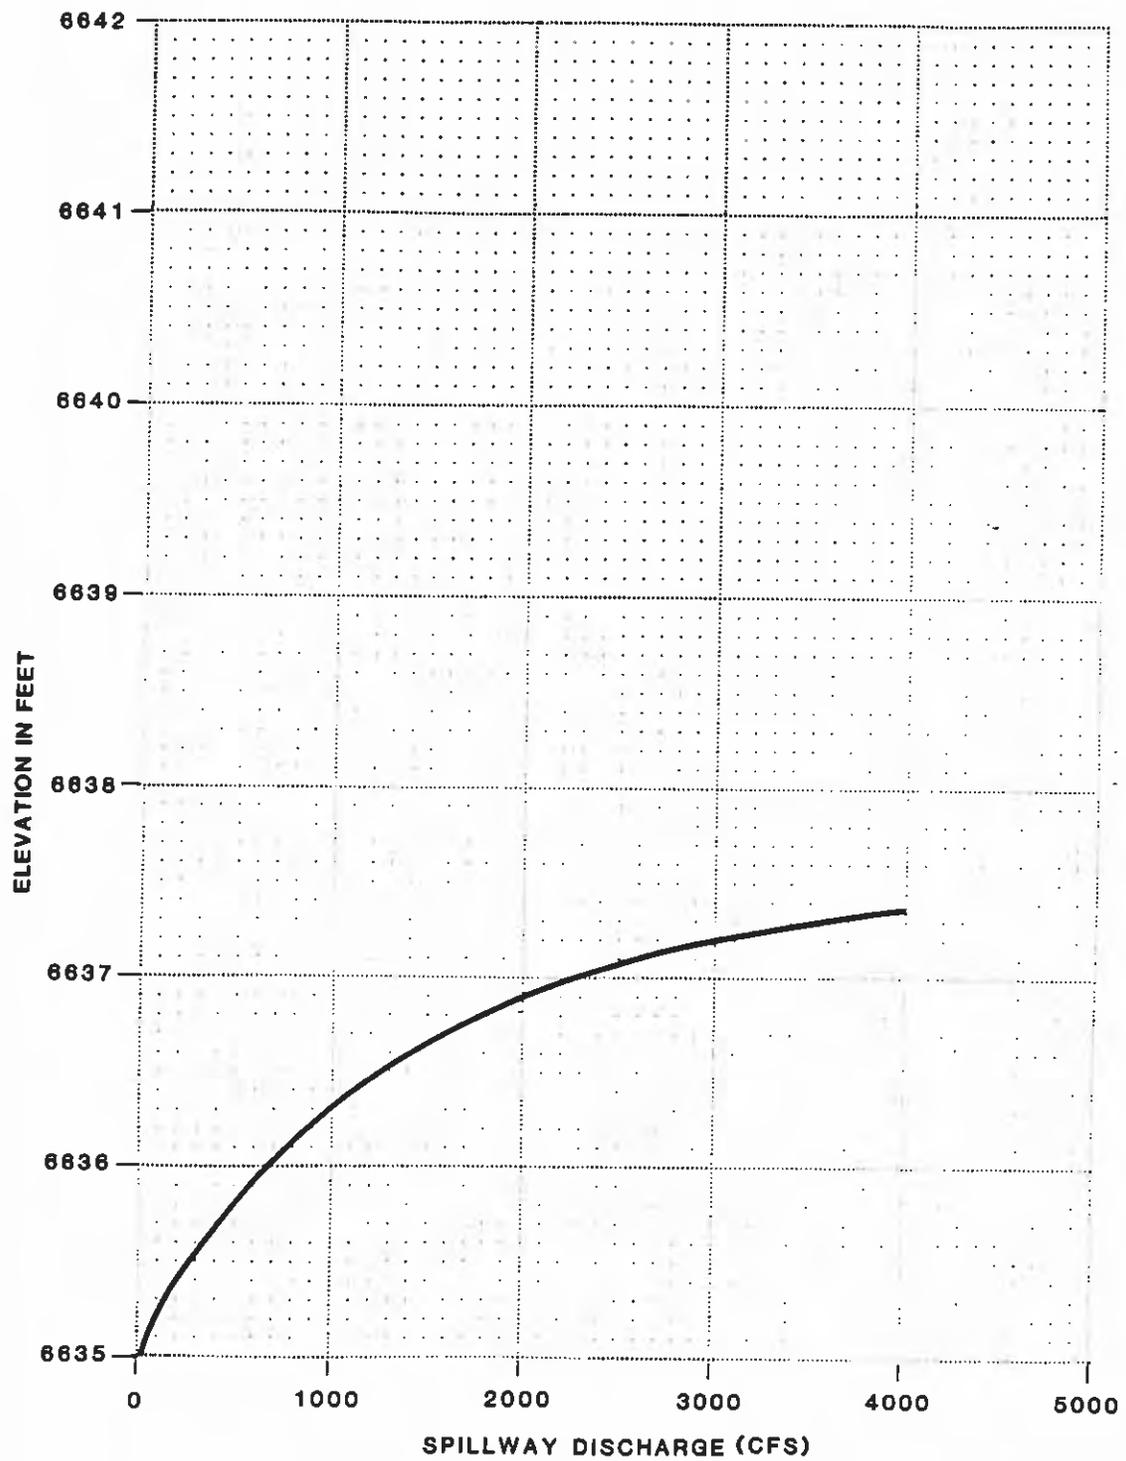
Figure 7

**SPILLWAY RATING CURVE
J16-A**

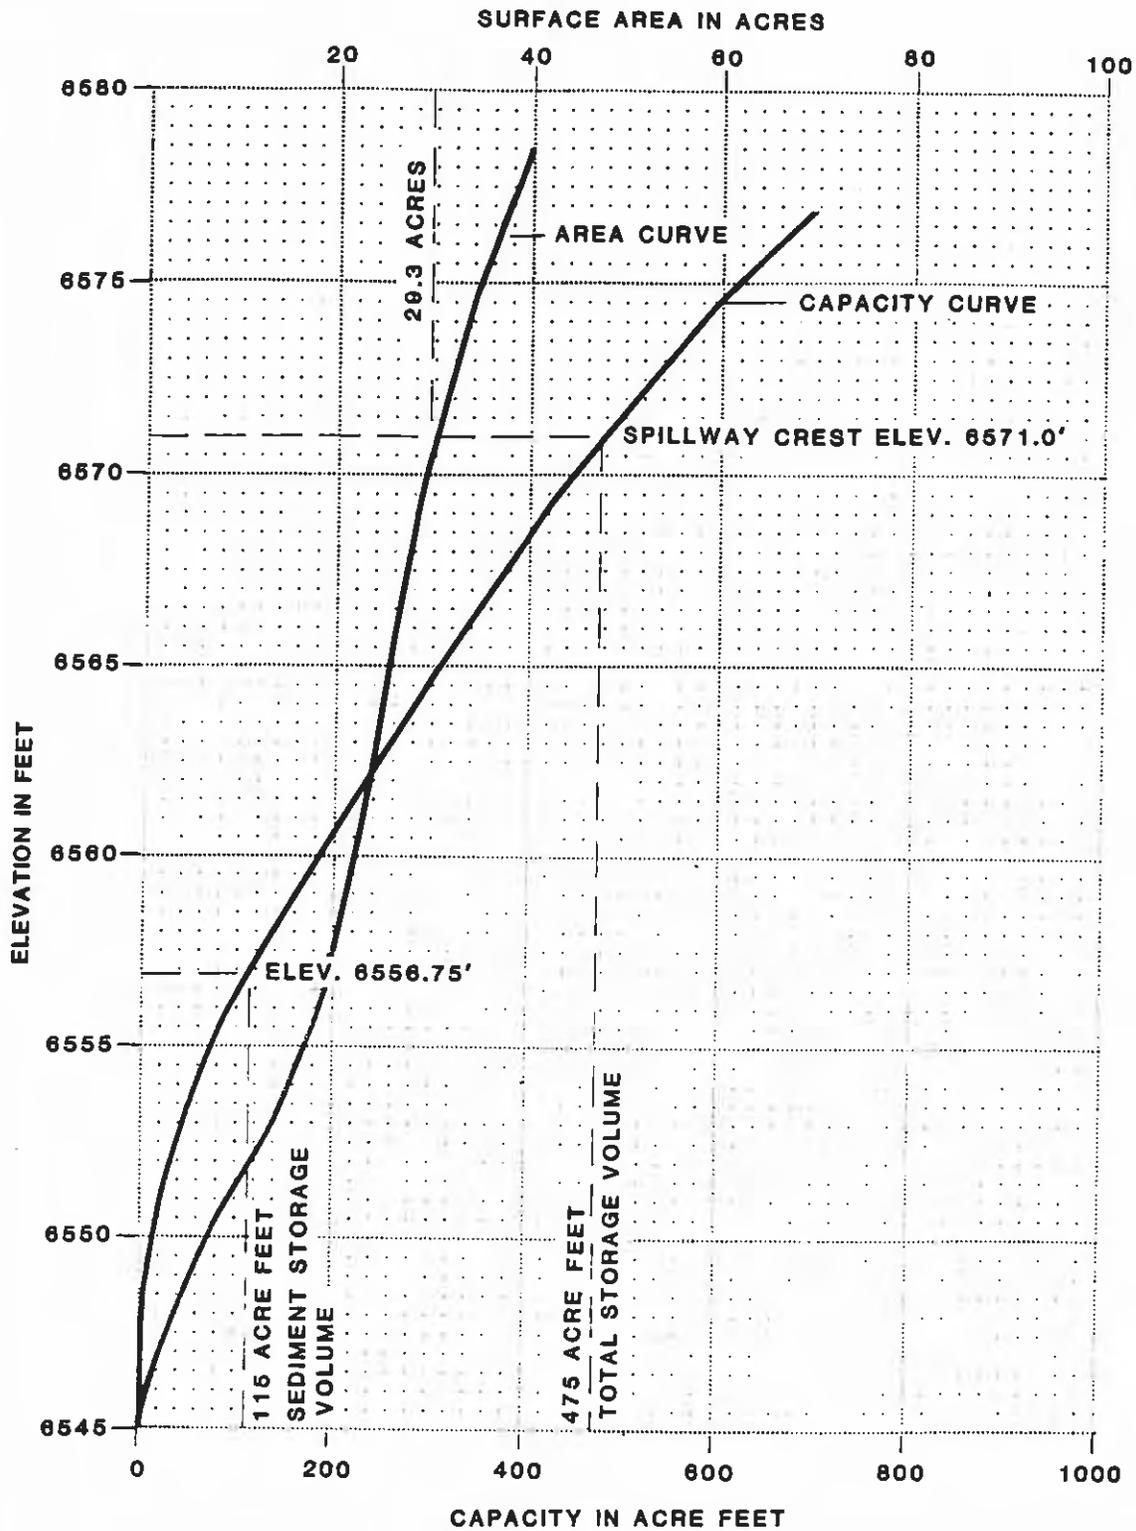
Figure 8

**VOLUME-ELEVATION
CURVE
REED VALLEY
RESERVOIR**

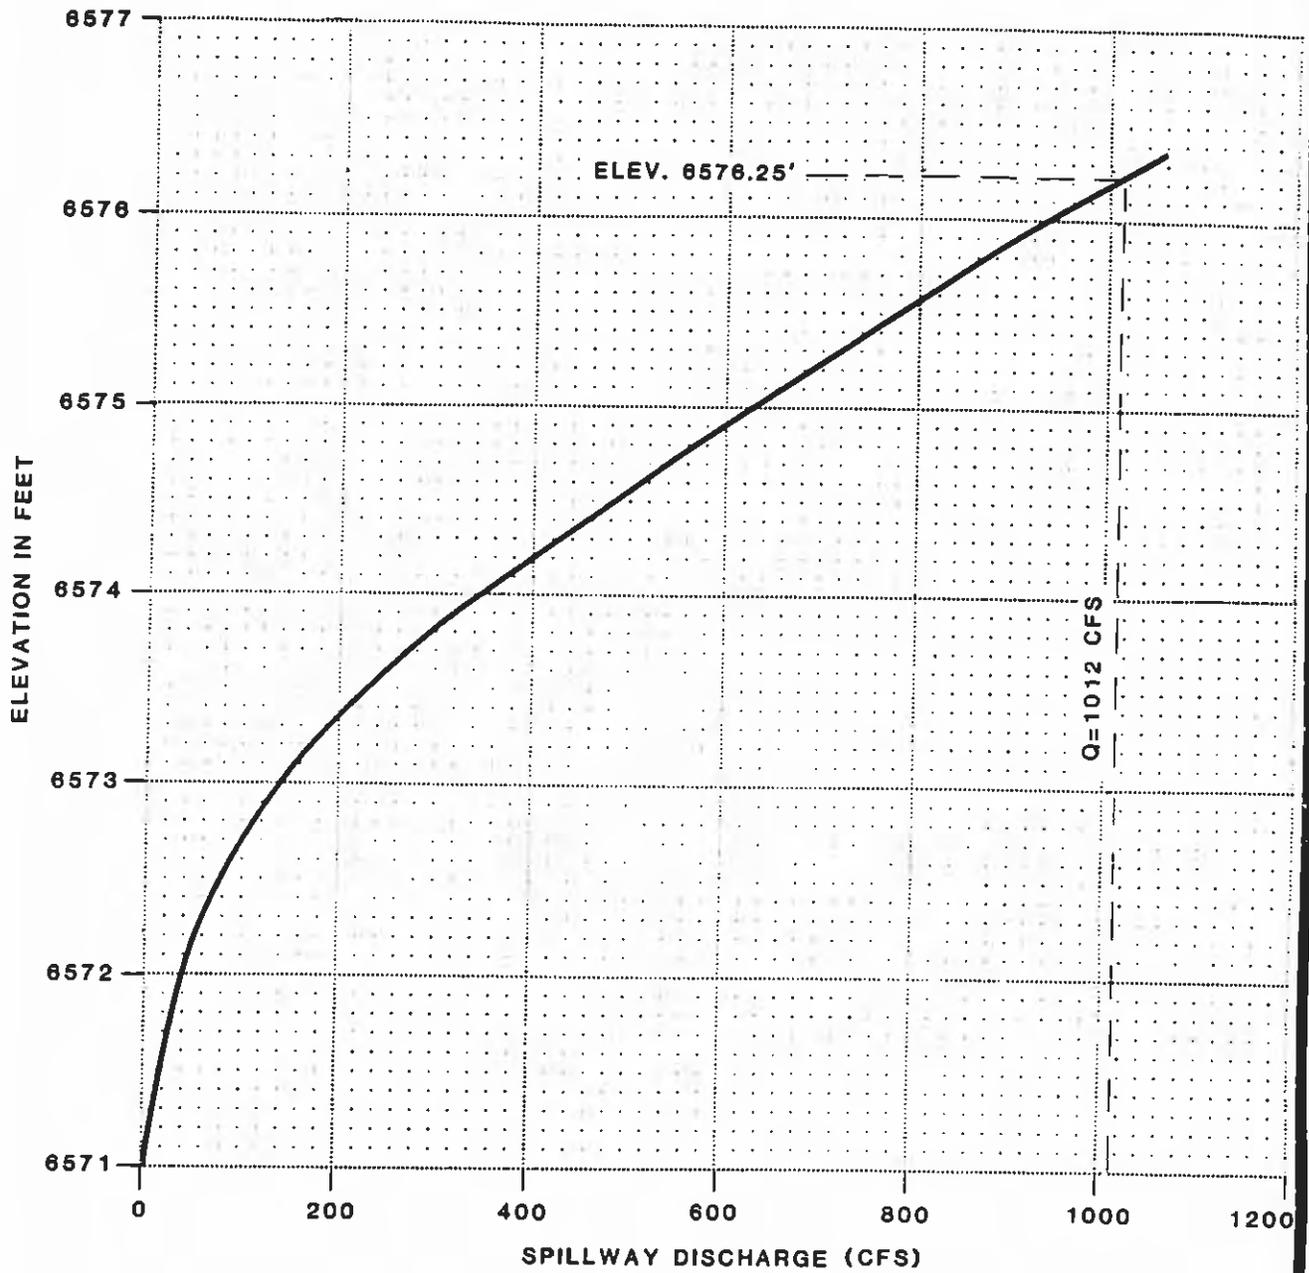
SPILLWAY
 RATING CURVE
 REED VALLEY
 DAM

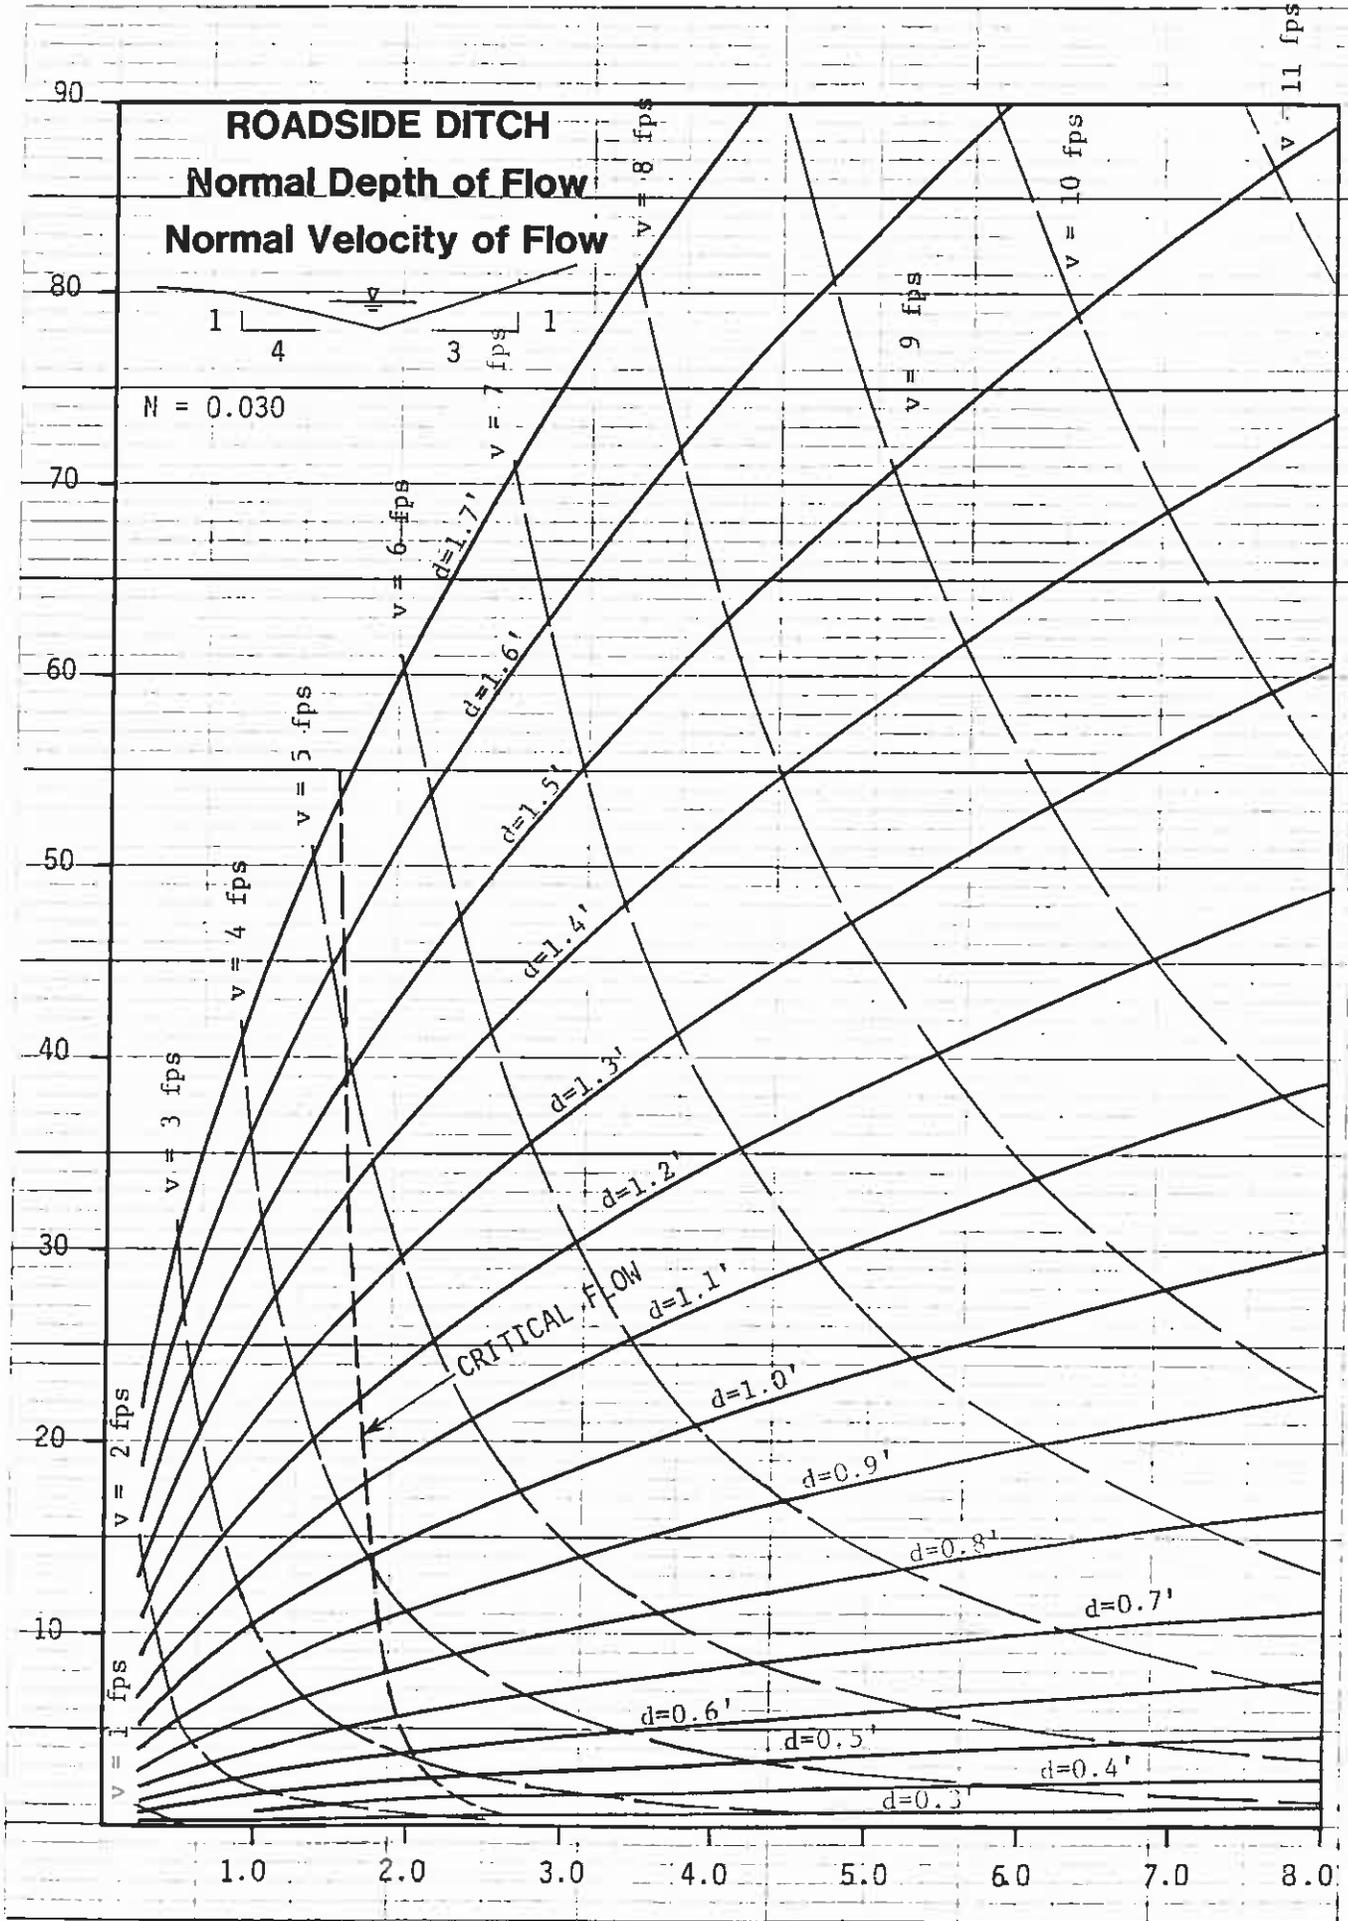
Roadside Ditches Capacity Charts

FLOW IN CFS

SLOPE IN %

v = 13 fps

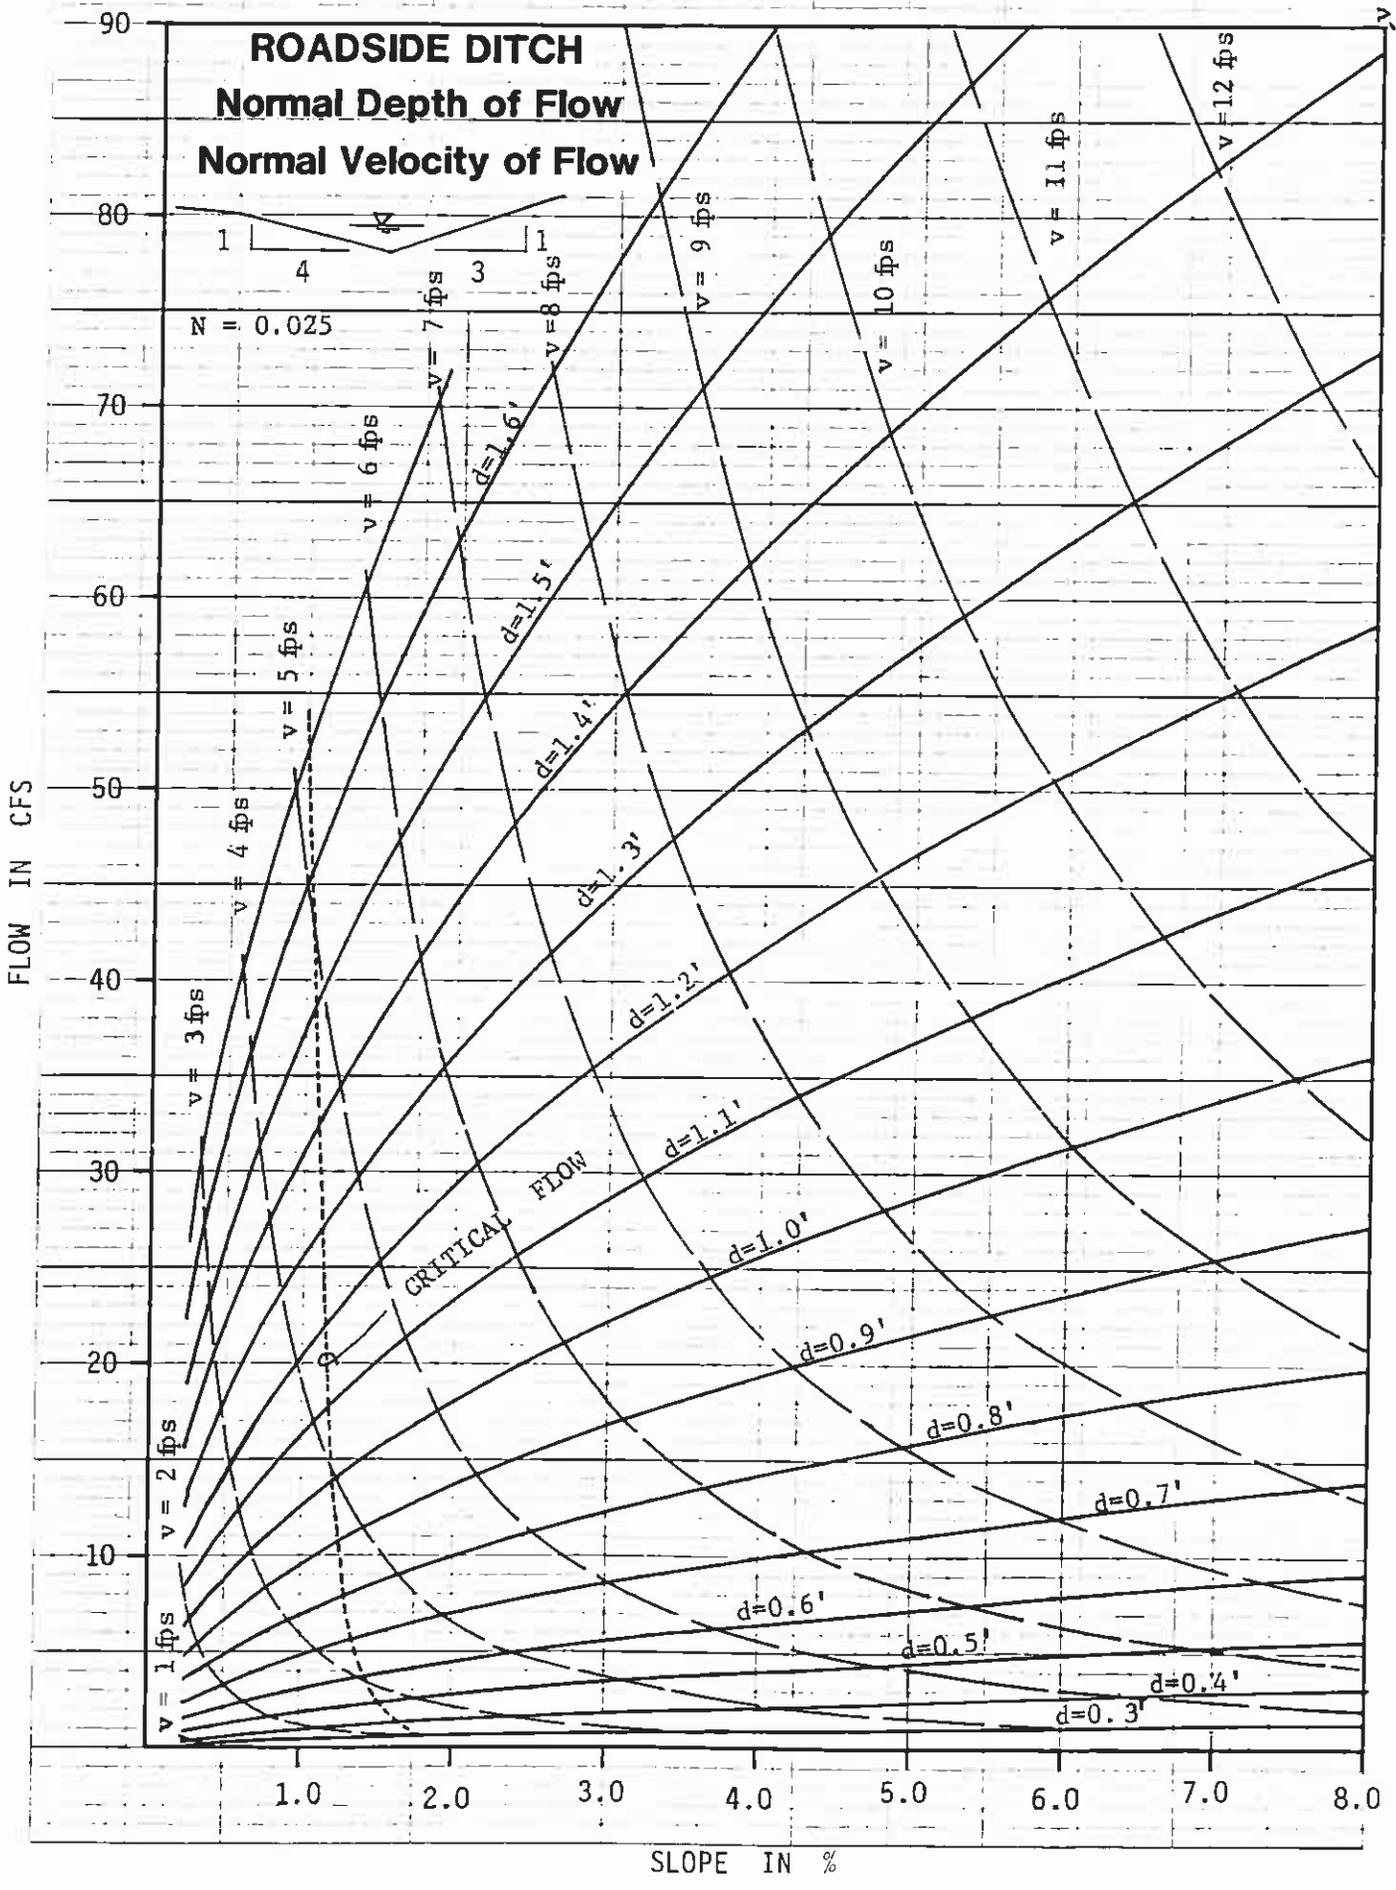
Normal Depth of Flow

Normal Velocity of Flow

SLOPE IN %

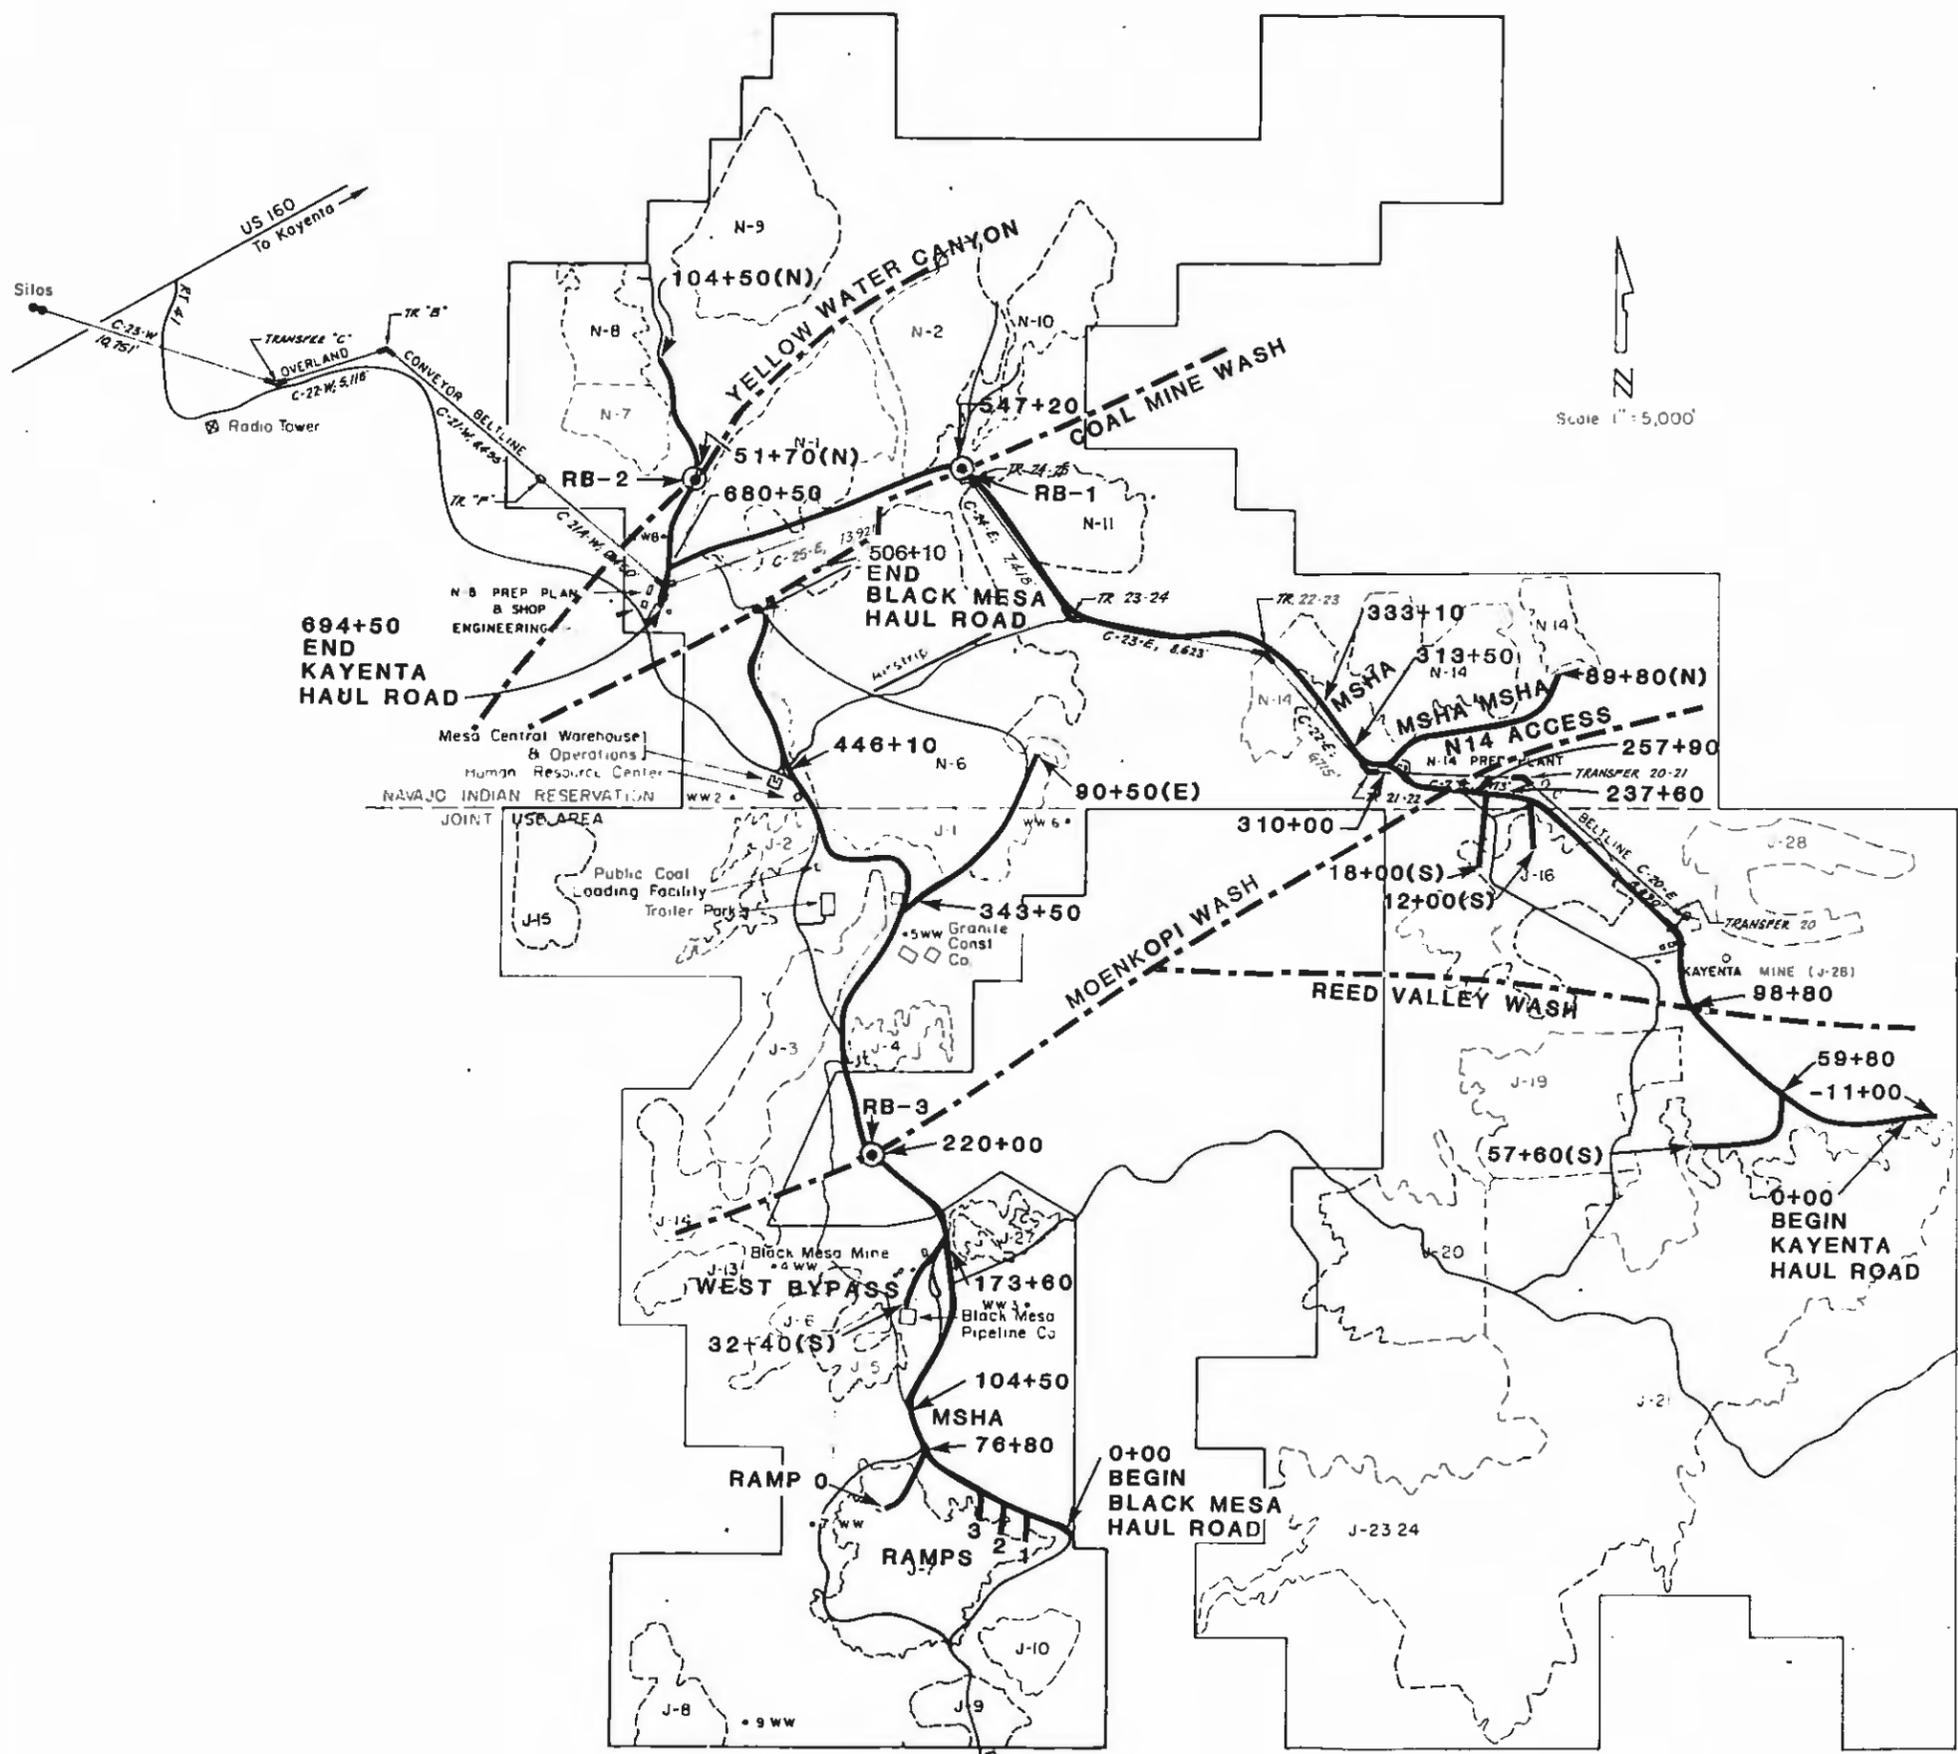
Scale 1" = 5,000'

SITE PLAN
 HAUL ROADS

The locations of the haul roads in relation to existing facilities are shown on Plate 1A, Site Plan, Haul Roads. The location of the conveyor beltline is shown on Plate 1B, Site Plan, Conveyor Beltline.
