Review Reports - MSHA Sedimentation

REVIEW REPORT
Sedimentation Structure
N14-F
Kayenta Mine
Navajo County, Arizona
for
PEABODY COAL COMPANY

REPORT
Dam-Break Analysis
for
Sedimentation Structures J28-B, J28-C, J28-D, and J28-G
Kayenta Mine
Navajo County, Arizona
for
PEABODY COAL COMPANY

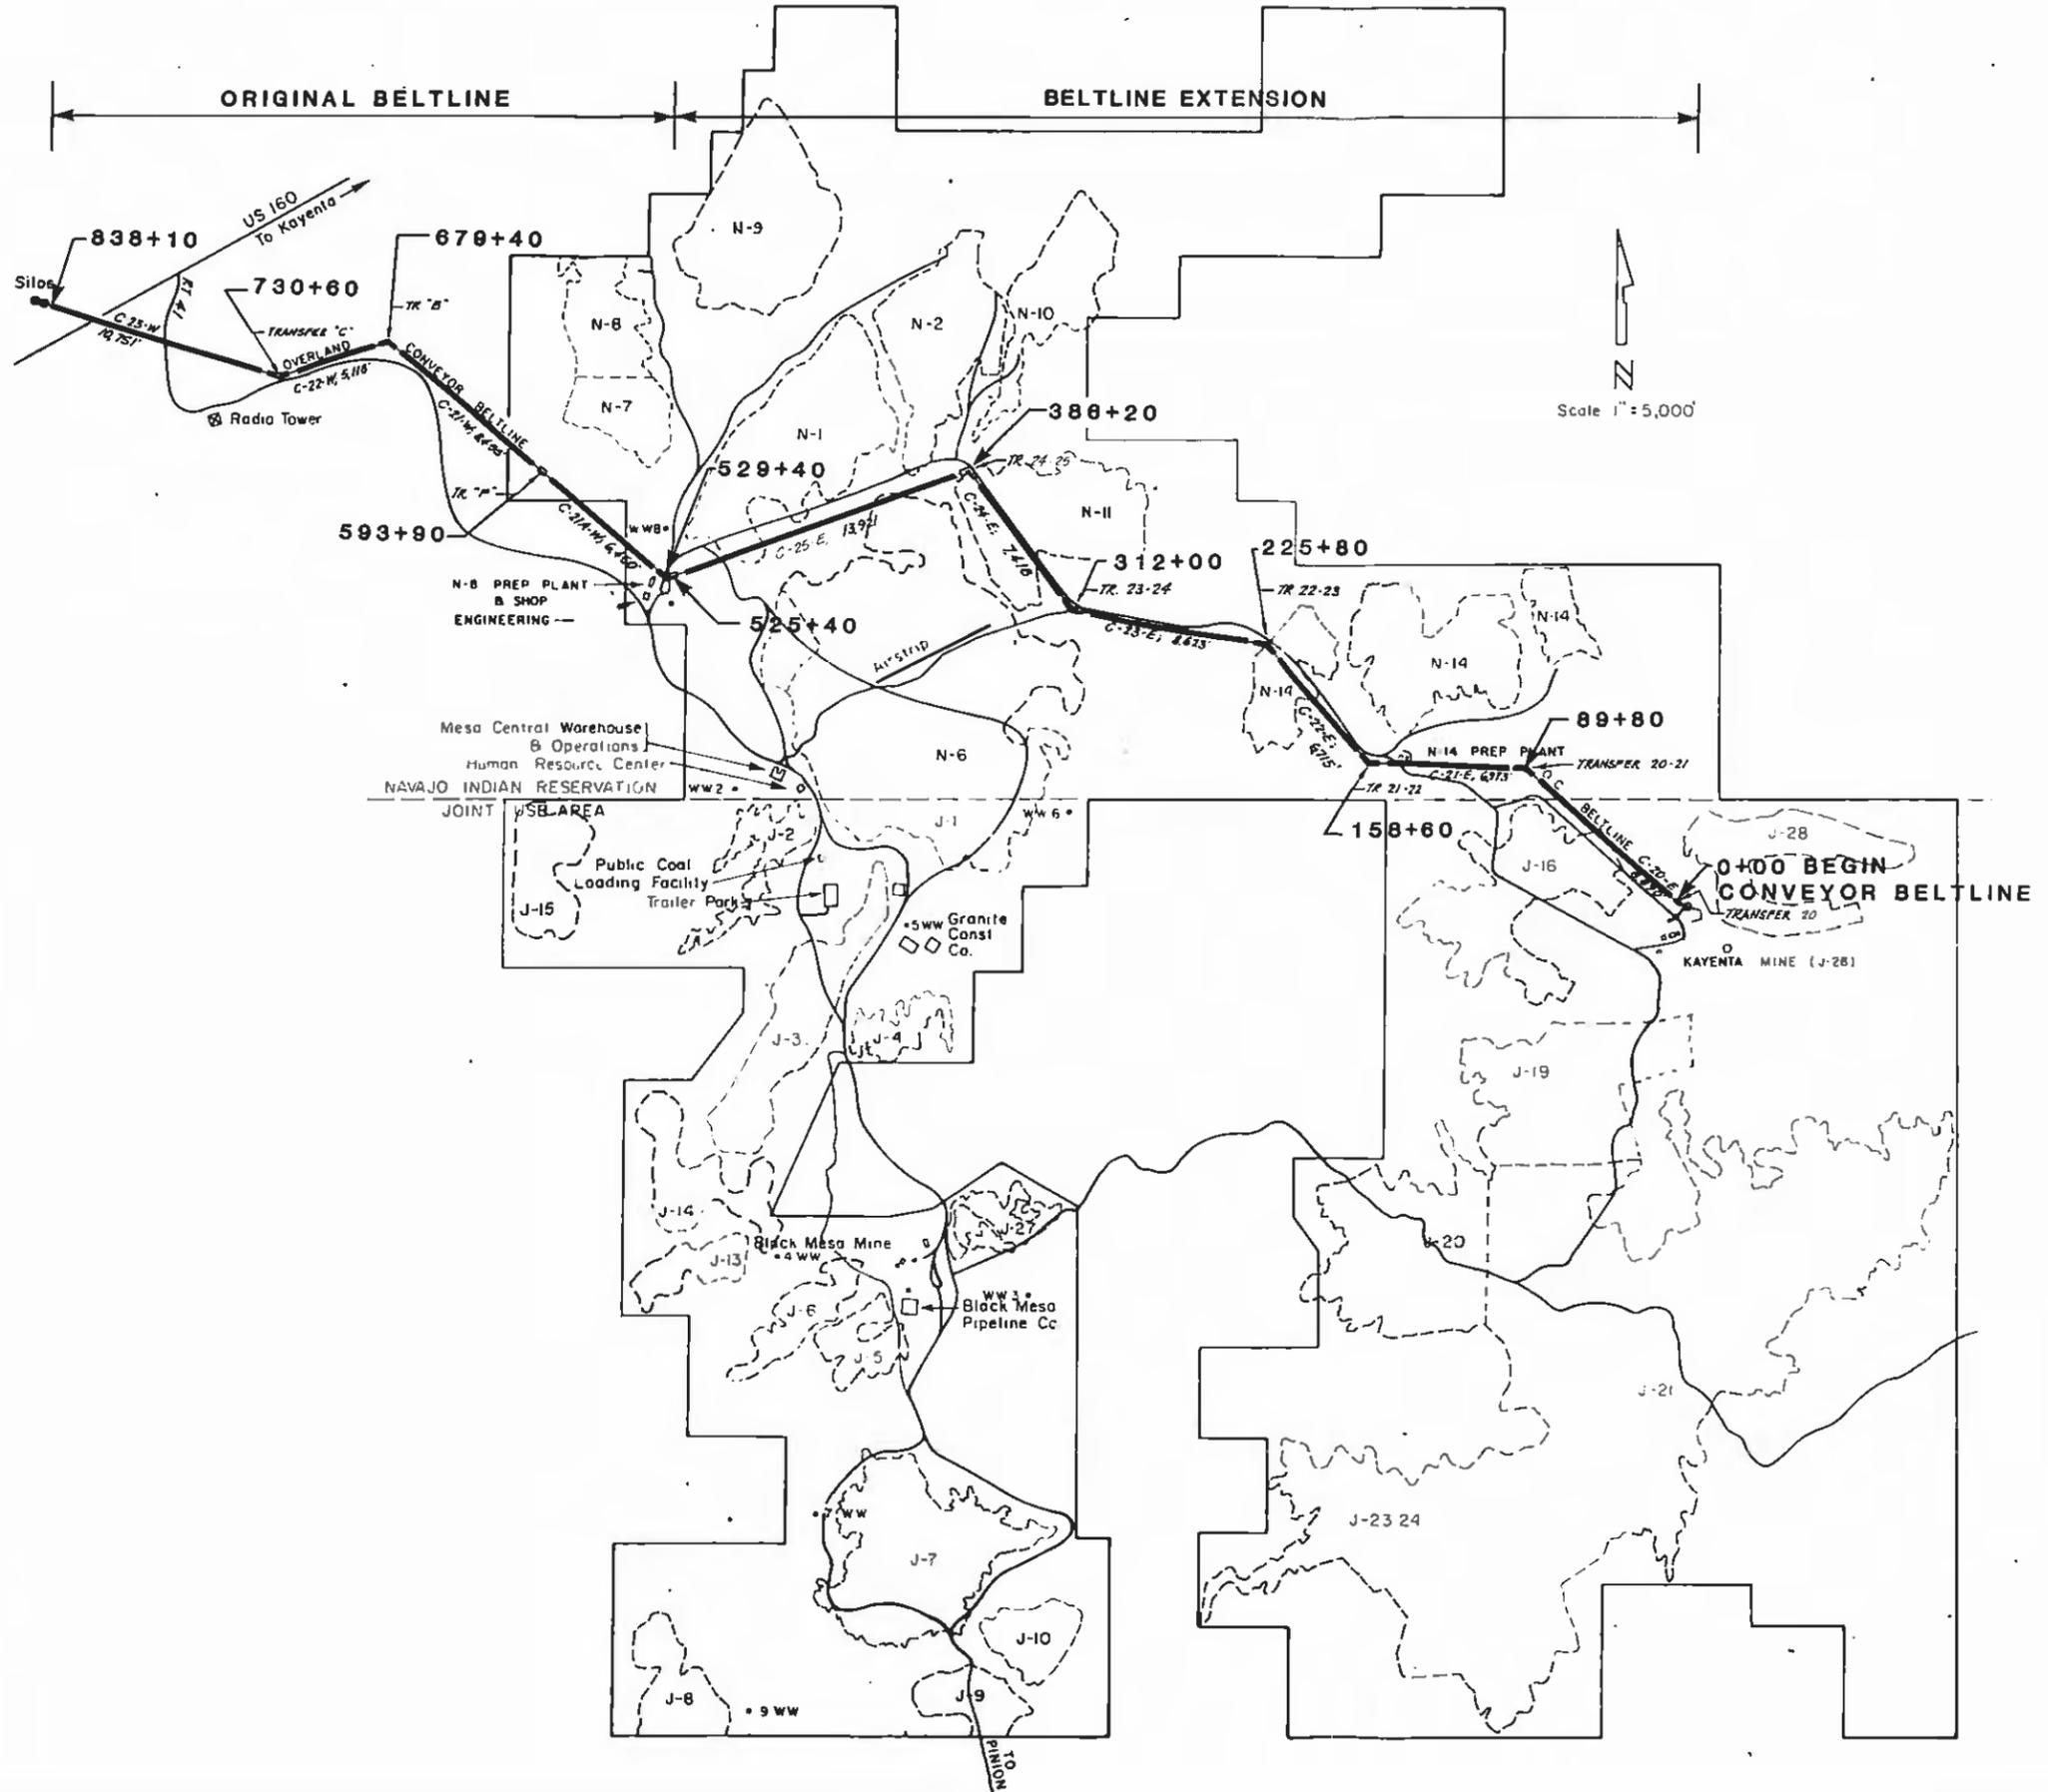
Scale 1" = 5,000'

**SITE PLAN
CONVEYOR BELTLINE**

The locations of the haul roads in relation to existing facilities are shown on Plate 1A, Site Plan, Haul Roads. The location of the conveyor beltline is shown on Plate 1B, Site Plan, Conveyor Beltline.

Note: For location of Stations, see Plate 1B.

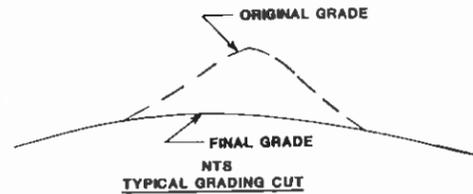
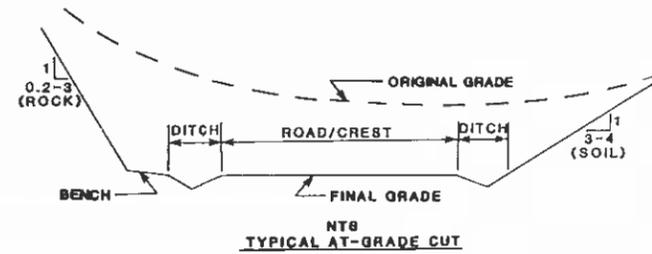
INSPECTION SUMMARY AT-GRADE CONSTRUCTION SECTIONS

A summary of our inspection of all the at-grade construction sections along the haul road and beltline alignments is presented on Plate 2A along with a typical cross section to indicate the features of this section. Stationing of the roads and beltlines where this form of construction applies is also presented. In general, it is our opinion that the conditions of the at-grade construction sections of the haul roads and beltline are good; however, maintenance of the drainage ditches is required at a few locations in order to better divert water from the roadbed. Severe erosion, which can be addressed through periodic maintenance, was noted at Station 126+40 and the perimeter slope of the West Bypass.

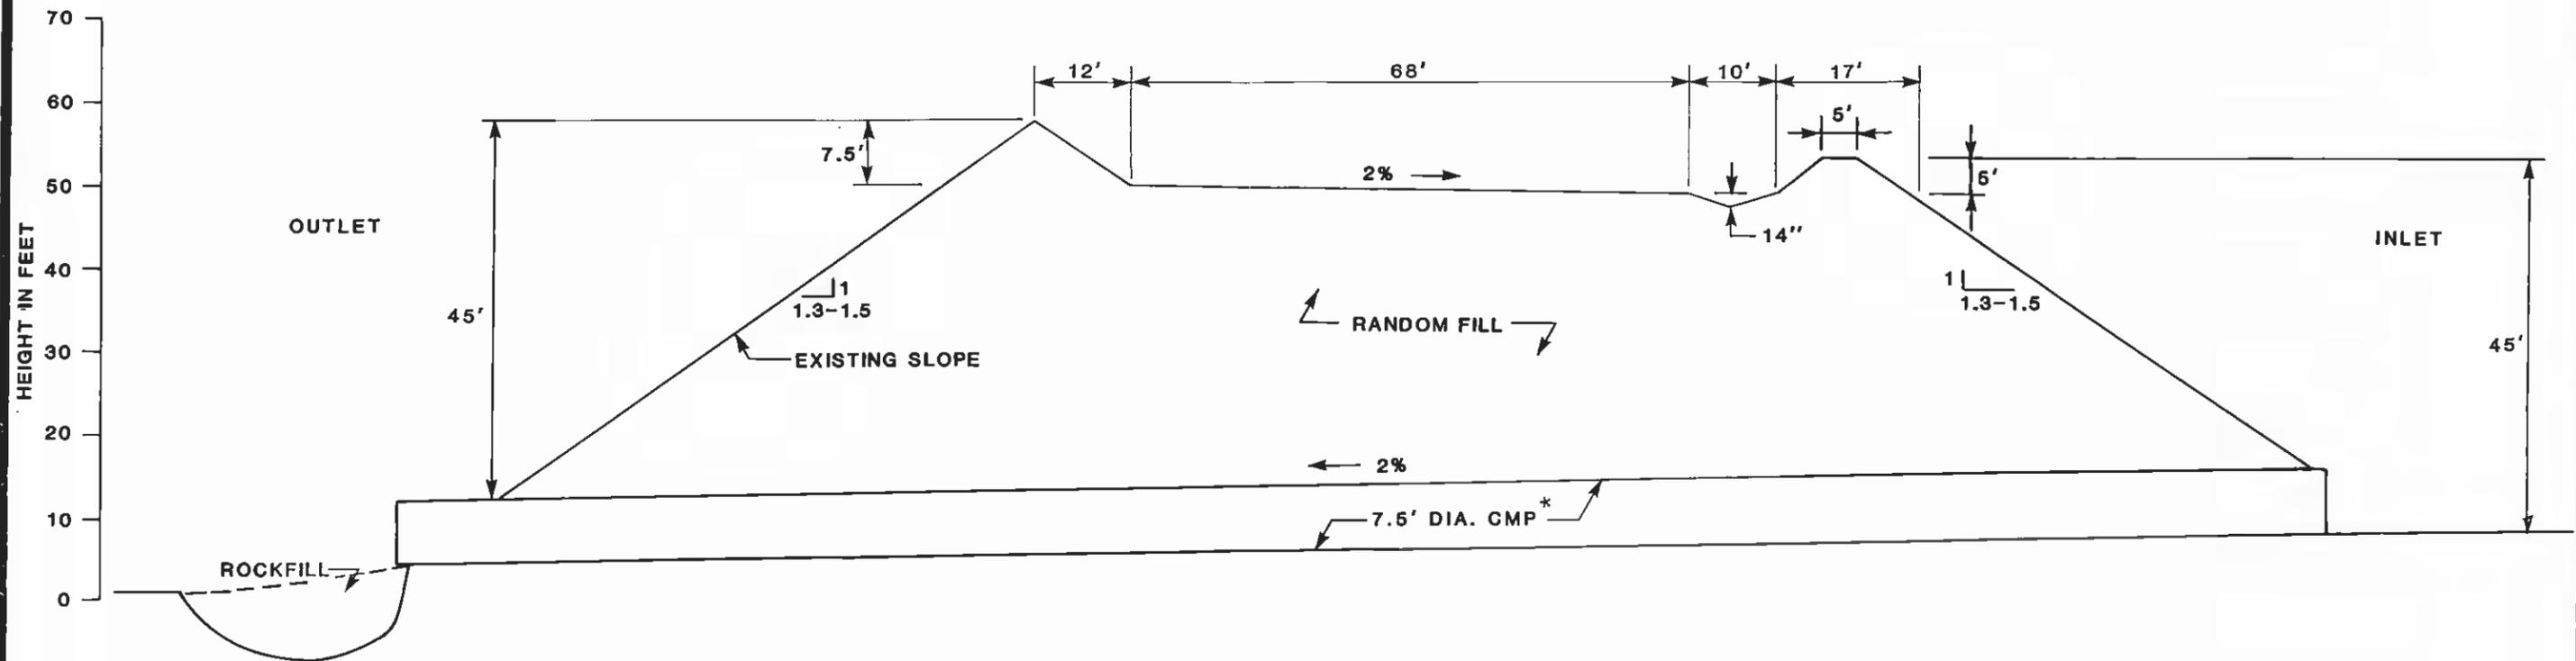
TYPICAL CROSS-SECTION
BLACK MESA HAUL ROAD
MOENKOPI WASH
CROSSING

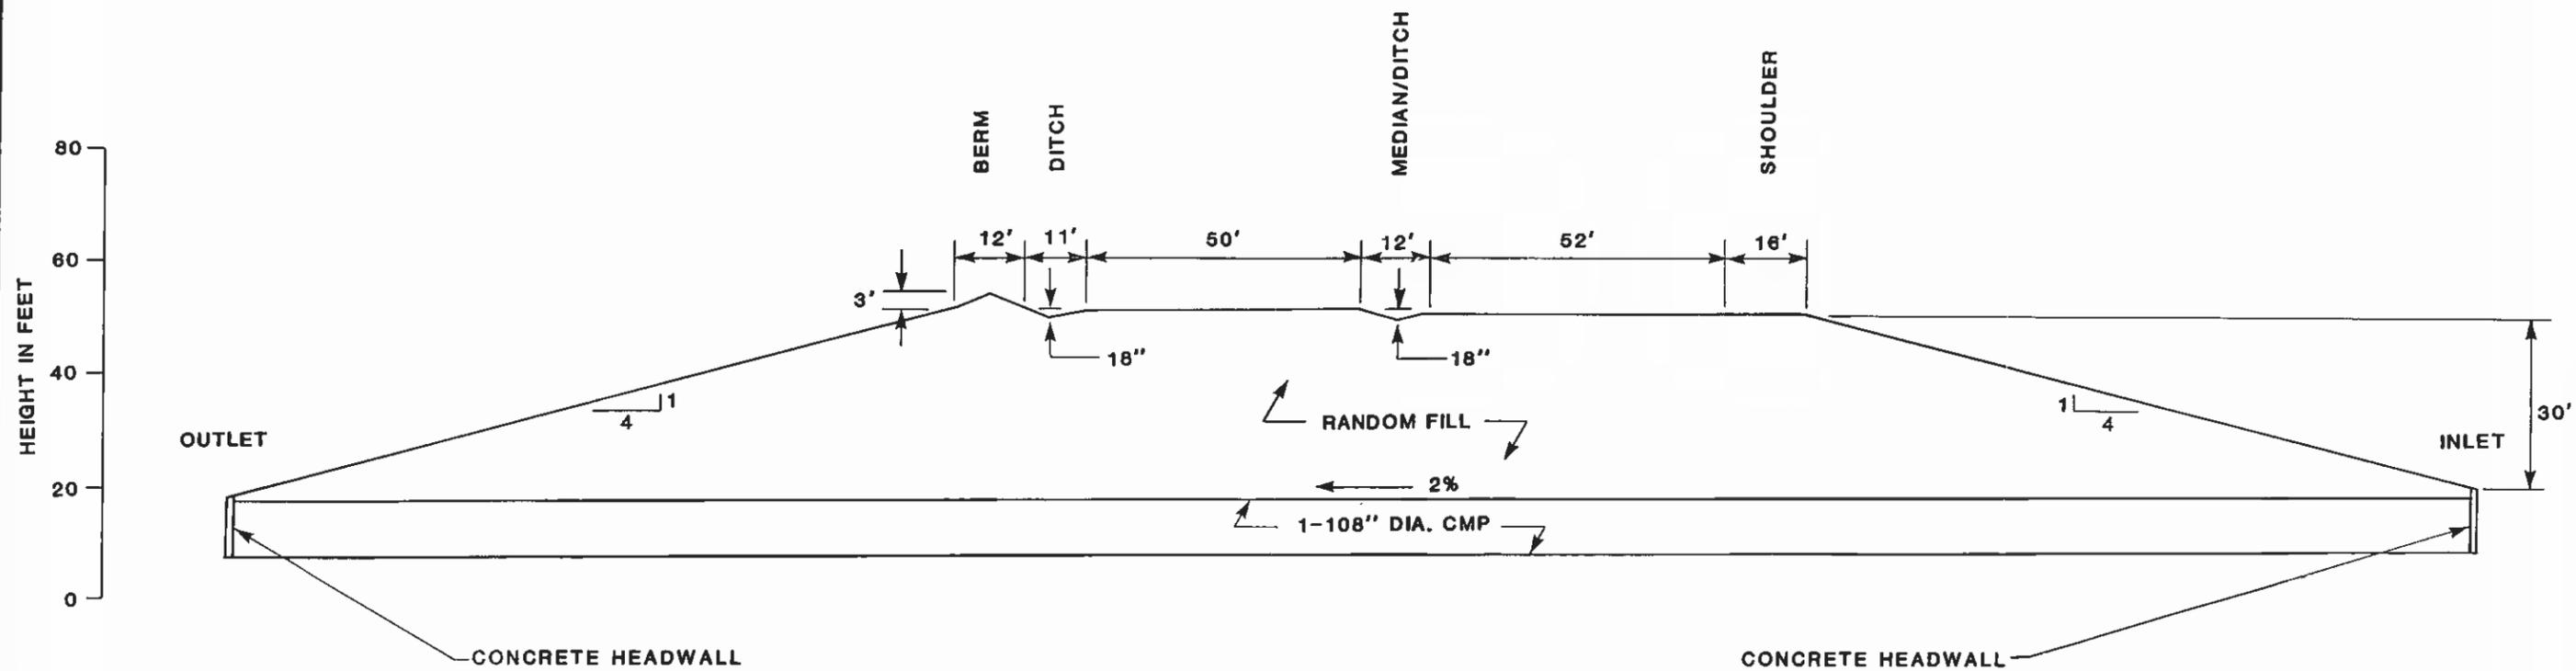
TYPICAL CROSS-SECTION
 KAYENTA HAUL ROAD
 REED VALLEY CROSSING

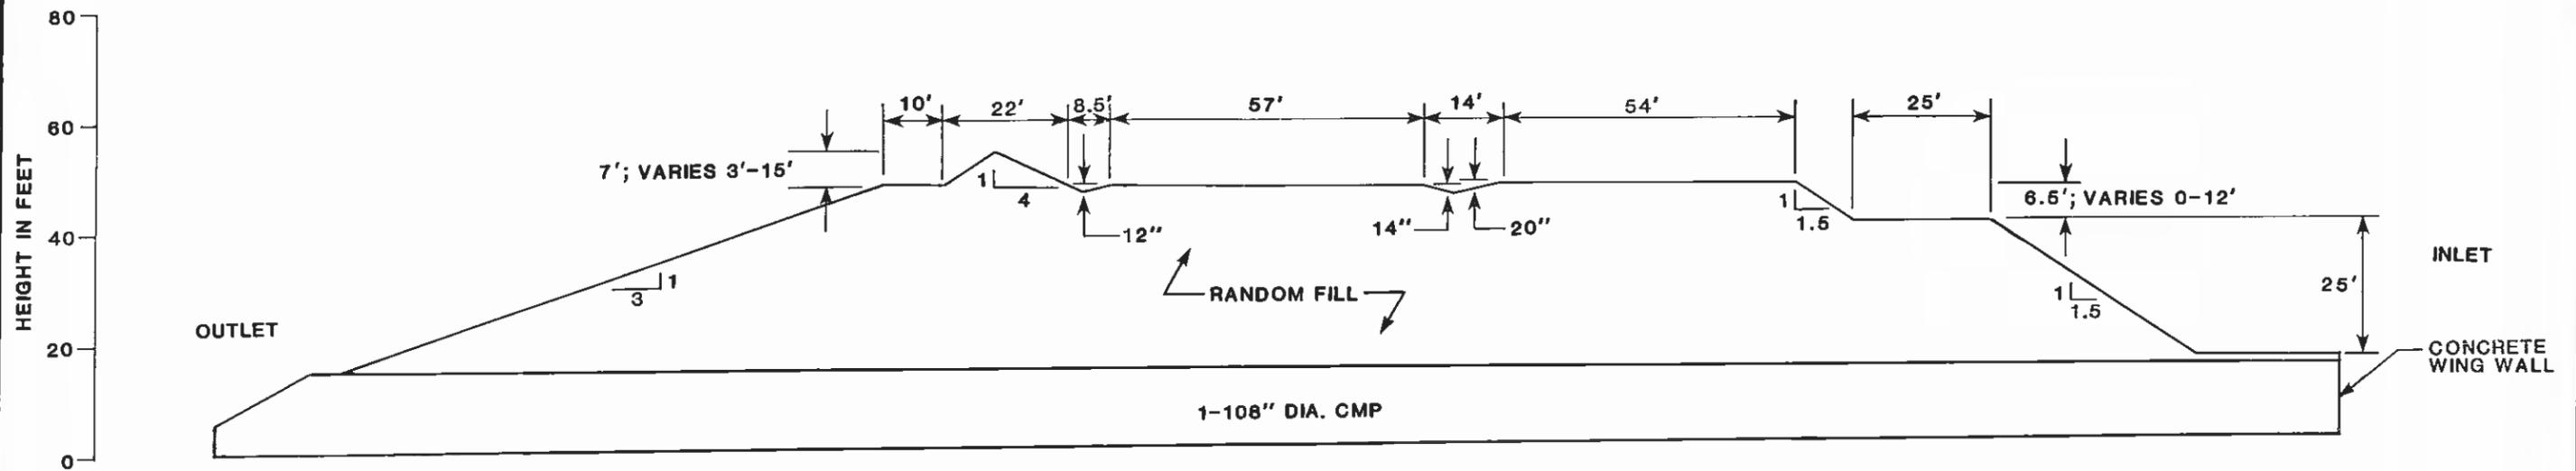
TYPICAL CROSS-SECTION
 KAYENTA HAUL ROAD
 MOENKOPI WASH
 CROSSING

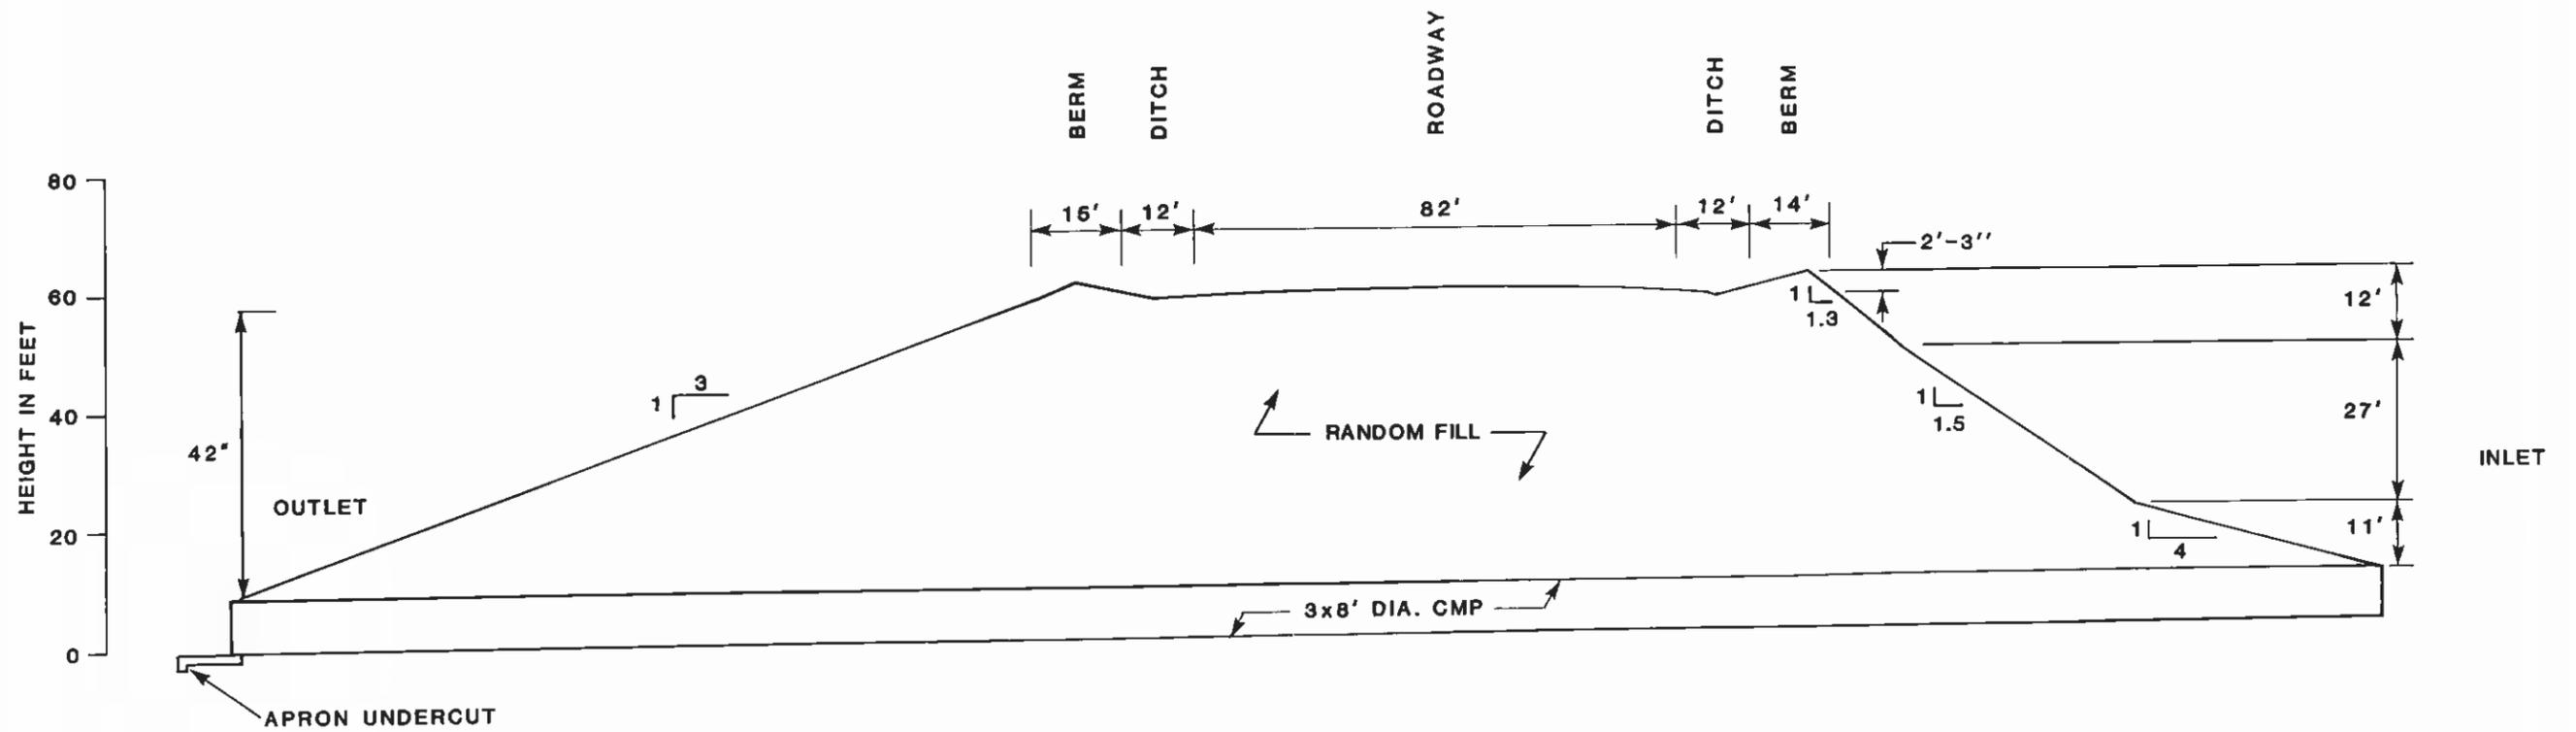
TYPICAL CROSS-SECTION
KAYENTA HAUL ROAD
COAL MINE WASH
CROSSING

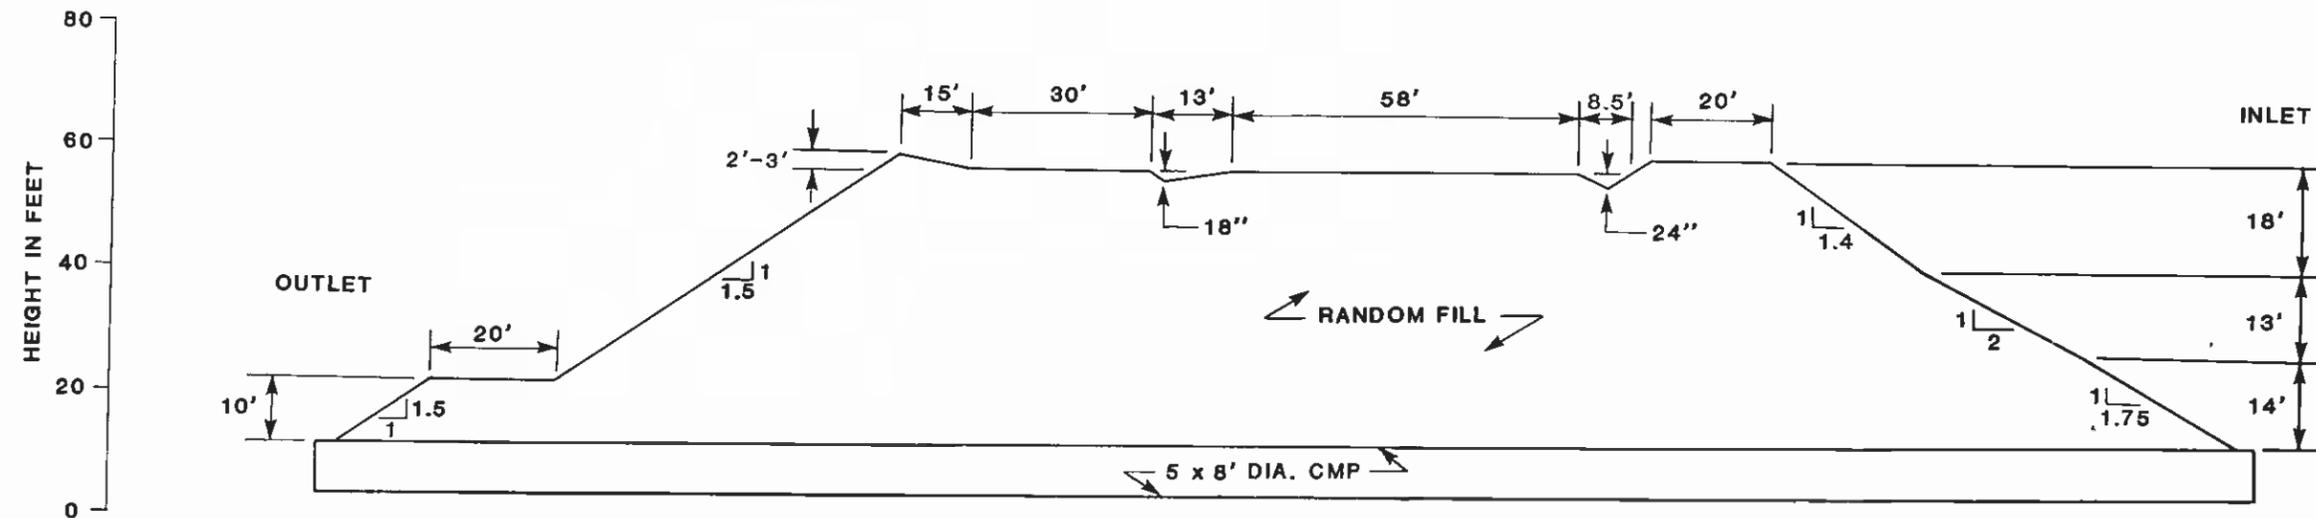
TYPICAL CROSS-SECTION
 KAYENTA HAUL ROAD (N8)
 YELLOW WATER
 CANYON CROSSING

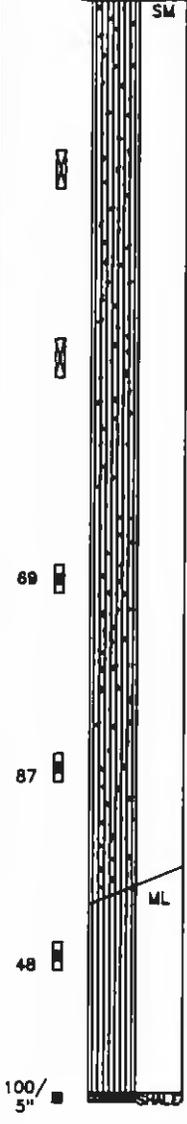
SURFACE ELEVATION: 8600.3 FEET
 PCC COORDINATES
 S 1858
 E 19732

SM MULTIPLE SHADES OF BROWN FILL CONSISTING OF SHALE AND SANDSTONE FRAGMENTS IN A MATRIX OF SAND AND SILT

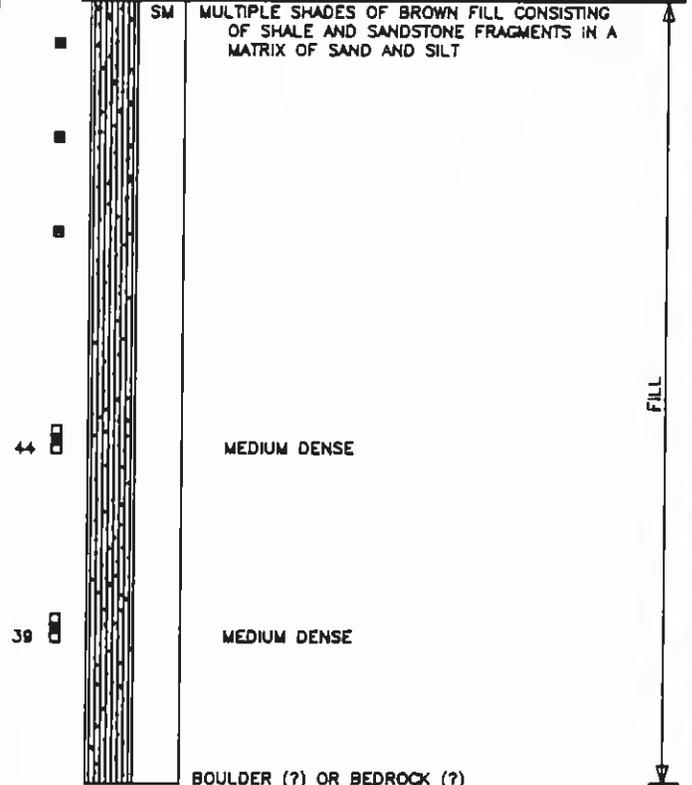
BOULDER (?) OR BEDROCK (?)

BORING TERMINATED AT 41.5 FEET ON 9/21/85.
NO GROUNDWATER ENCOUNTERED.

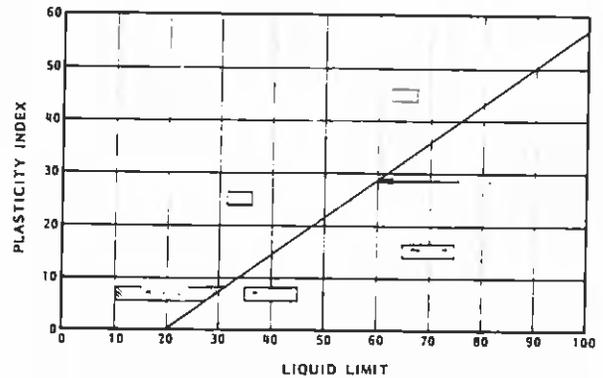
PLASTICITY CHART

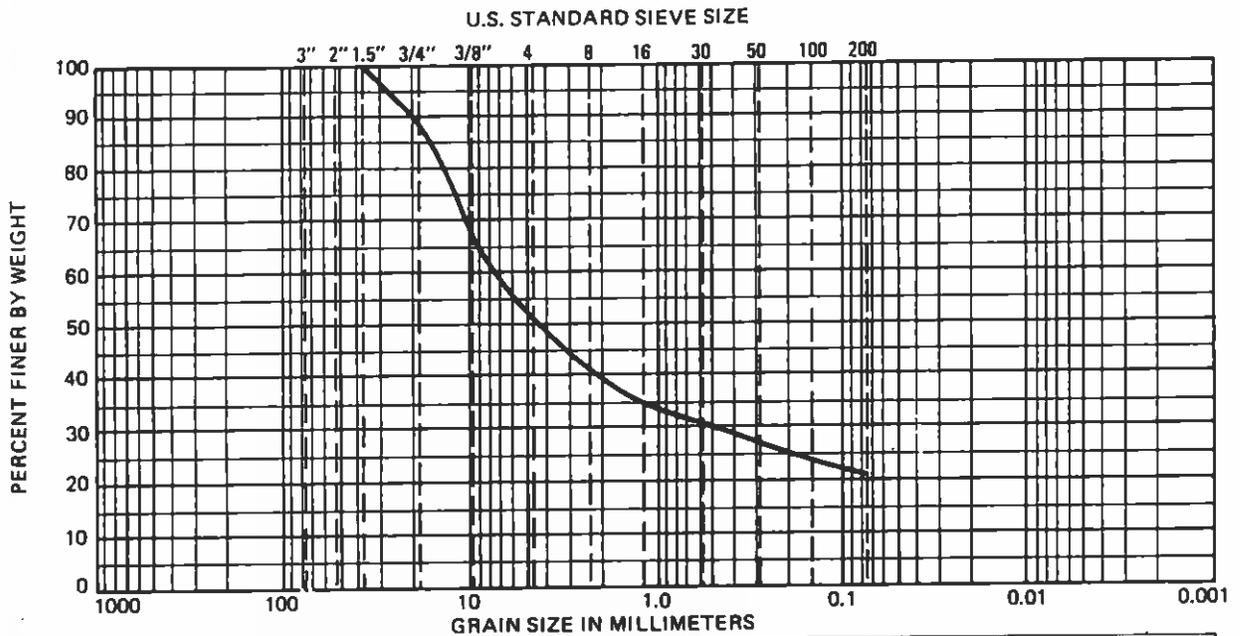
COBBLES		GRAVEL		SAND			SILT OR CLAY								
		COARSE	FINE	COARSE	MEDIUM	FINE									
RB-1	DEPTH	CLASSIFICATION									NAT. W.C	LL	PL	PI	
SAMPLE	COMPOSITE	GM-GE	BROWN FILL CONSISTING OF SHALE & SANDSTONE FRAGMENTS IN A MATRIX OF SAND AND SILT									7.7	-	-	-
1-8

COMPOSITE GRADATION CURVE OF EMBANKMENT FILL

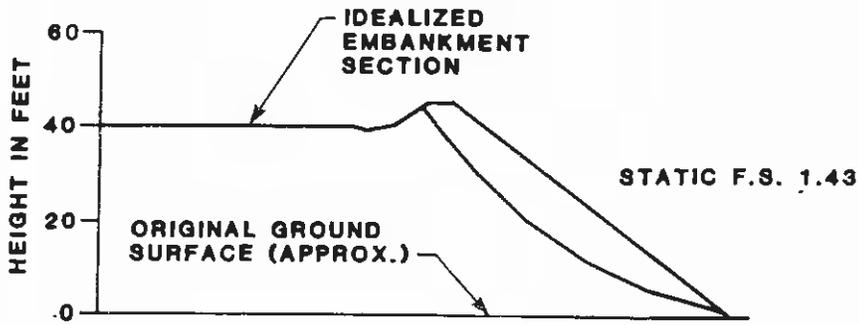
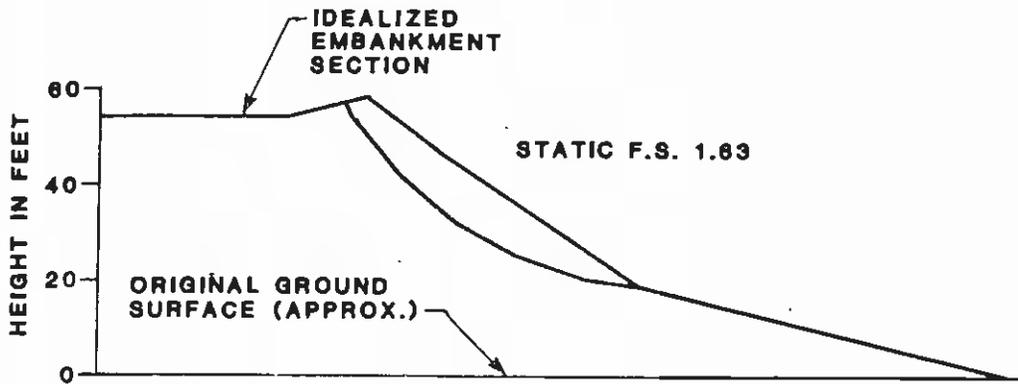
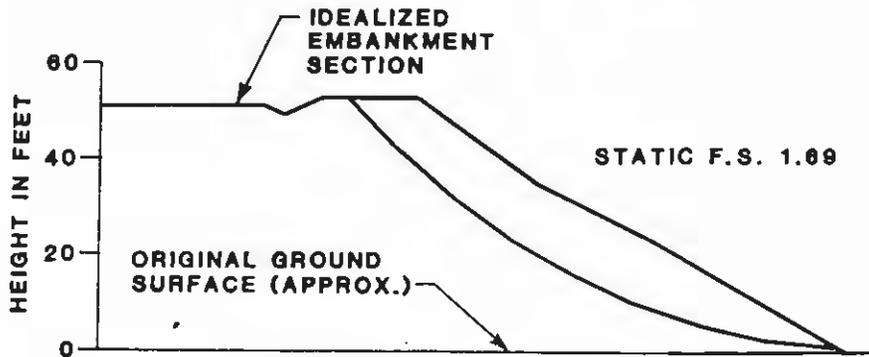
Plate 8A

BLACK MESA HAUL ROAD
MOENKOPI WASH CROSSING

KAYENTA HAUL ROAD
COAL MINE WASH CROSSING

KAYENTA HAUL ROAD
YELLOW WATER CANYON CROSSING

SCALE: 1" = 40'

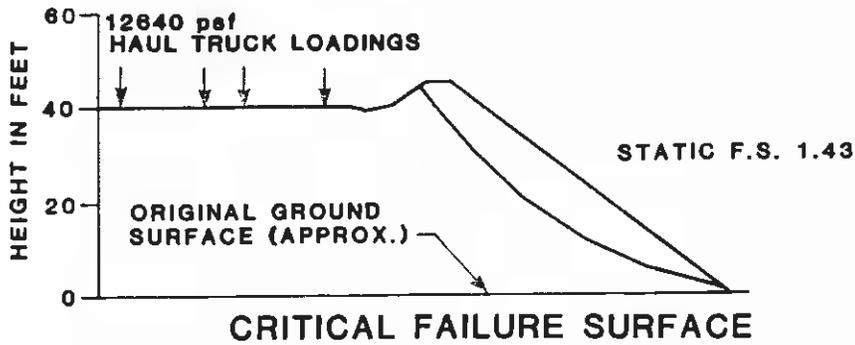
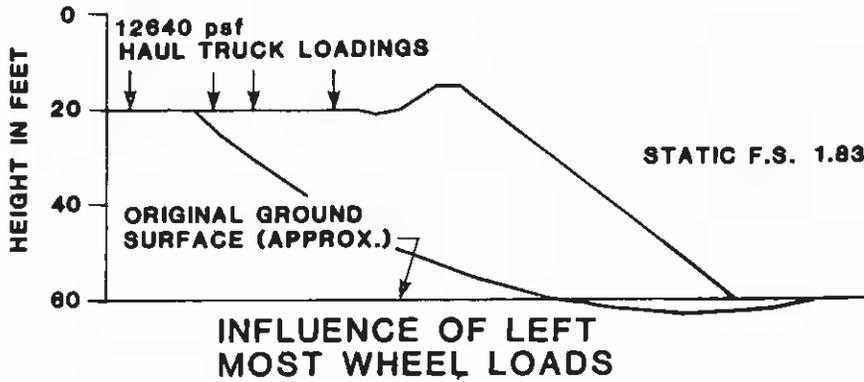
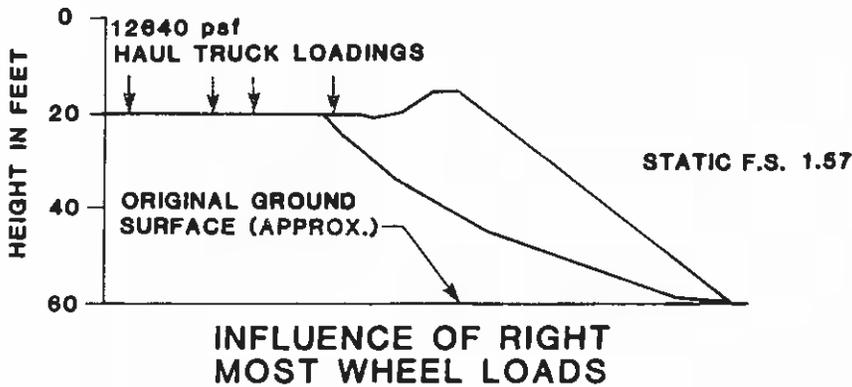
Plate 8B

BLACK MESA HAUL ROAD
MOENKOPI WASH CROSSING

SCALE 1" = 40'

STABILITY ANALYSIS
CRITICAL
FAILURE SURFACES
HAUL ROAD EMBANKMENTS

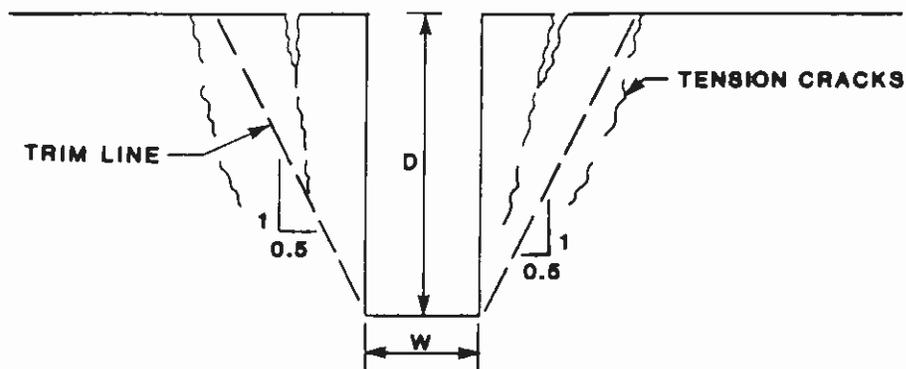
DETAIL OF GULLY TRIMMING

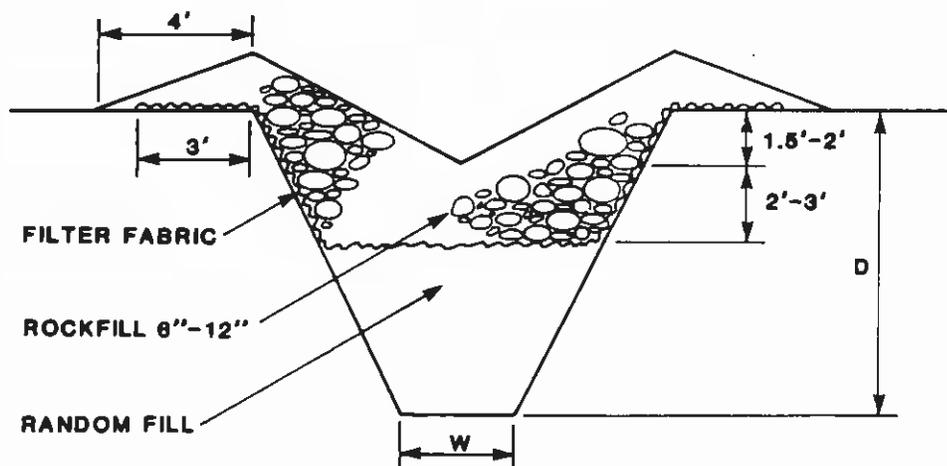
DETAIL OF REMEDIAL ROCK-LINING FOR GULLIES

W = EXISTING BASE WIDTH OF GULLY

REMEDIAL TREATMENT FOR GULLIES

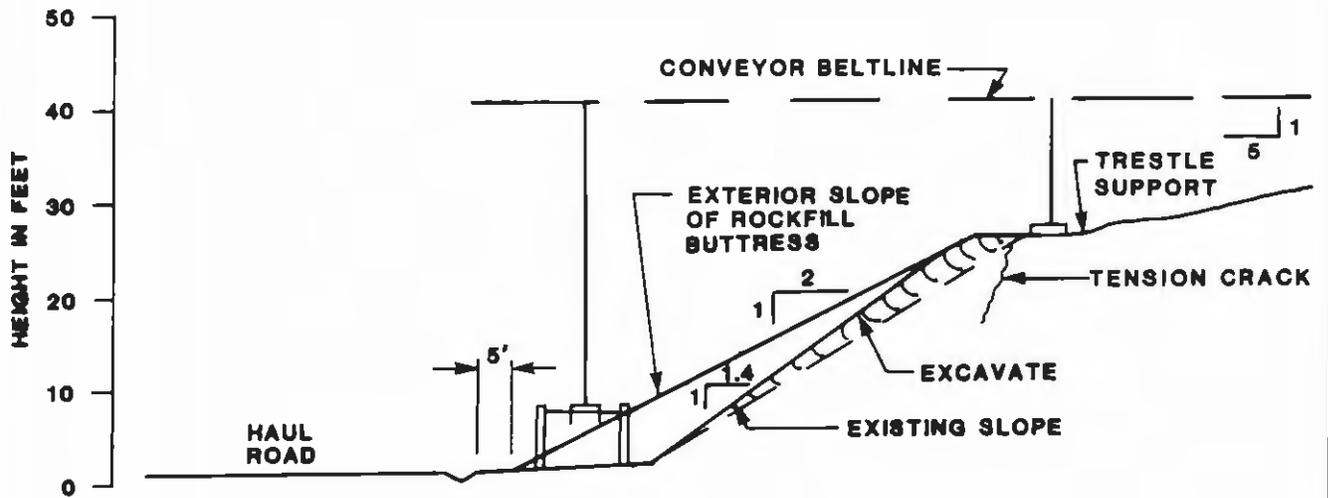
RECOMMENDED REMEDIAL
SLOPE STABILIZATION
CONVEYOR BELTLINE
STATION 497+00

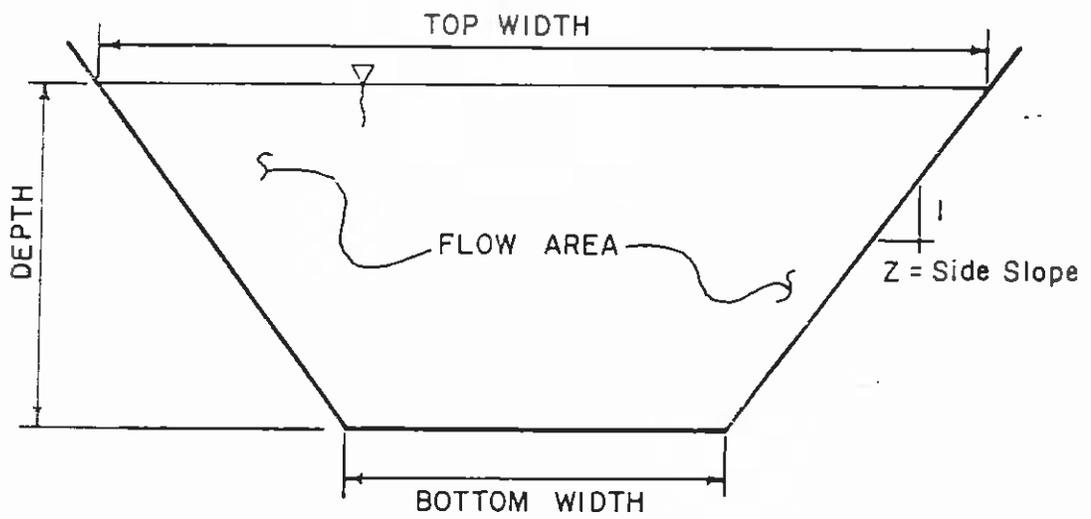
TRAPEZOIDAL
CHANNEL

Depth (ft)	Flow Rate (cfs)	Velocity (fps)	Froude Number	Velocity Head(ft)	Energy Head(ft)	Flow Area (sq ft)	Top Width (ft)
1.00	6.06	.67	.137	.01	1.01	9.00	12.00
2.00	23.59	.98	.150	.01	2.01	24.00	18.00
3.00	55.35	1.23	.158	.02	3.02	45.00	24.00
4.00	104.23	1.45	.165	.03	4.03	72.00	30.00
5.00	172.90	1.65	.170	.04	5.04	105.00	36.00
6.00	263.89	1.83	.174	.05	6.05	144.00	42.00
7.00	379.60	2.01	.178	.06	7.06	189.00	48.00
8.00	522.32	2.18	.182	.07	8.07	240.00	54.00
9.00	694.24	2.34	.185	.08	9.08	297.00	60.00
10.00	897.47	2.49	.188	.10	10.10	360.00	66.00
11.00	1134.07	2.64	.191	.11	11.11	429.00	72.00
12.00	1406.02	2.79	.193	.12	12.12	504.00	78.00
13.00	1715.25	2.93	.196	.13	13.13	585.00	84.00

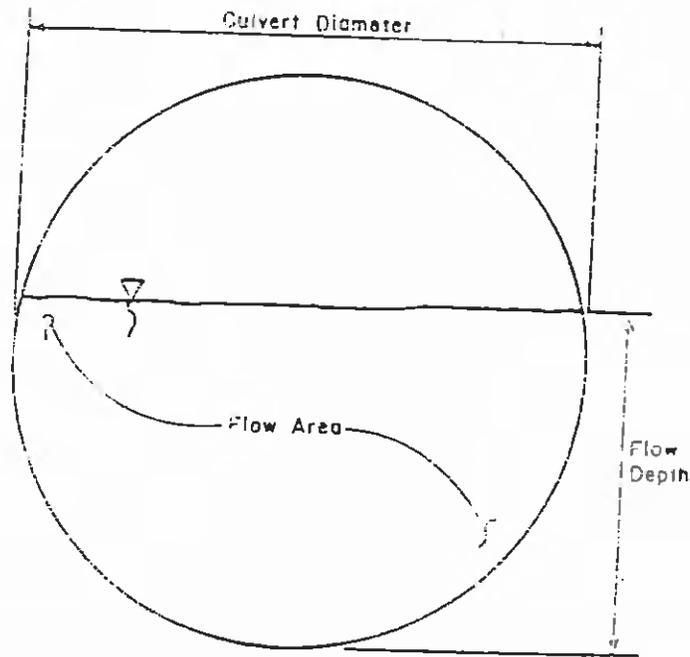
CROSS-SECTION

PIPE CULVERT

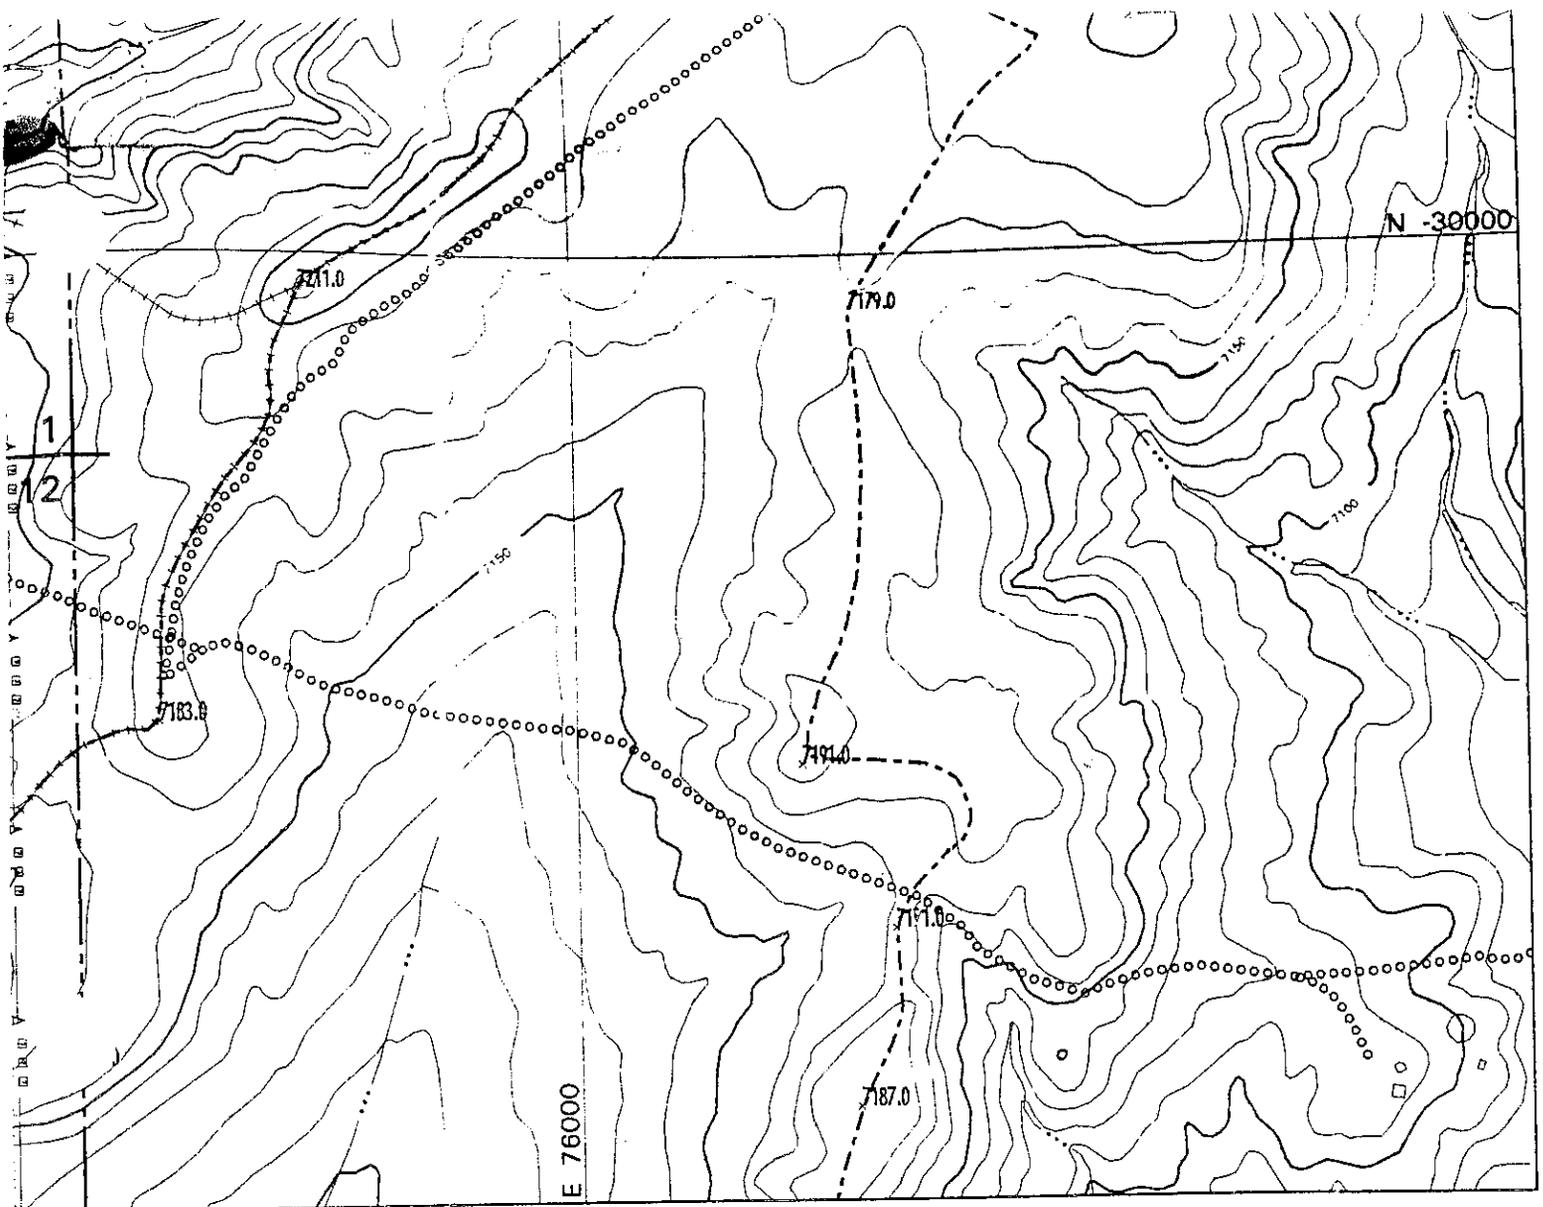
J21-A1

REVISIONS			Drawing No. 85400			
CHK'D	DATE	DESCRIPTION	Drainage Area and Facilities Map Sheet No. N-9			
JGS	3/1/95	5YR Permit Ren				
JGS	10-18-95	E Q SITES	Black Mesa Complex P.W.C.C. 1300 S. Yale Flagstaff, AZ 86001			
JGS	6-26-96	CULVERT REV.				
JGS	12-2-96	5 YR. MIM PLAN REV.				
JGS	10-15-97	OSM RESPONSE				
			DESIGNED BY:	P.W.C.C.	SCALE:	1 in. = 400 ft.
			DRAWN BY:	P.W.C.C.	DRAWING DATE:	02/23/95
			CHECKED BY:	J. Schlenvogt	PHOTO DATE:	11/19/84
			CONTOUR INTERVAL:	10

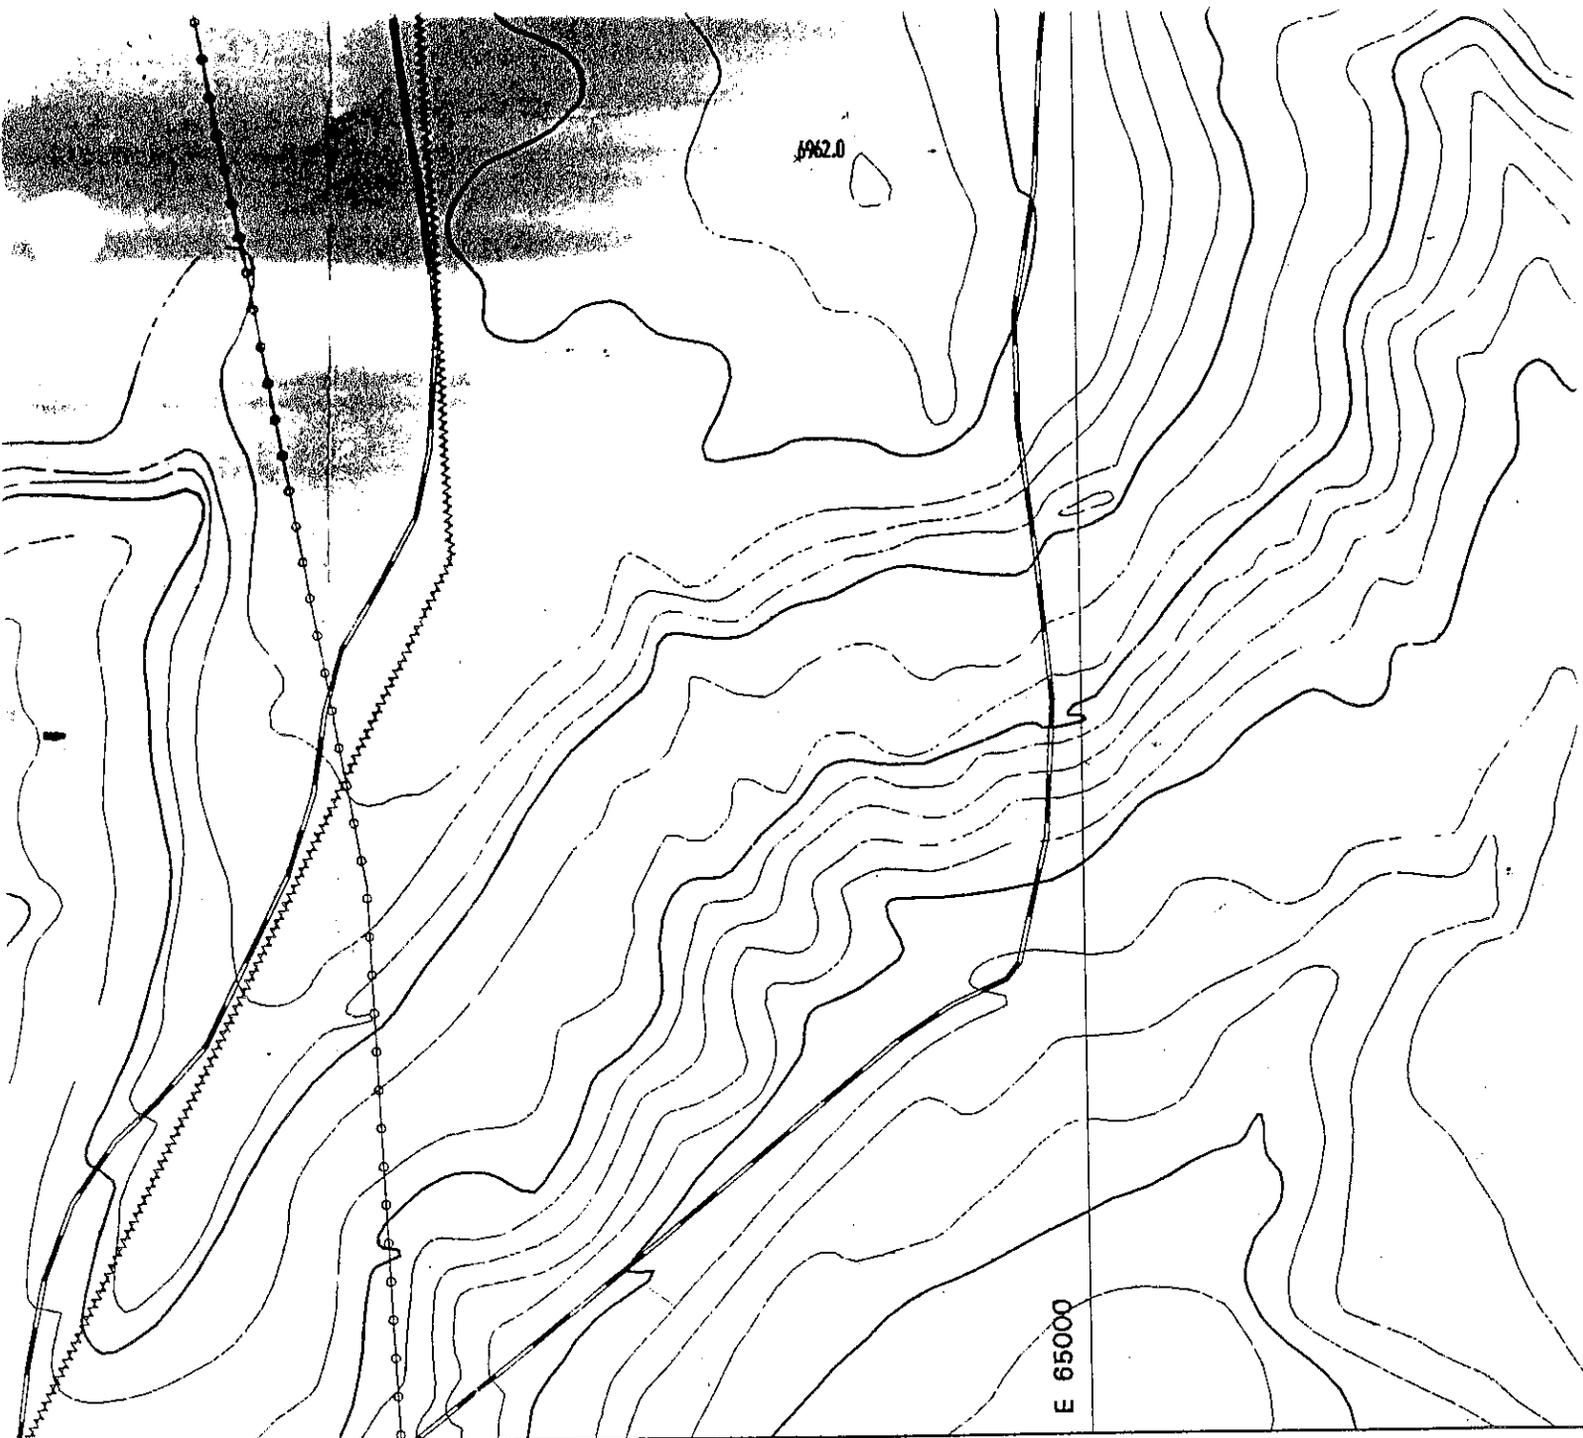
(Sheet 6A)

DESIGNED BY:	J. Schlenvogt	SCALE:	1 in. = 100 ft.
DRAWN BY:	S. Walker	DRAWING DATE:	2/15/95
CHECKED BY:	J. Schlenvogt	PHOTO DATE:	7/1/82
CONTOUR INTERVAL: 20
