ATTACHMENT AA

N-14 East
Ephemeral Reclaimed Channel
Diversion Design Report
(See Drawing No. 85352, Sheets M-7 and M-8)

N-14 East - Ephemeral Reclaimed
Channel Design Summary

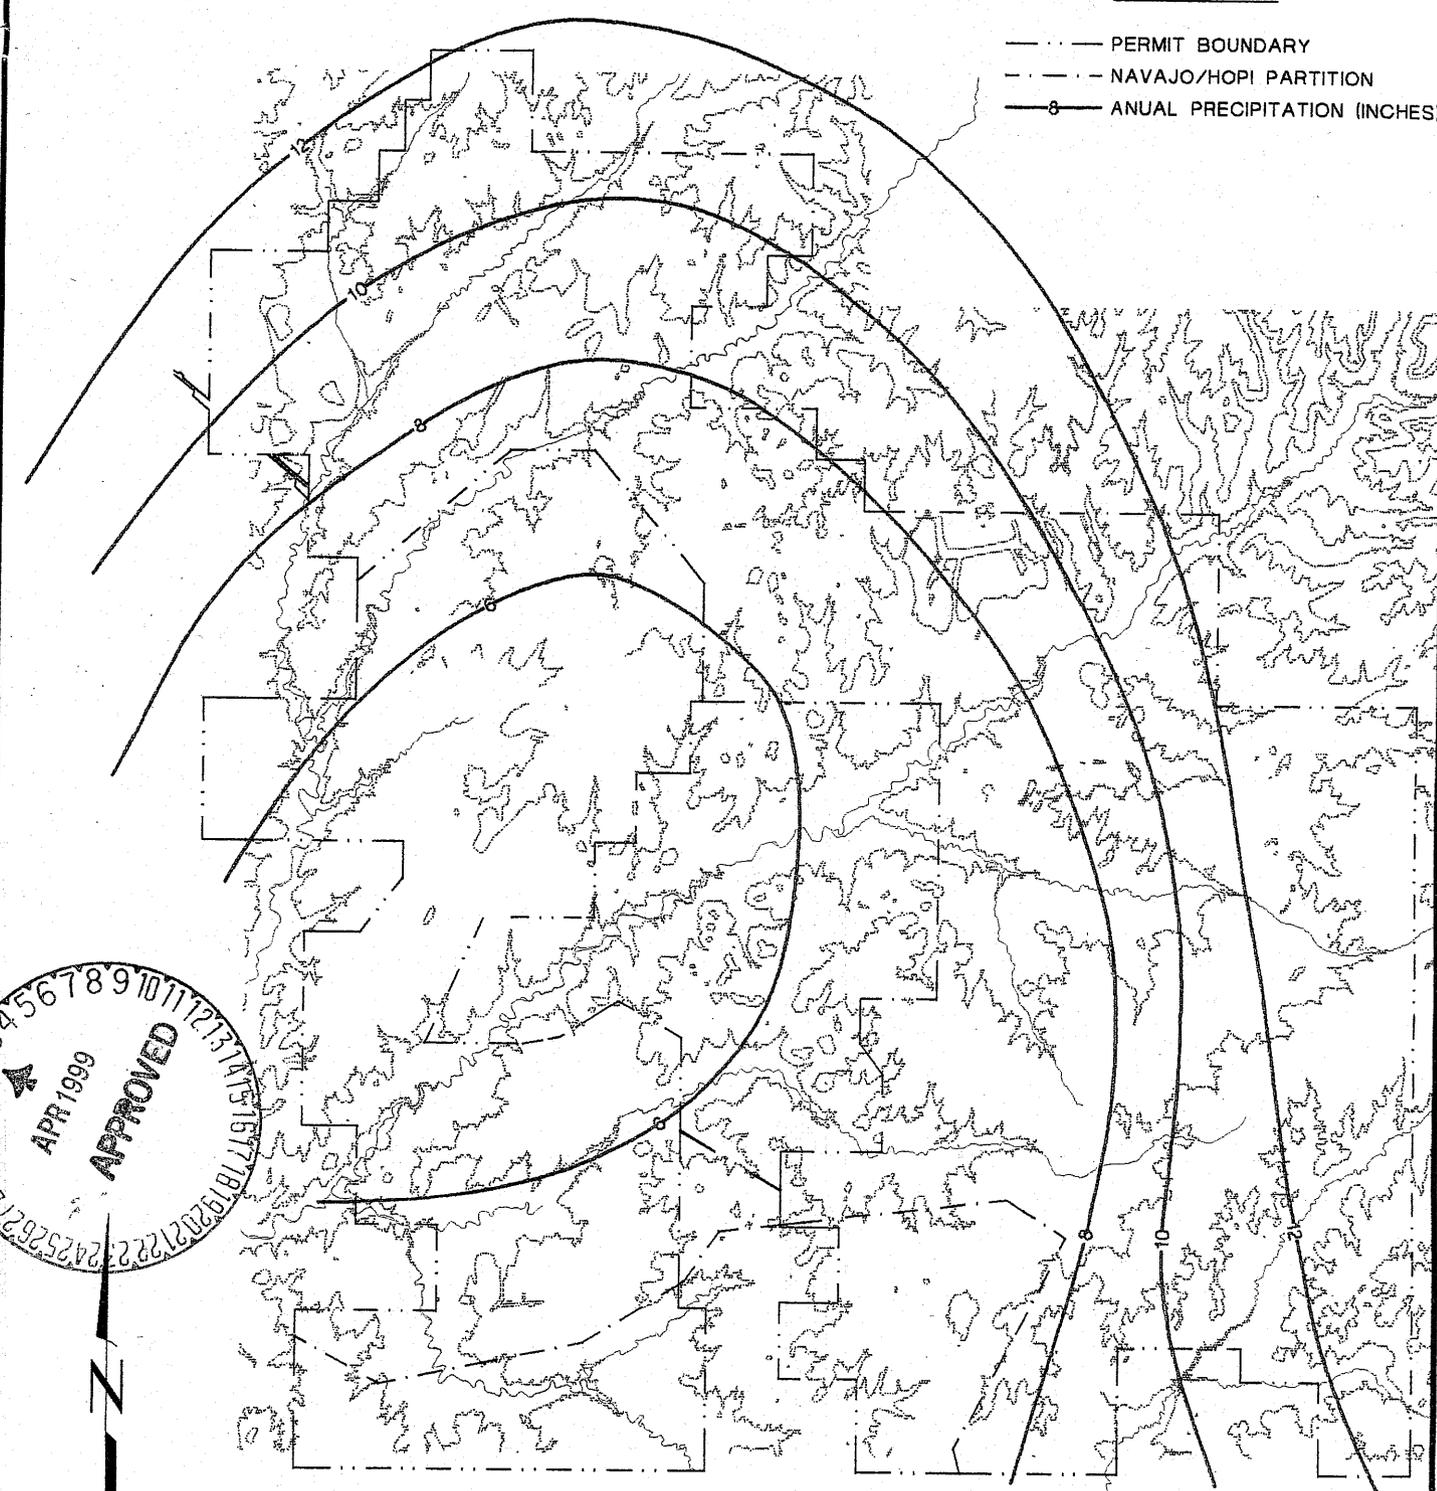
PROJECT No: 1342861.0190100
 AutoCAD FILE: PRECIP.DWG
 SCALE: AS NOTED
 FIGURE No: 1

LEGEND

- · — · — PERMIT BOUNDARY
- - - - - NAVAJO/HOPI PARTITION
- 8 — ANNUAL PRECIPITATION (INCHES)

KAYENTA AND BLACK MESA MINES

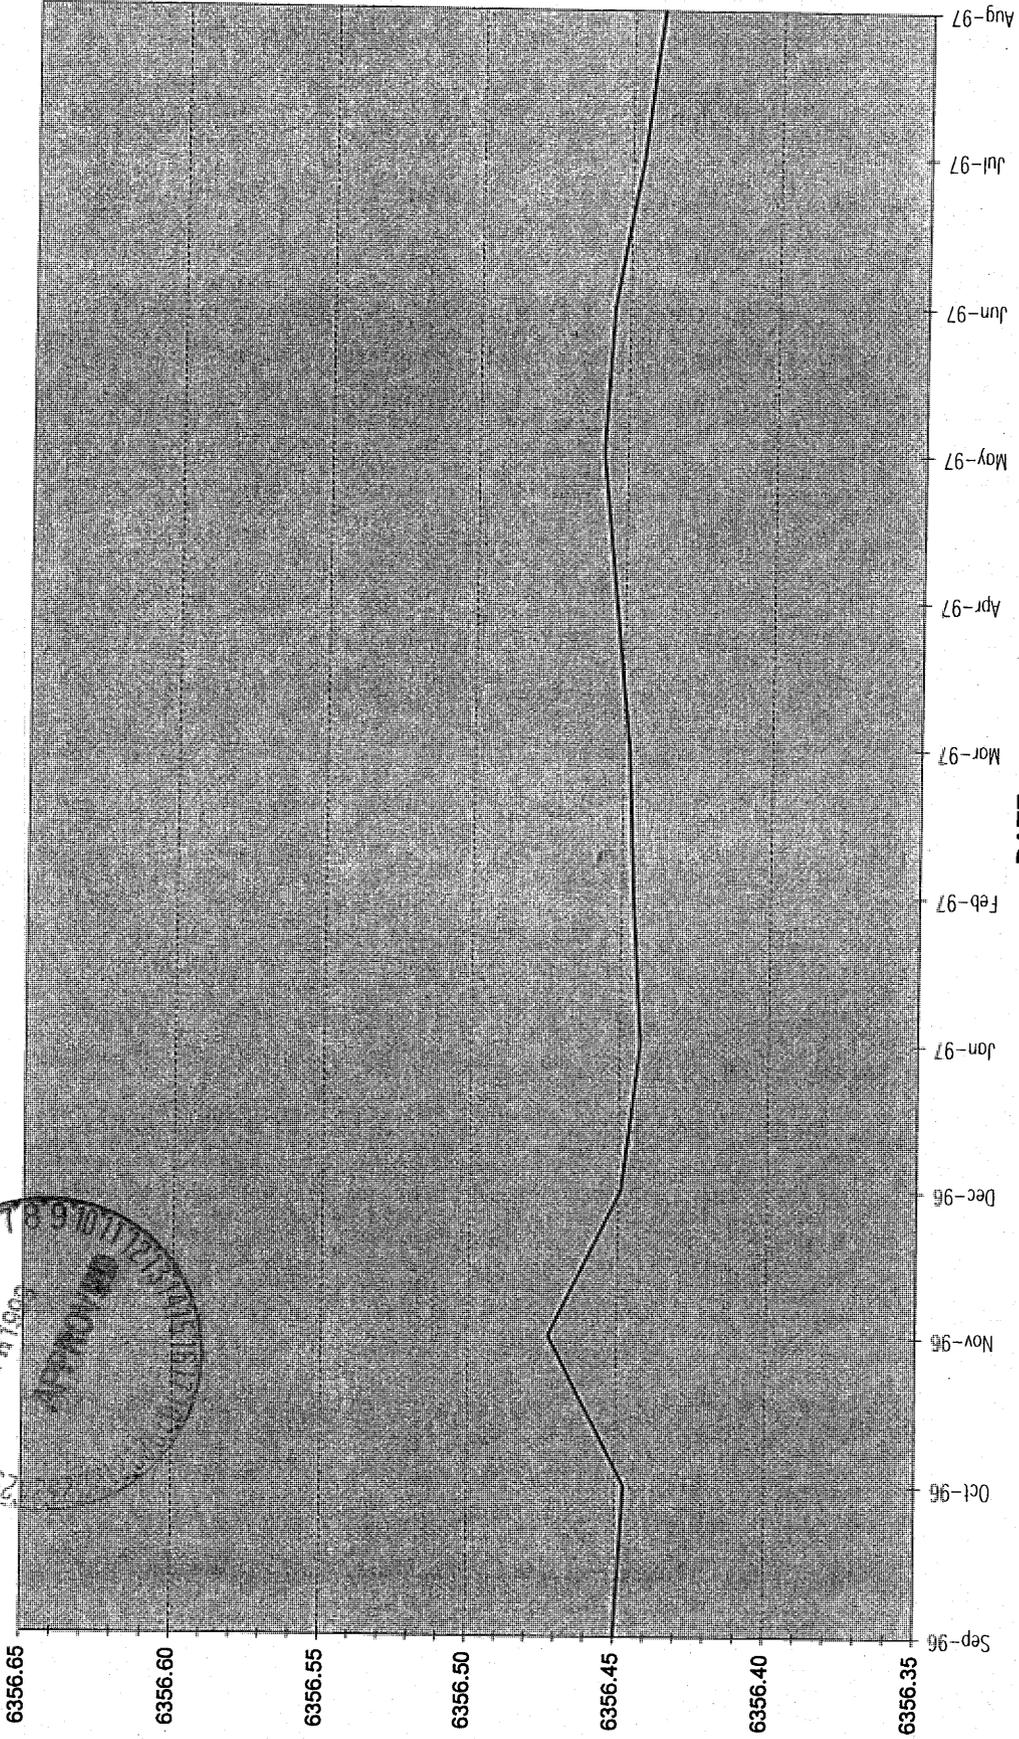
J2-A DAM SETTLEMENT MONUMENT #1

1996-1997

ELEVATION OF MONUMENT (FEET)

DATE

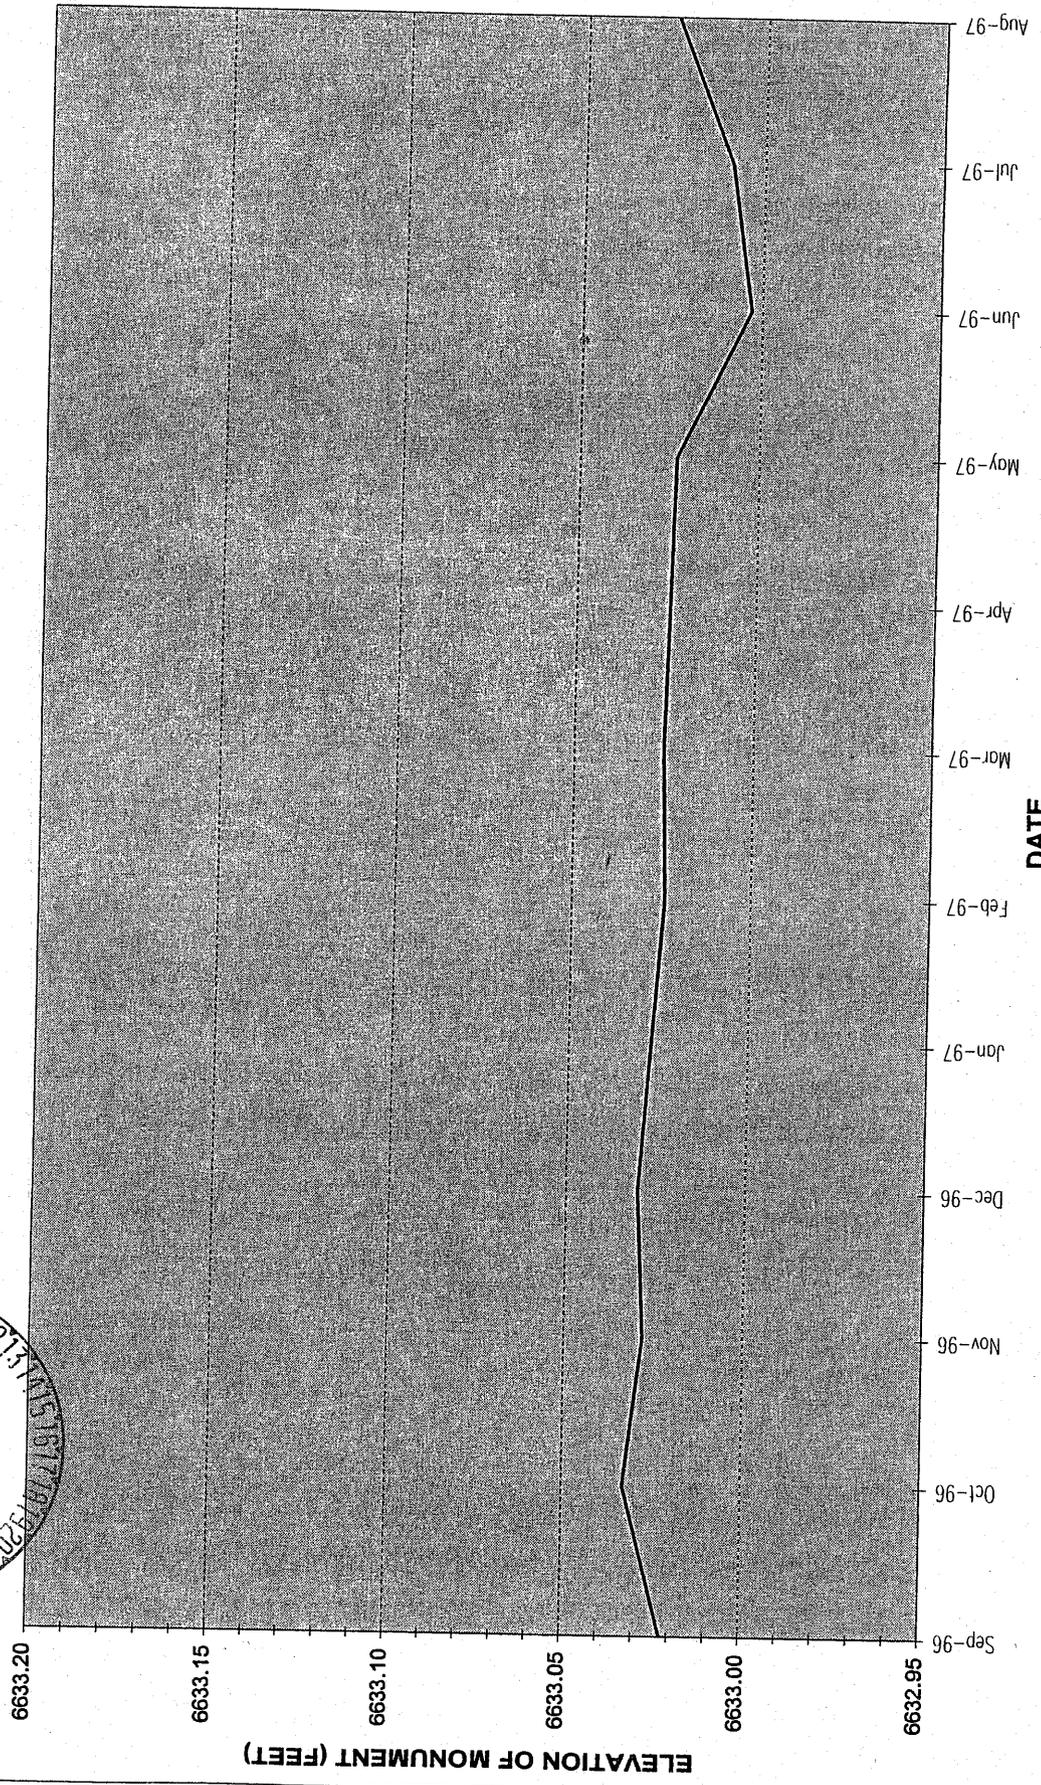
1996-1997 J16-A DAM SETTLEMENT MONUMENT #2

ELEVATION OF MONUMENT (FEET)

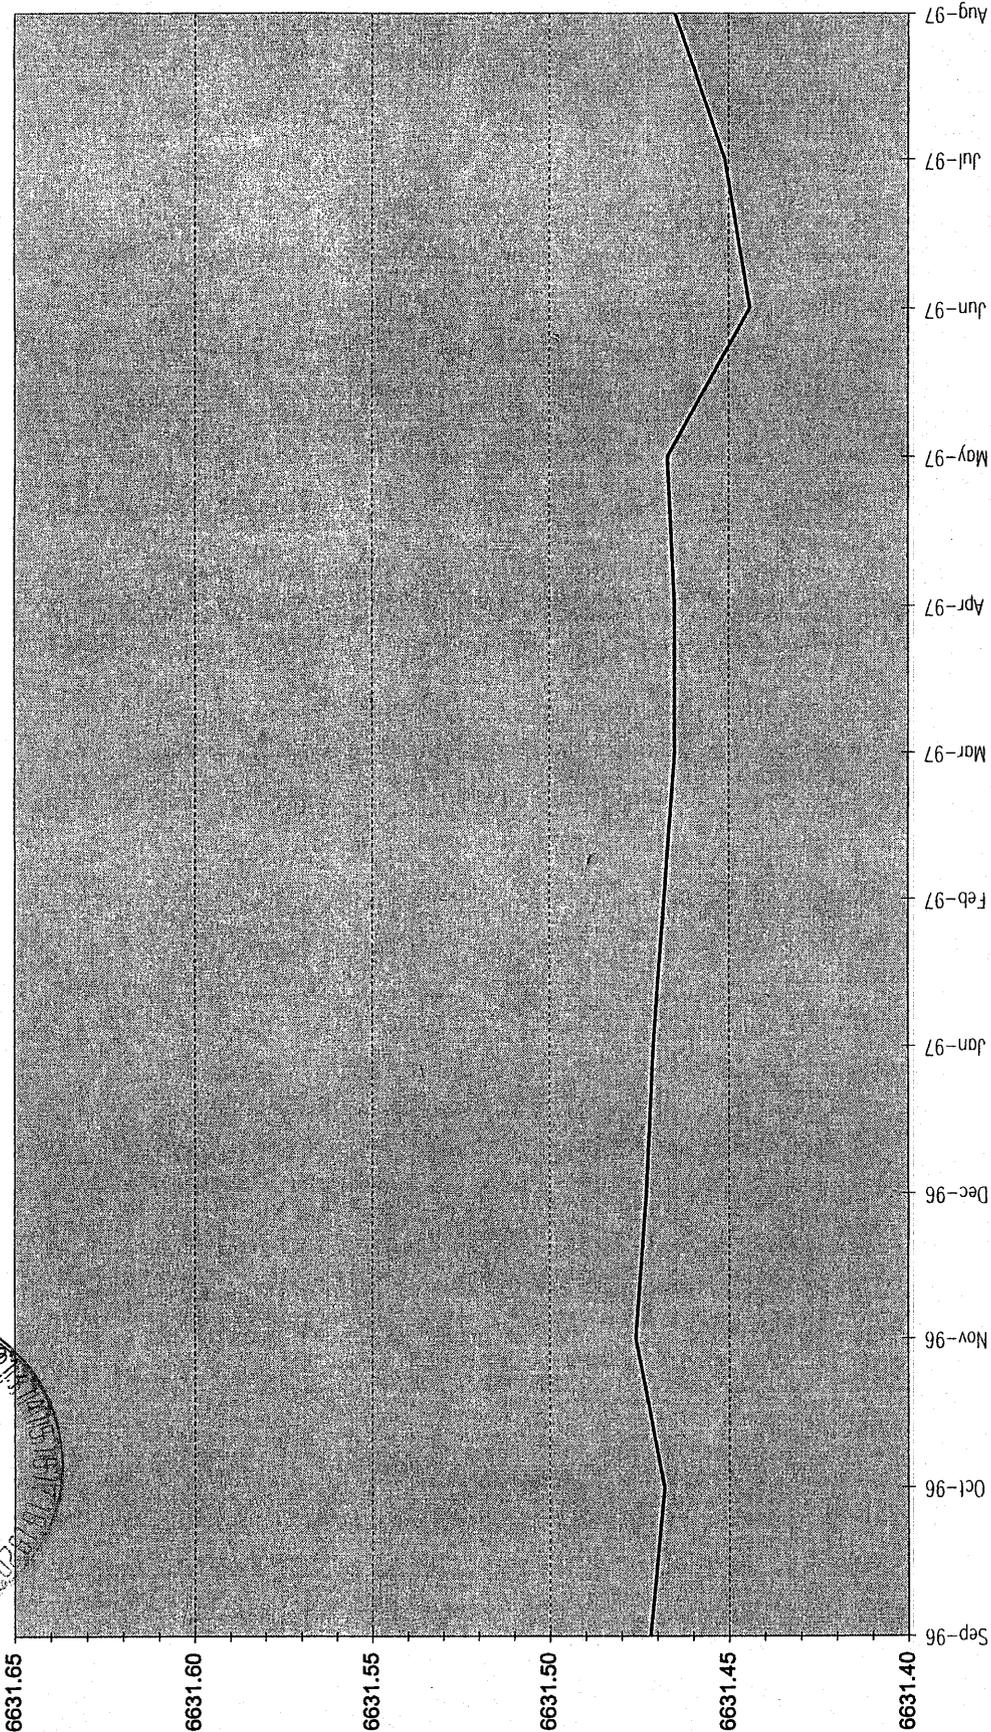
1996-1997 J16-A DAM SETTLEMENT MONUMENT #4

ELEVATION OF MONUMENT (FEET)

DATE

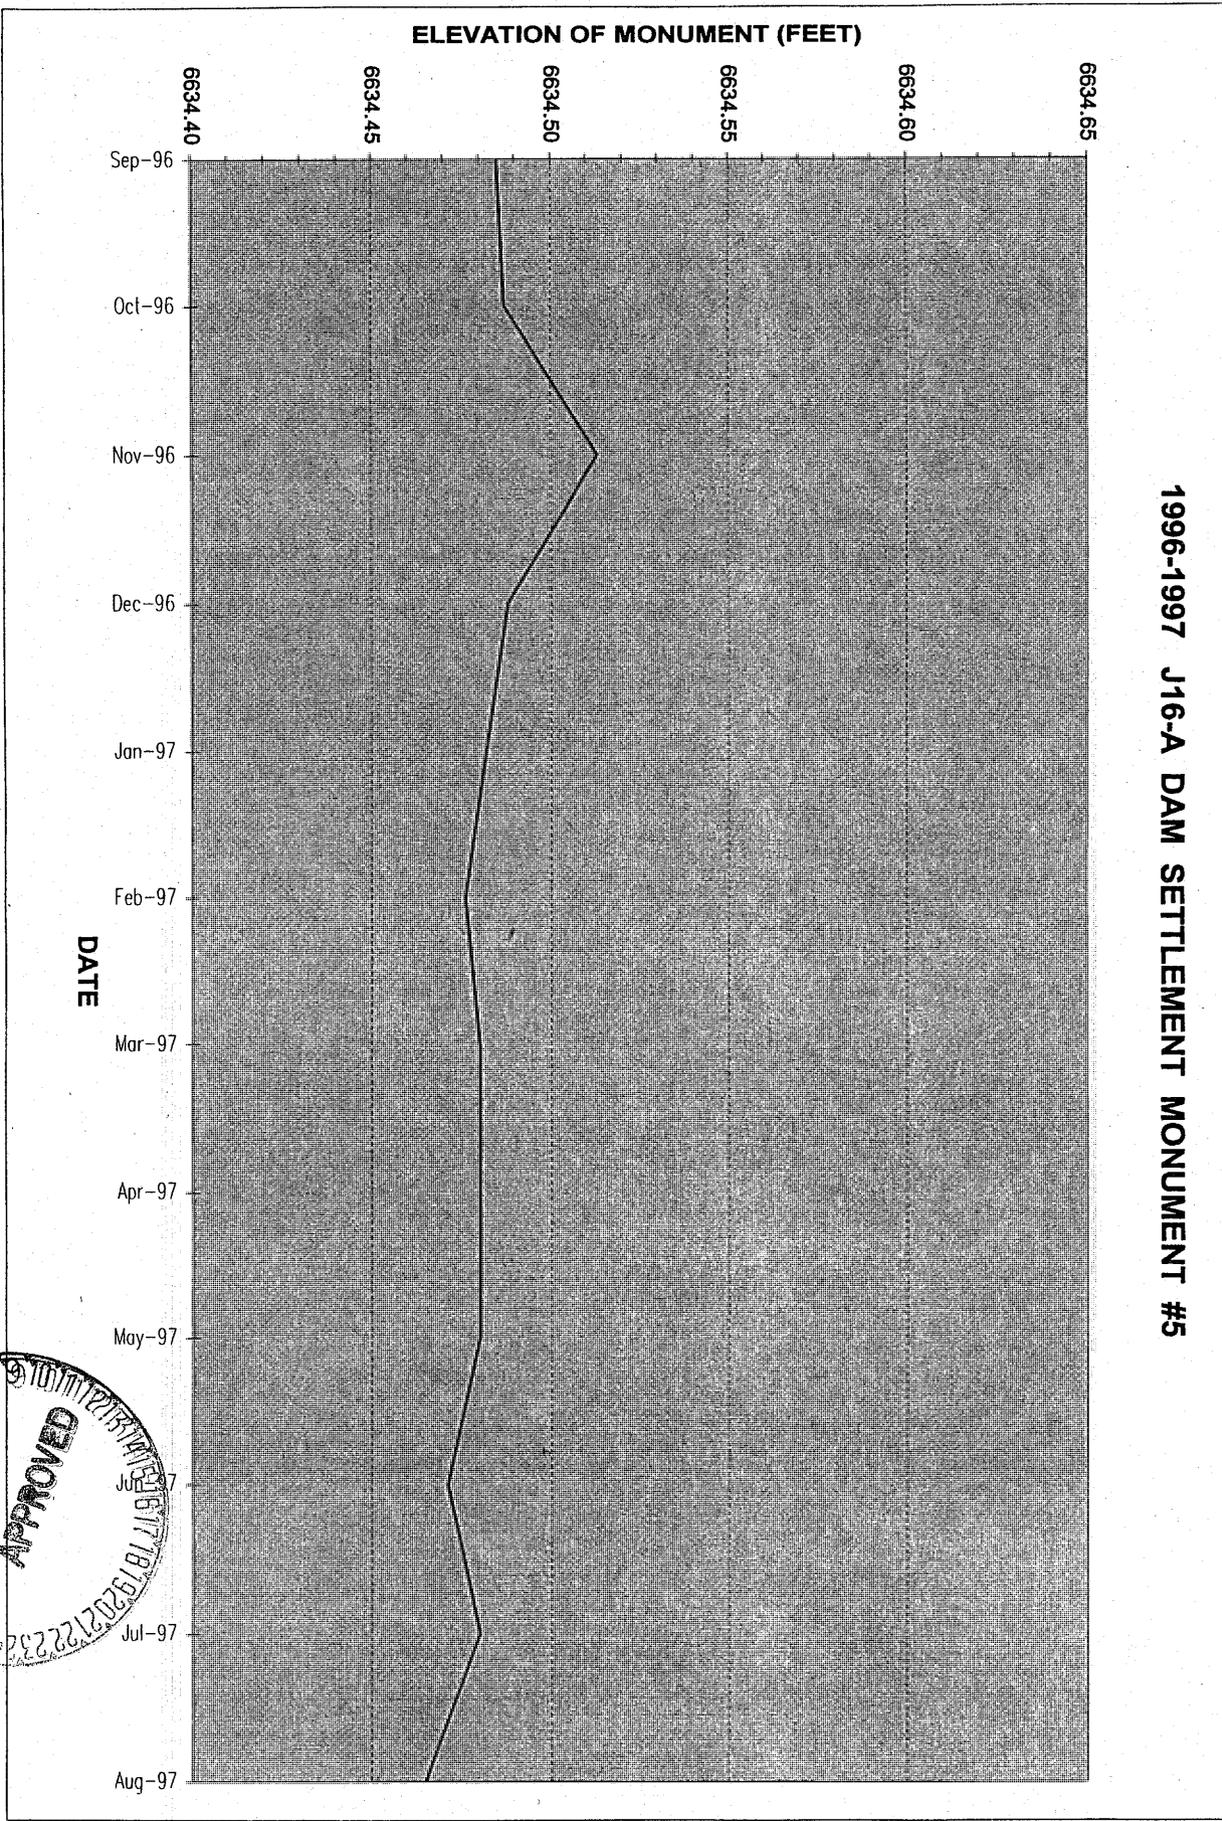
1996-1997 J16-A DAM SETTLEMENT MONUMENT #5

ELEVATION OF MONUMENT (FEET)

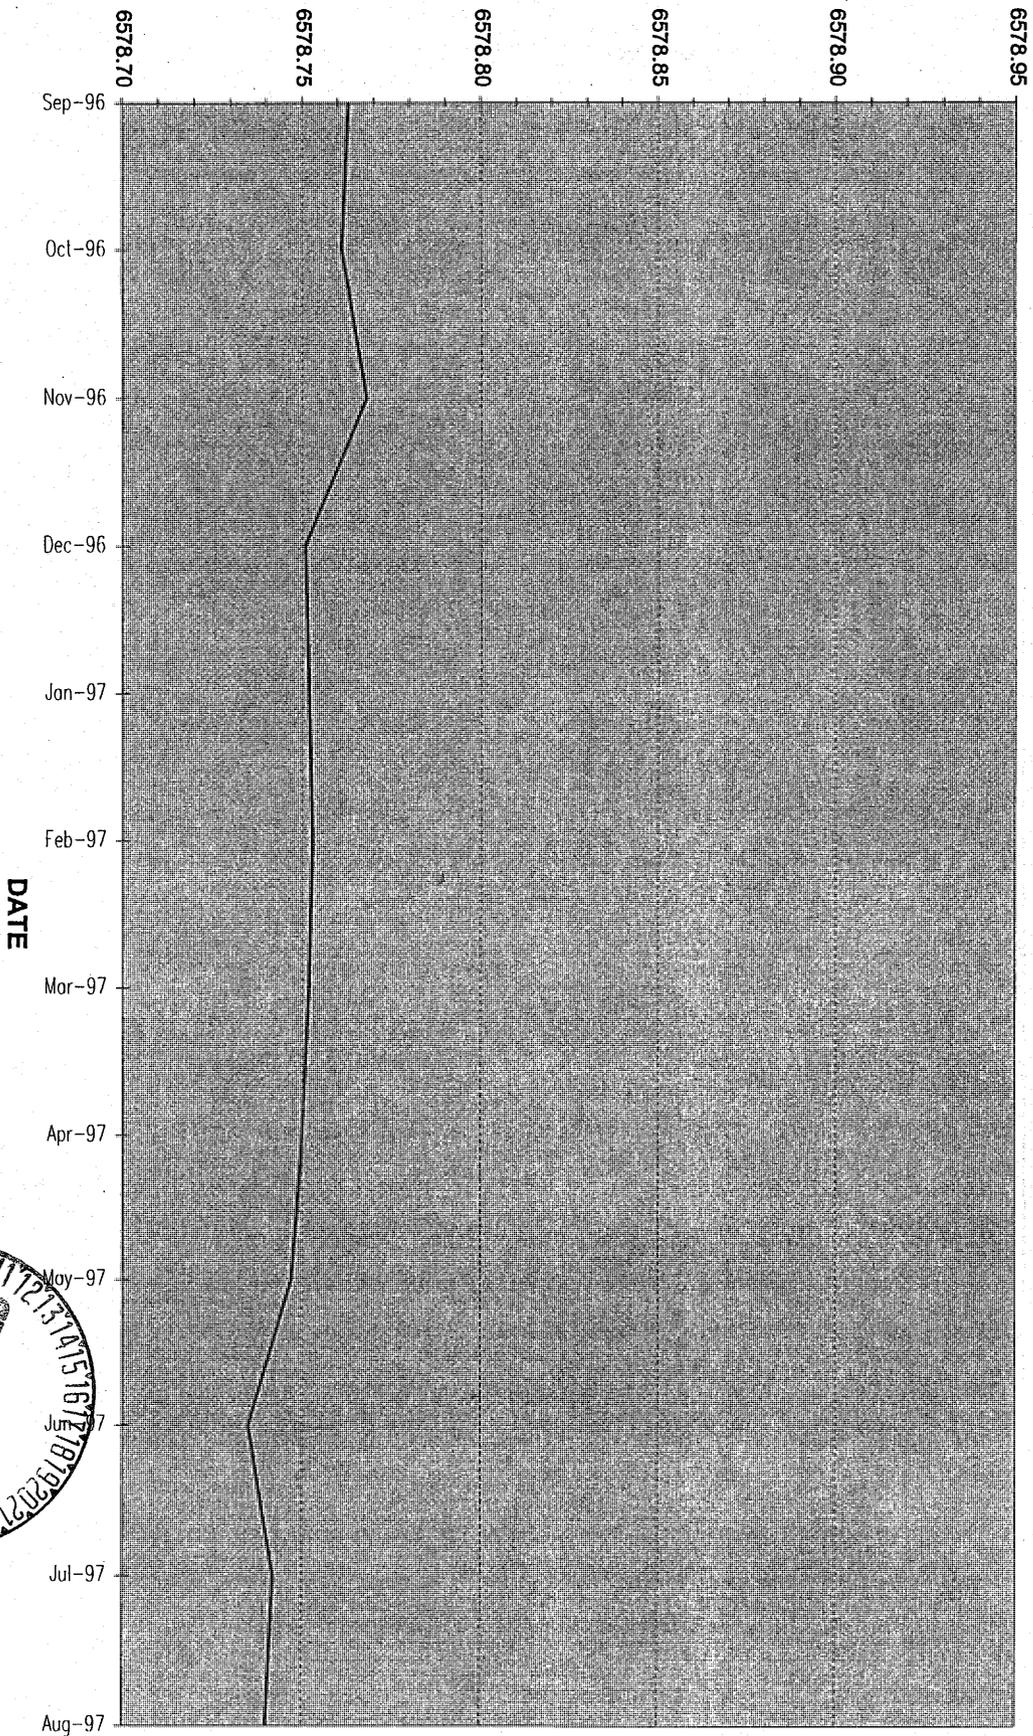
1996-1997 J16-L DAM SETTLEMENT MONUMENT #1

ELEVATION OF MONUMENT (FEET)

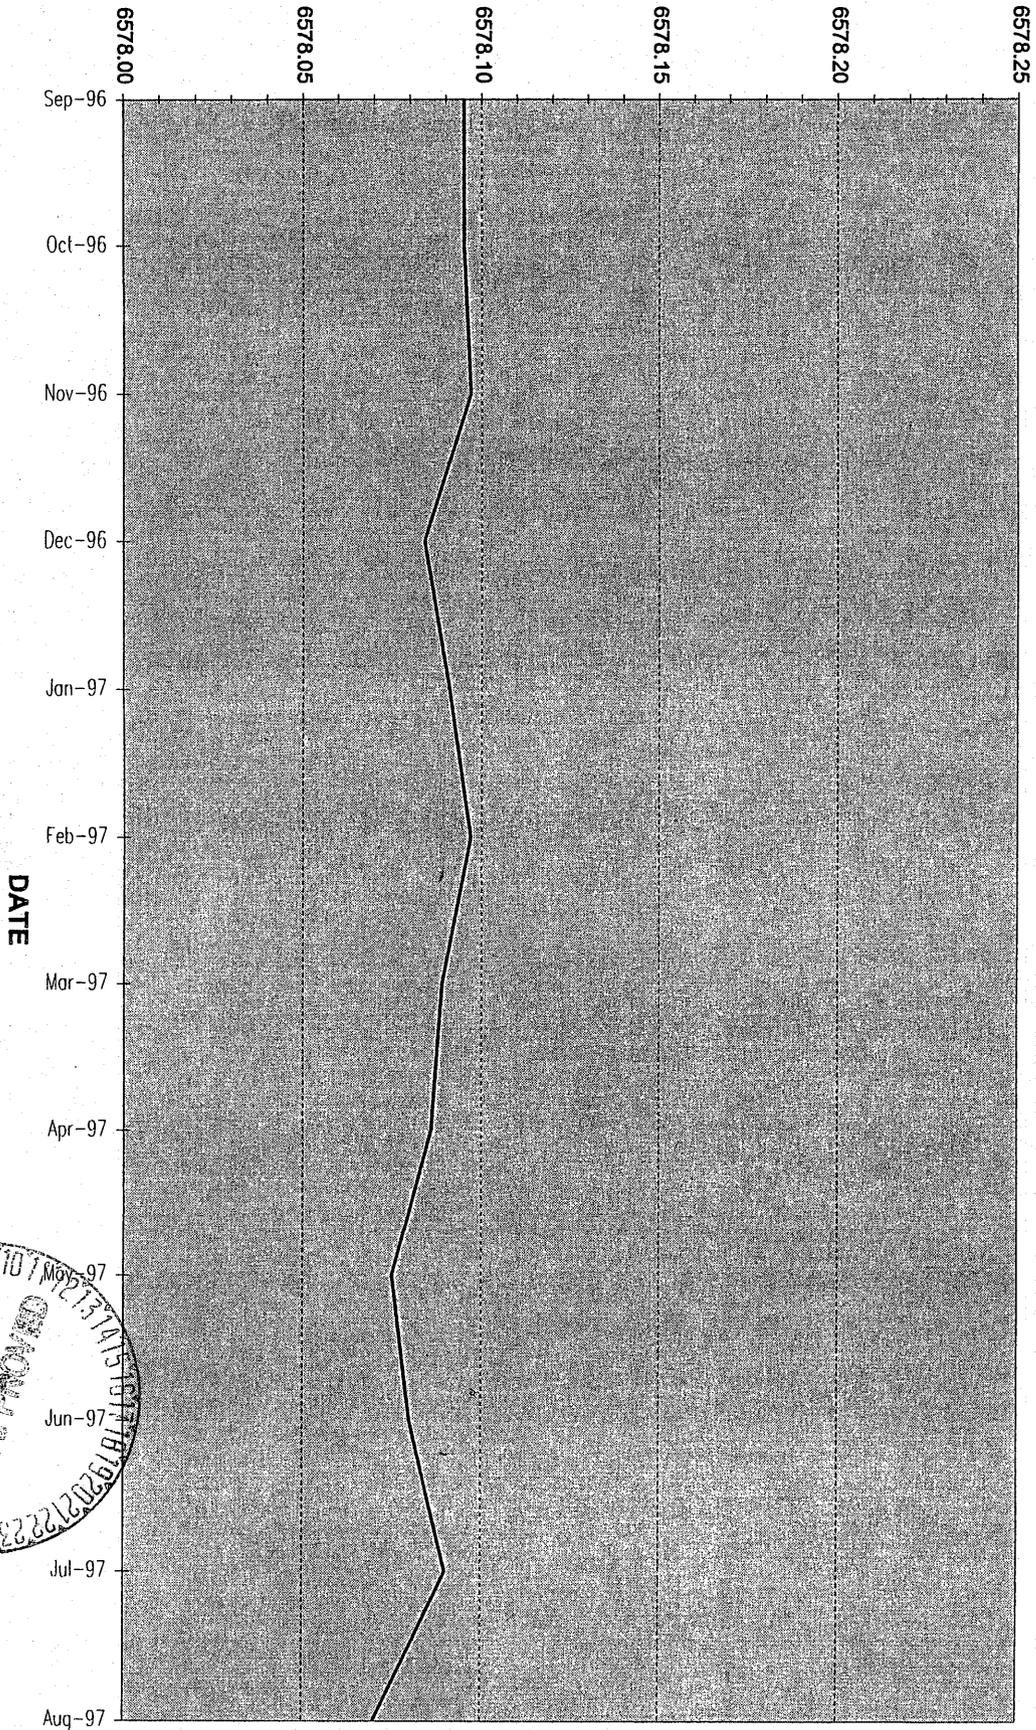
1996-1997 J16-L DAM SETTLEMENT MONUMENT #2

ELEVATION OF MONUMENT (FEET)

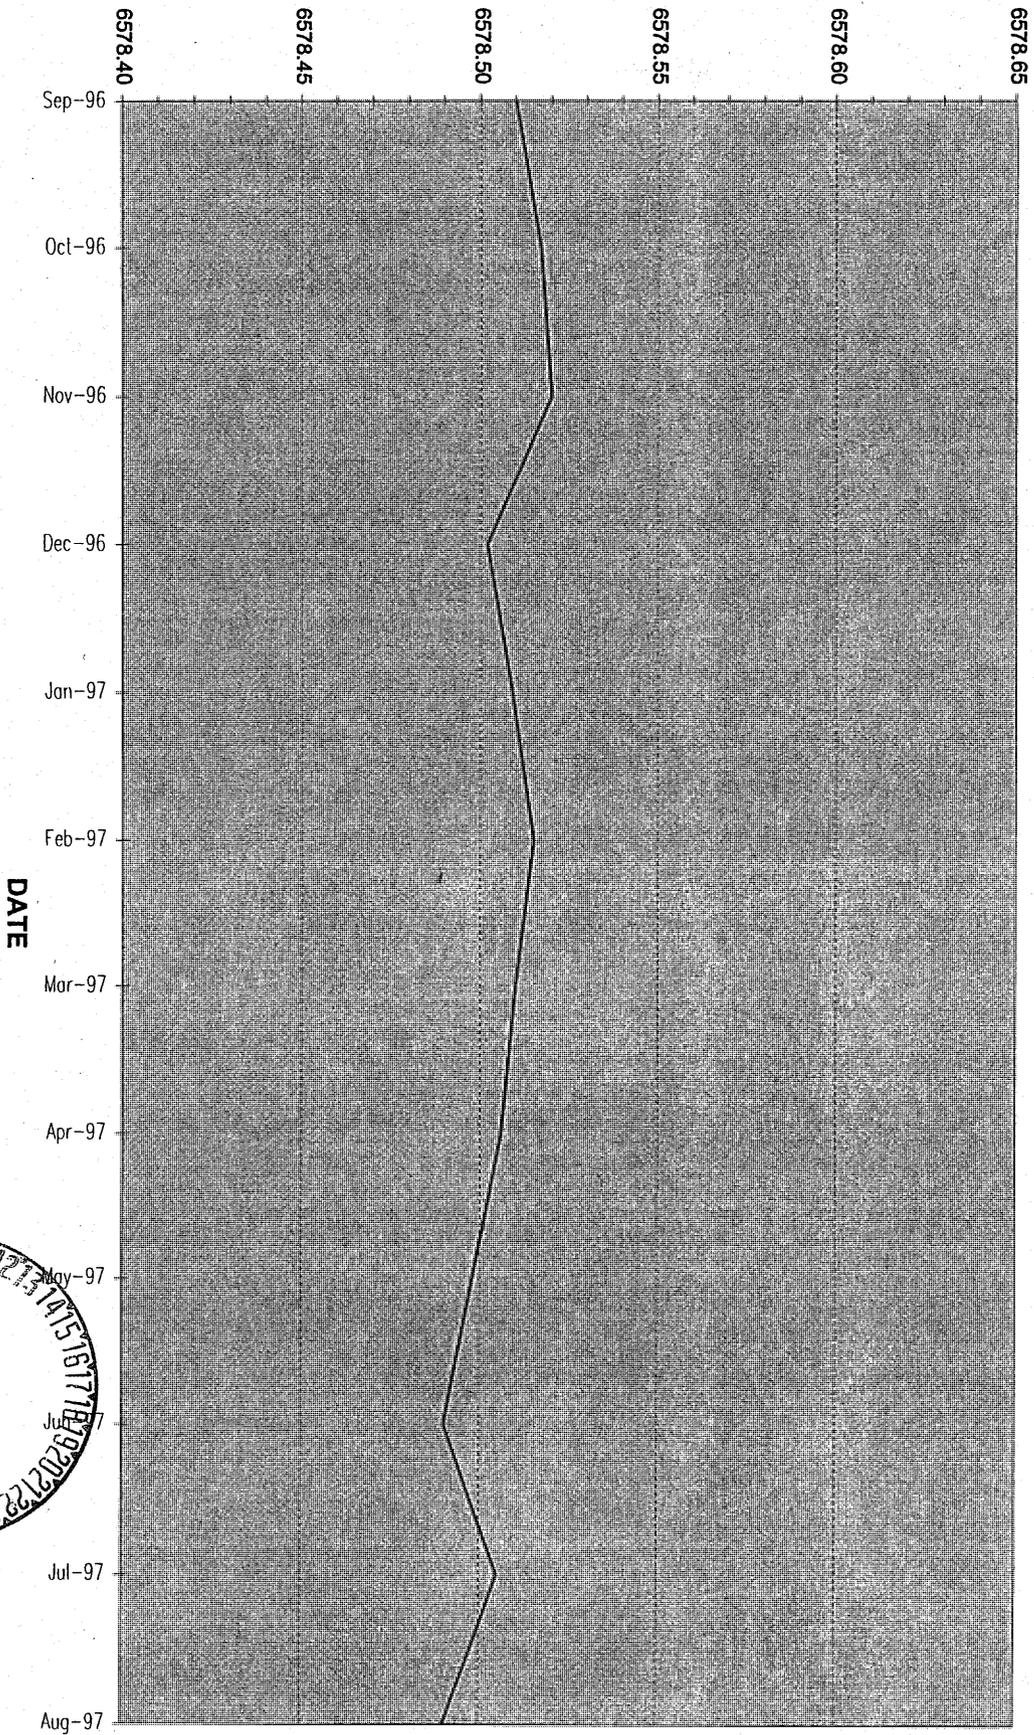
1996-1997 J16-L DAM SETTLEMENT MONUMENT #3

ELEVATION OF MONUMENT (FEET)

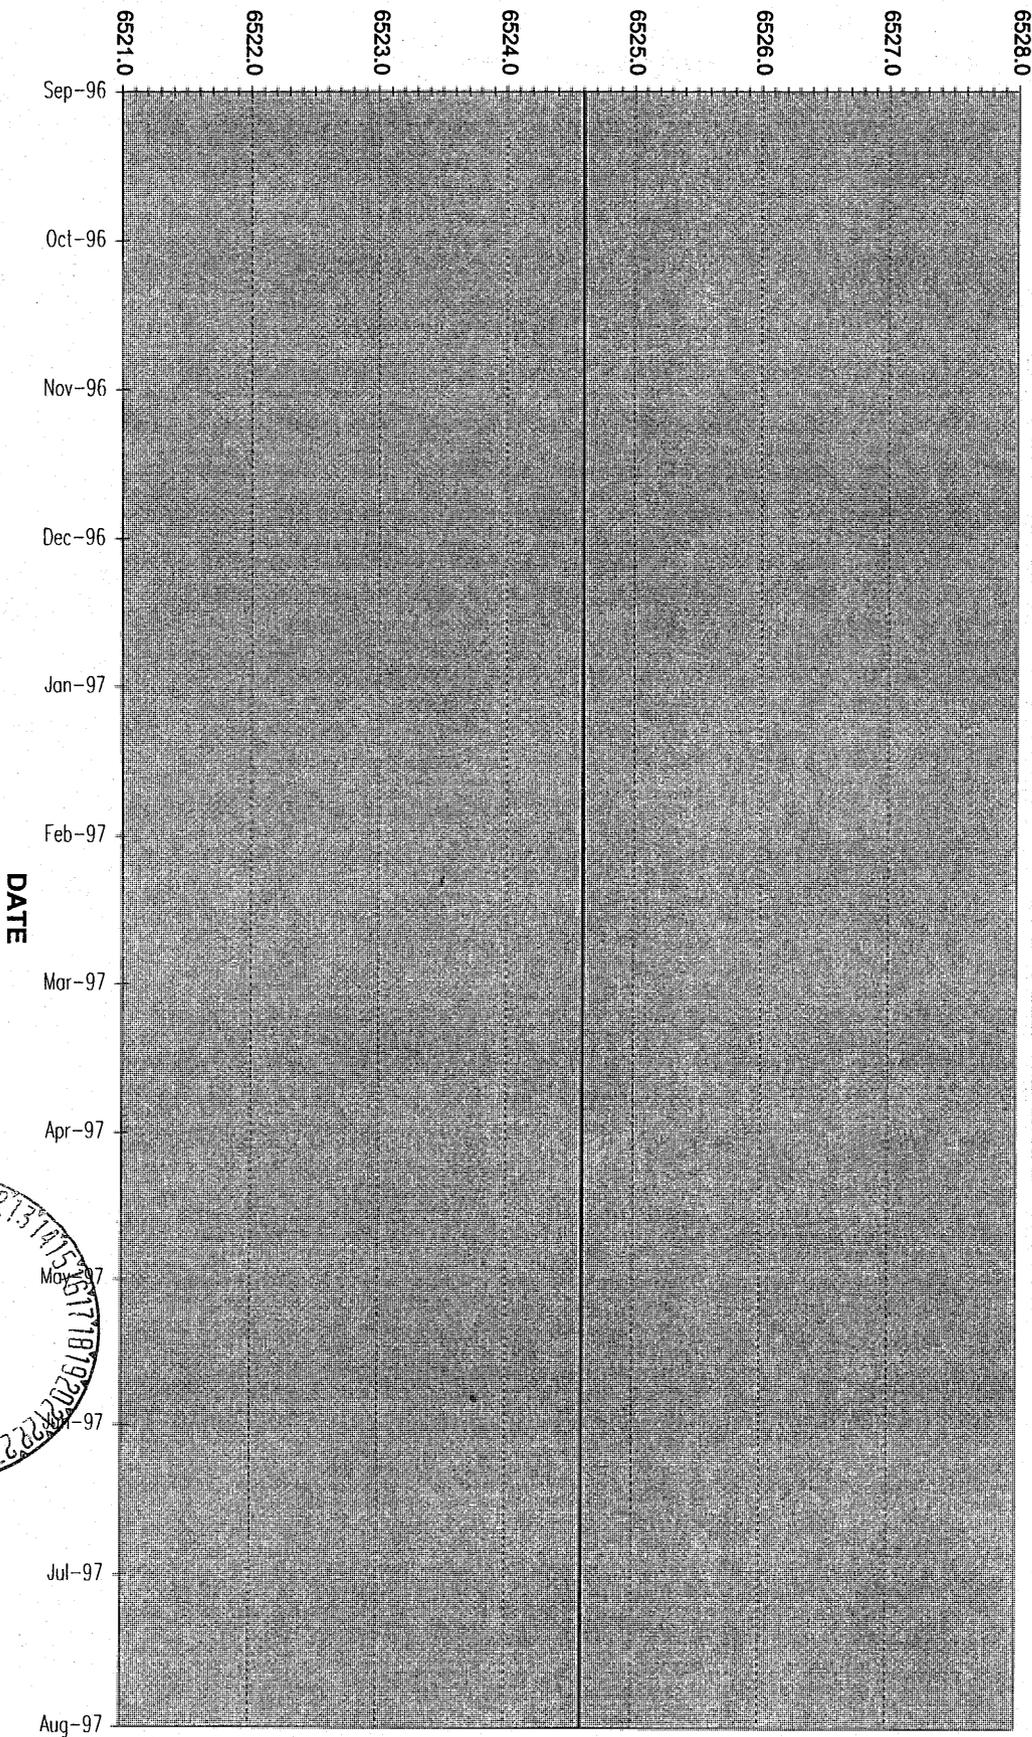
1996-1997 J16-L DAM WATER MONITORING WELL #1

ELEVATION OF MONUMENT (FEET)

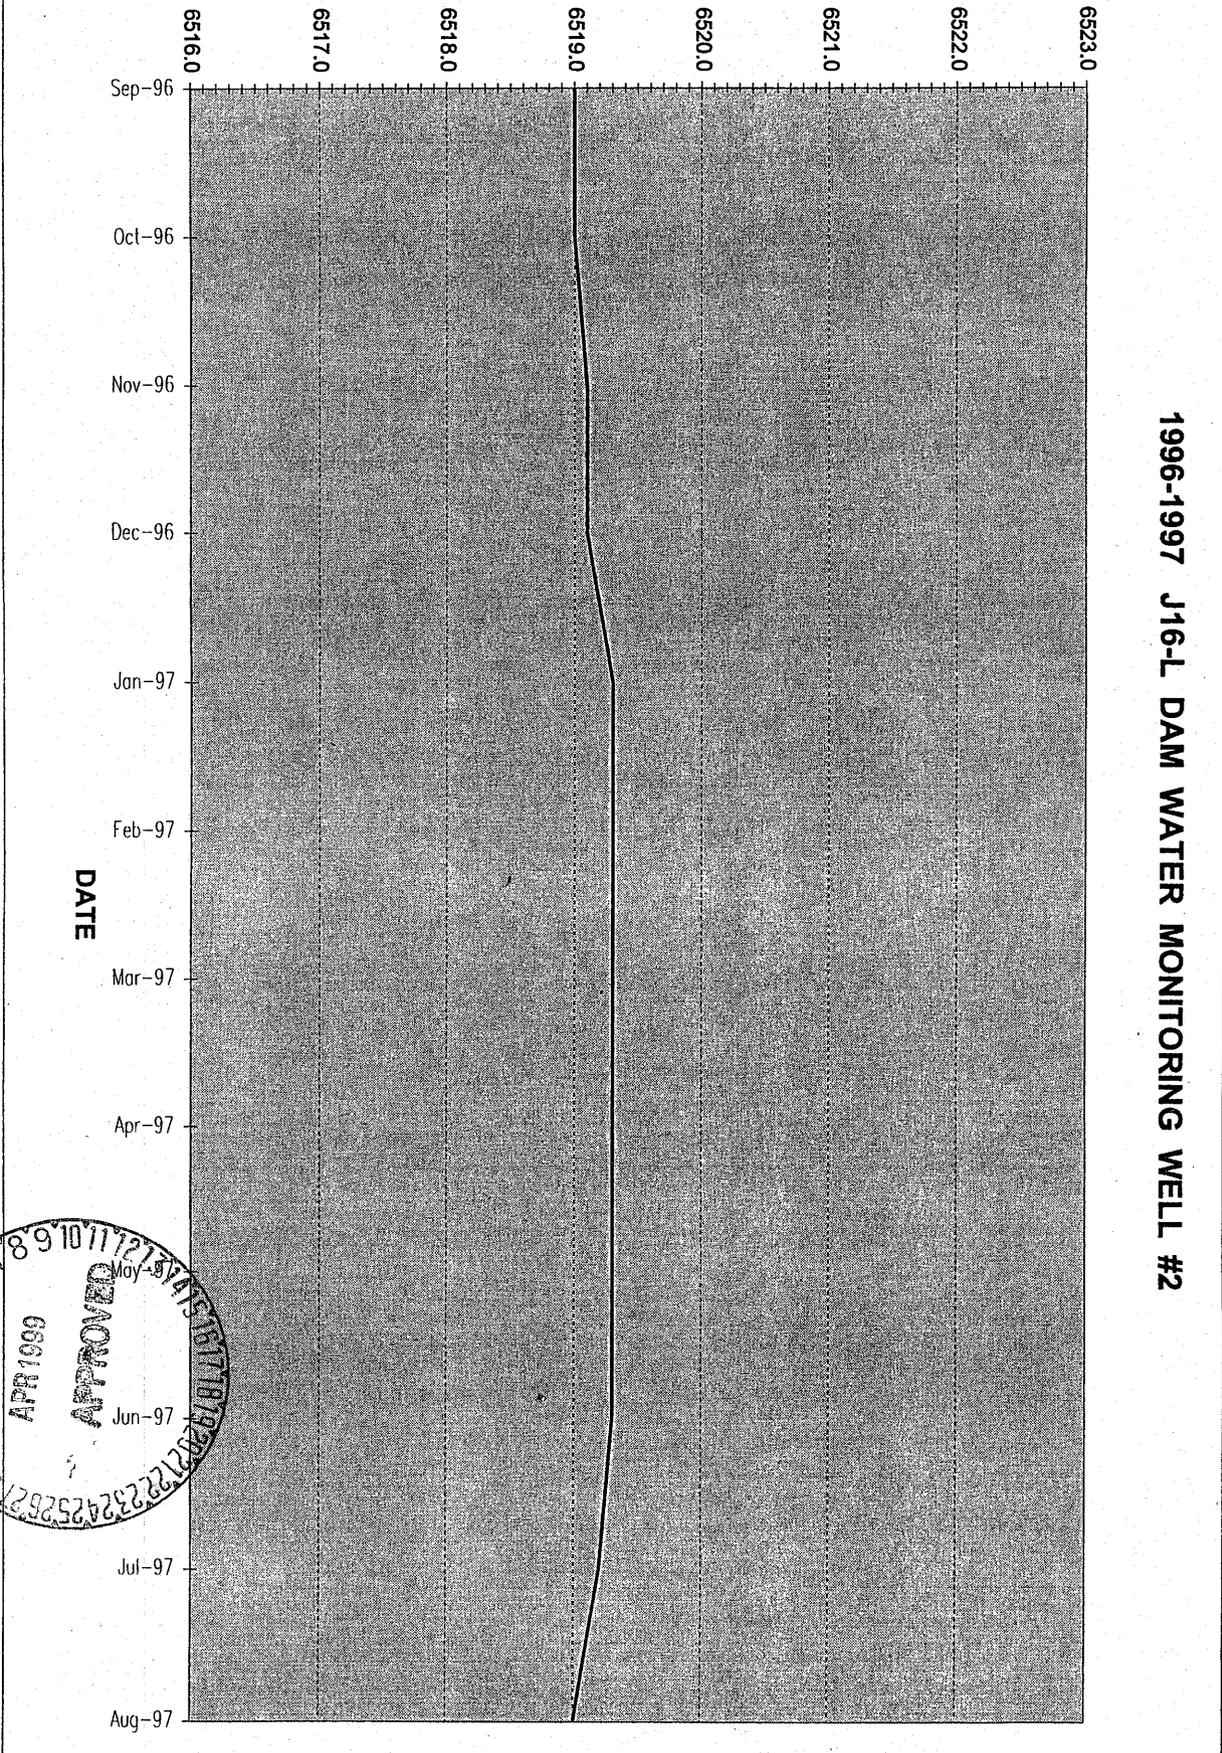
1996-1997 J16-L DAM WATER MONITORING WELL #2

ELEVATION OF MONUMENT (FEET)

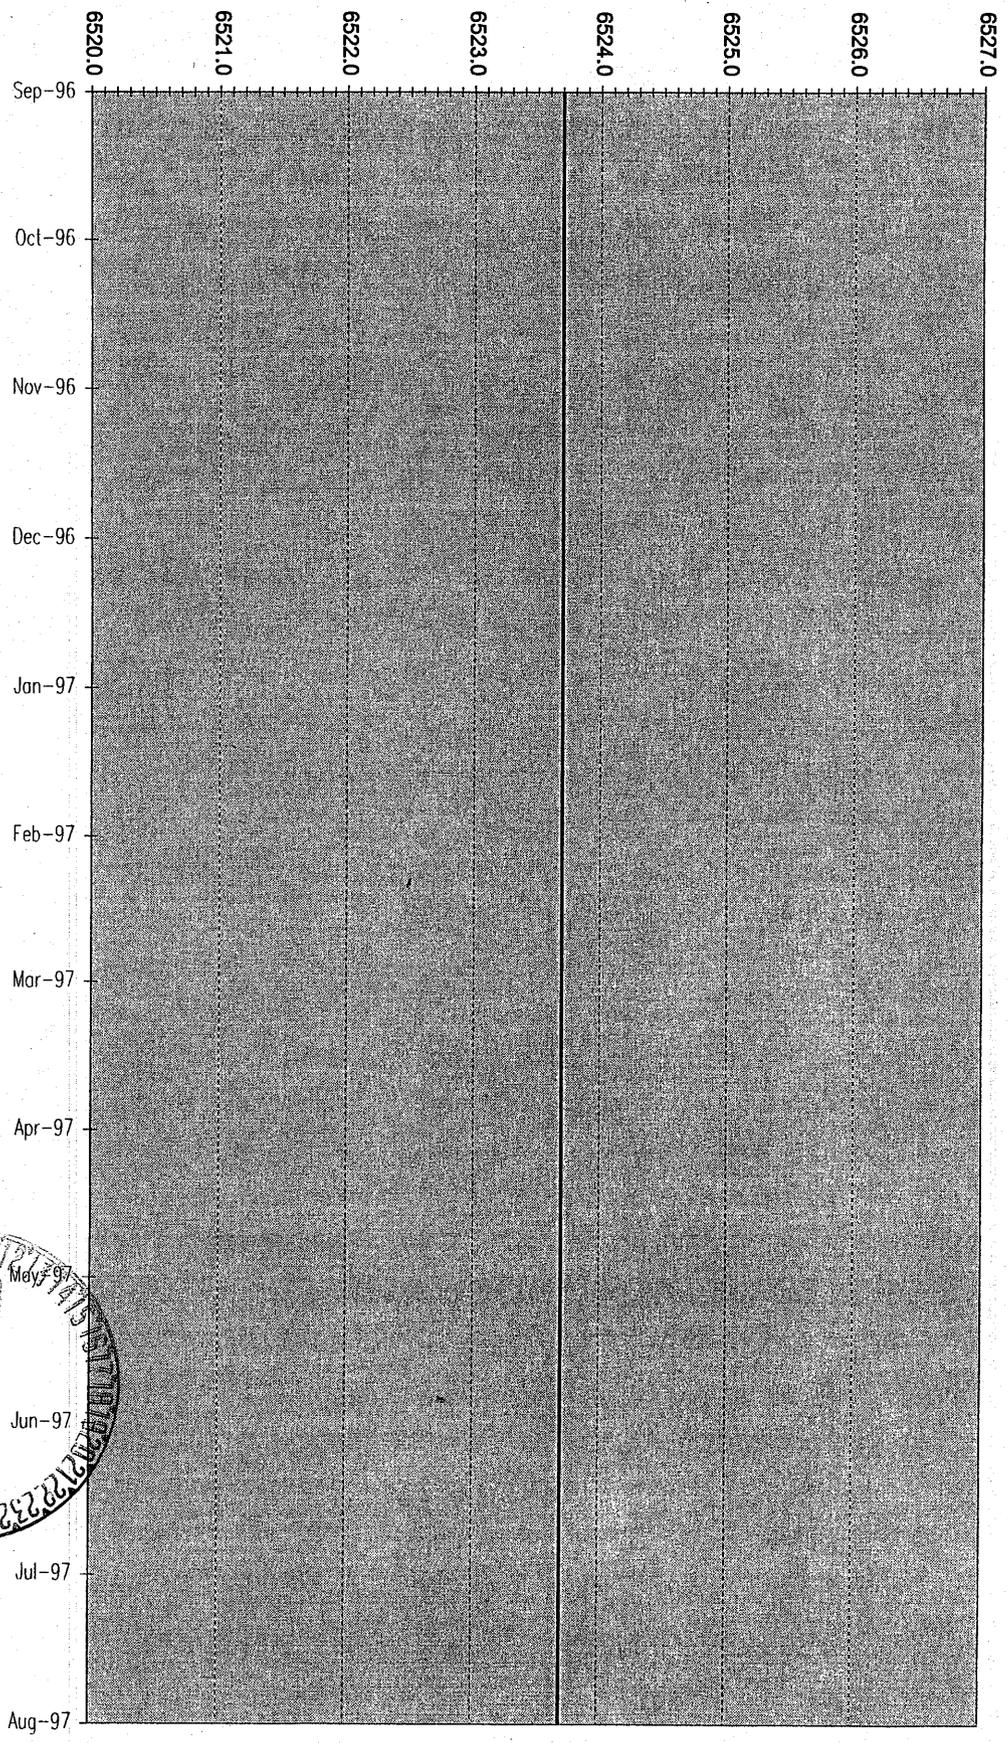
1996-1997 J16-L DAM WATER MONITORING WELL #3

ELEVATION OF MONUMENT (FEET)

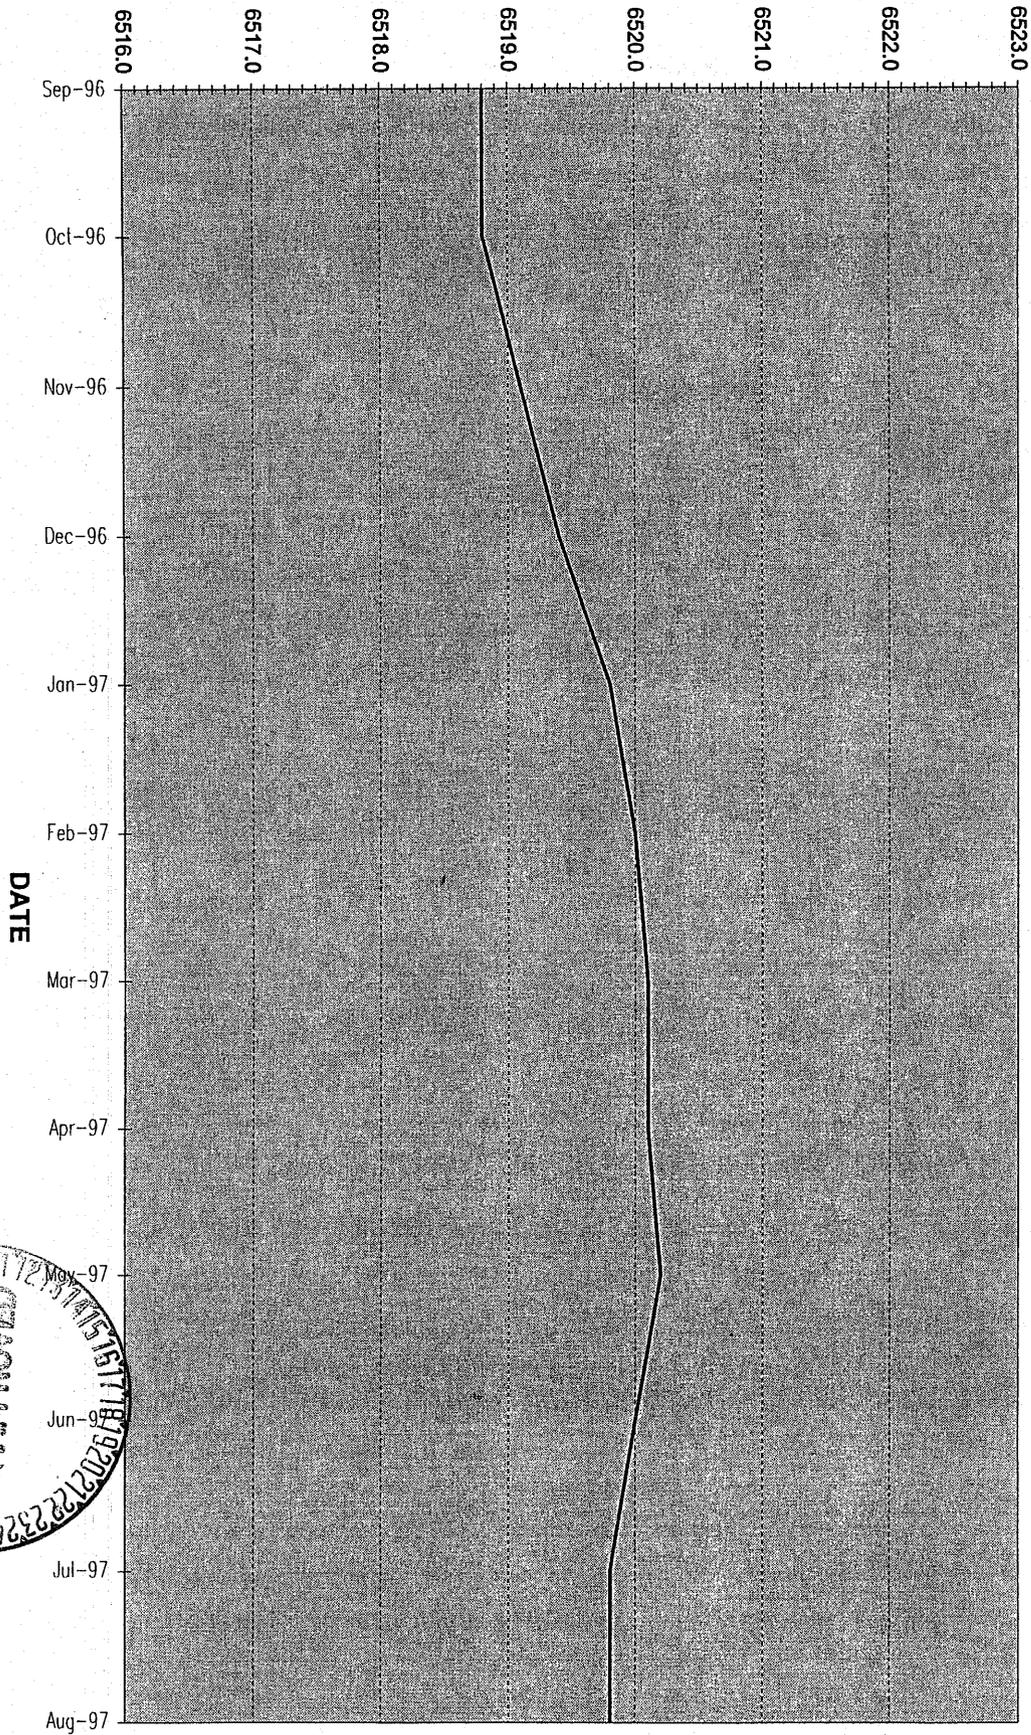
1996-1997 J16-L DAM WATER MONITORING WELL #4

ELEVATION OF MONUMENT (FEET)
