ATTACHMENT AA

N-14 East
Ephemeral Reclaimed Channel
Diversion Design Report
(See Drawing No. 85352, Sheets M-7 and M-8)

N-14 East - Ephemeral Reclaimed
Channel Design Summary

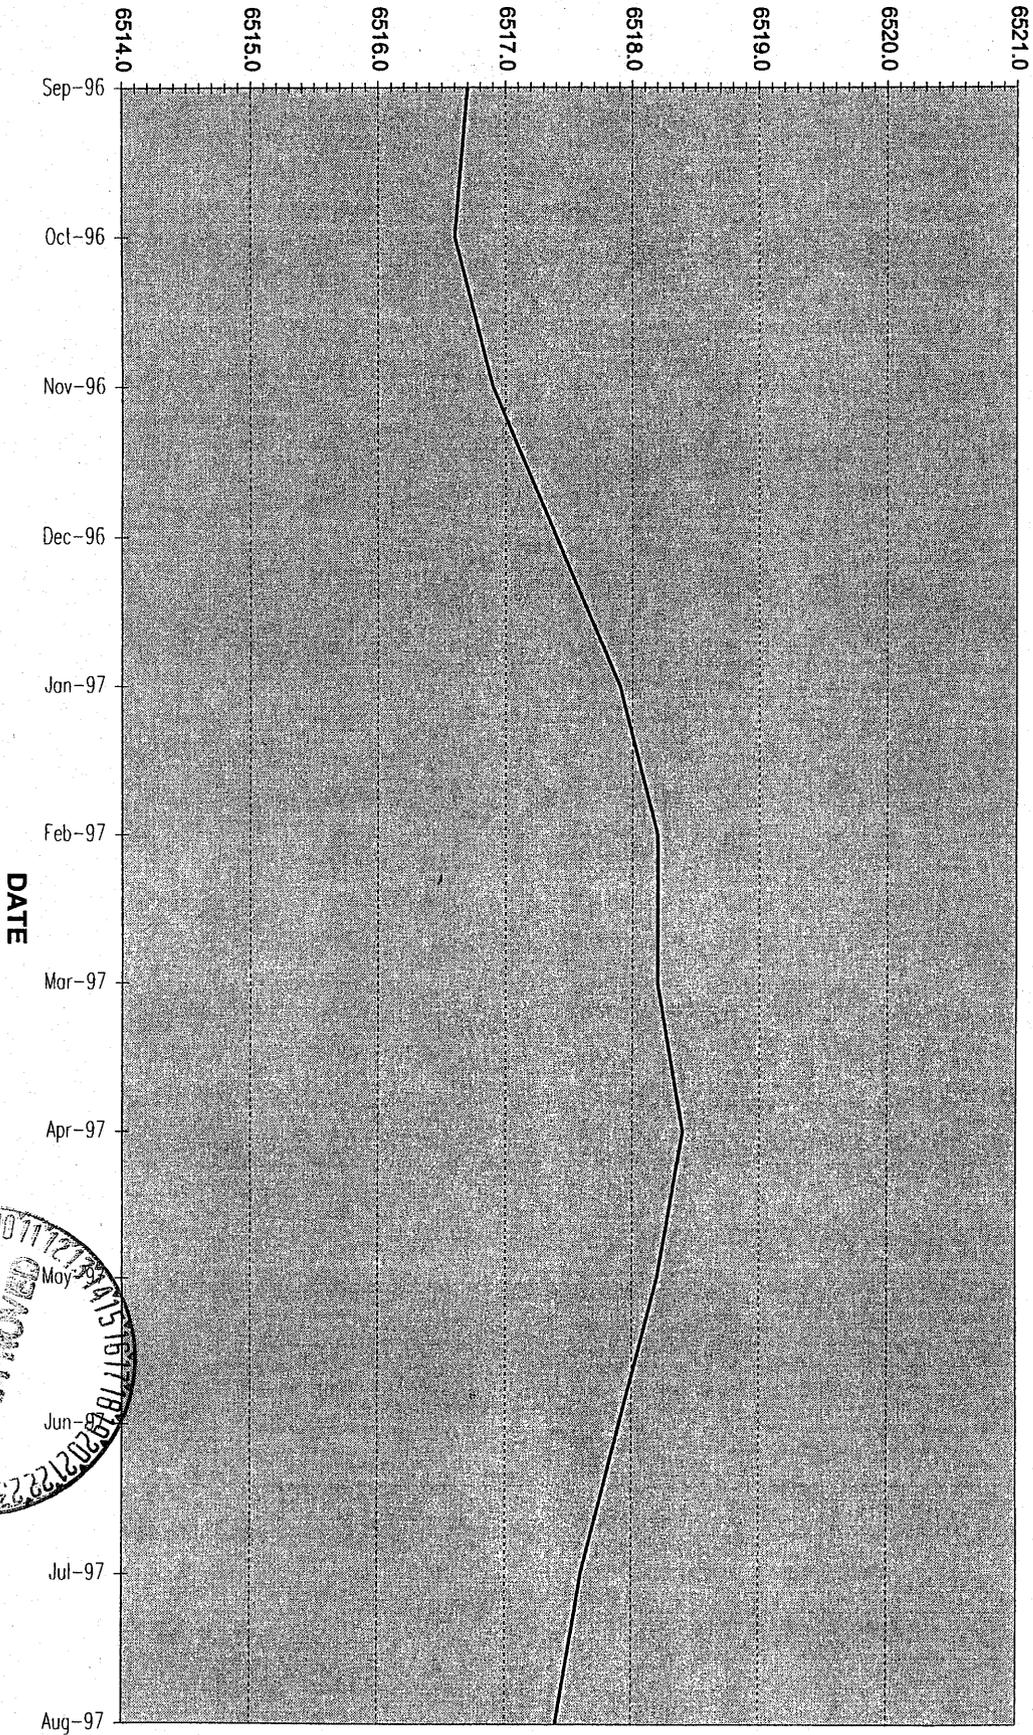
1996-1997 J16-L DAM WATER MONITORING WELL #5

ELEVATION OF MONUMENT (FEET)

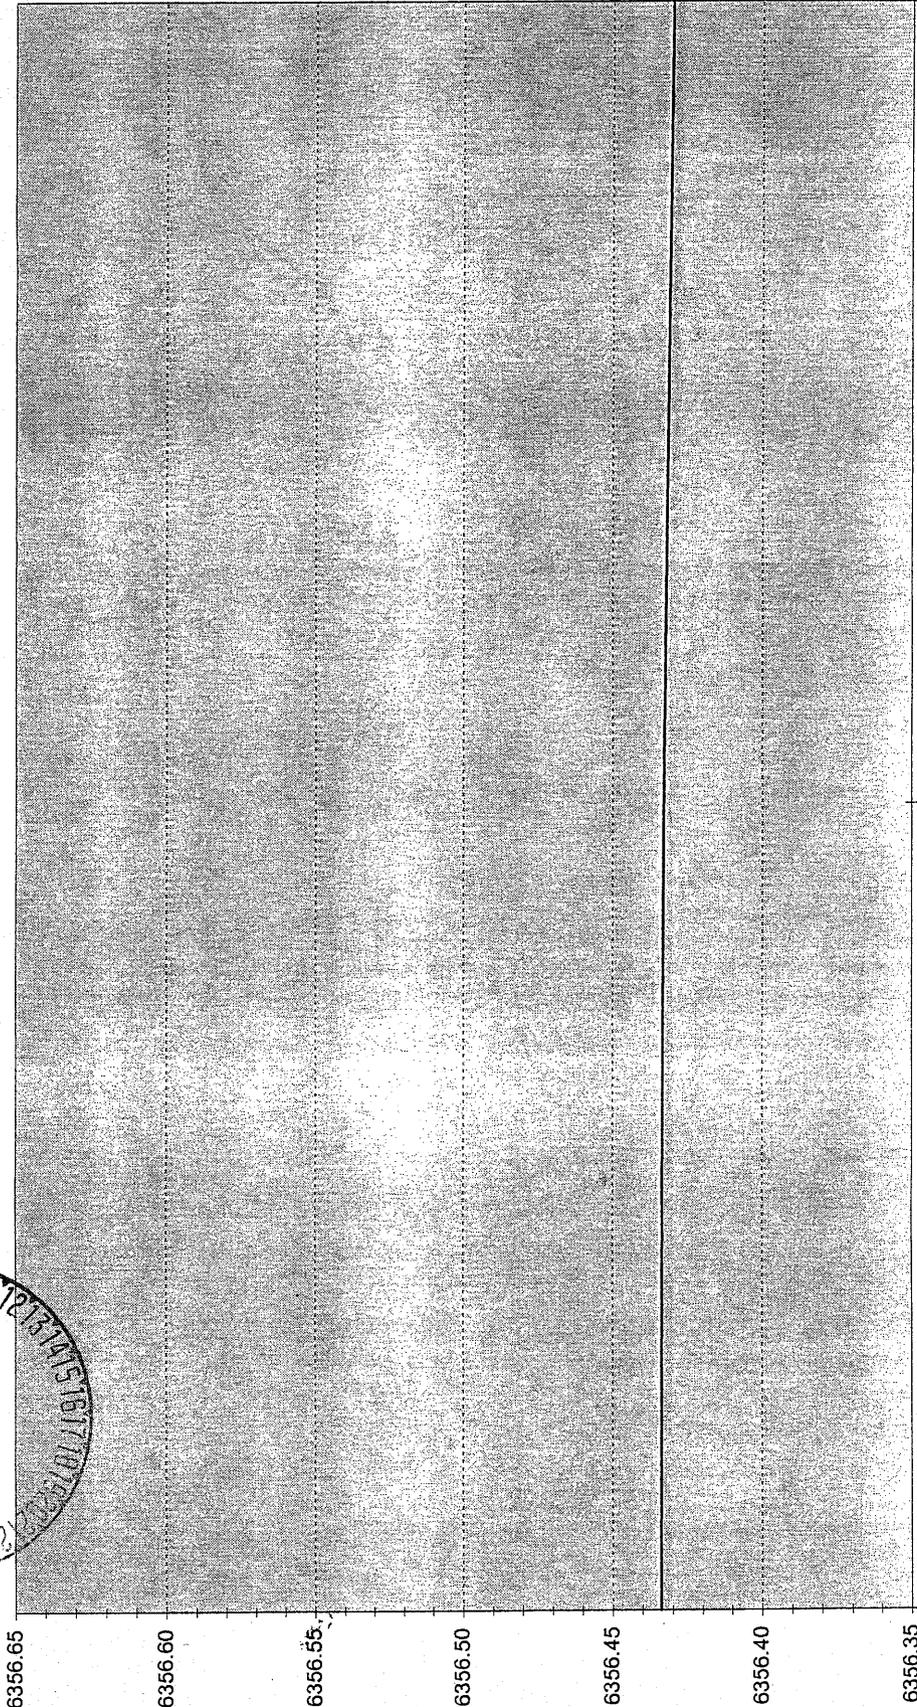
J2-A DAM SETTLEMENT MONUMENT #1

6356.65
6356.60
6356.55
6356.50
6356.45
6356.40
6356.35

ELEVATION OF MONUMENT (FEET)

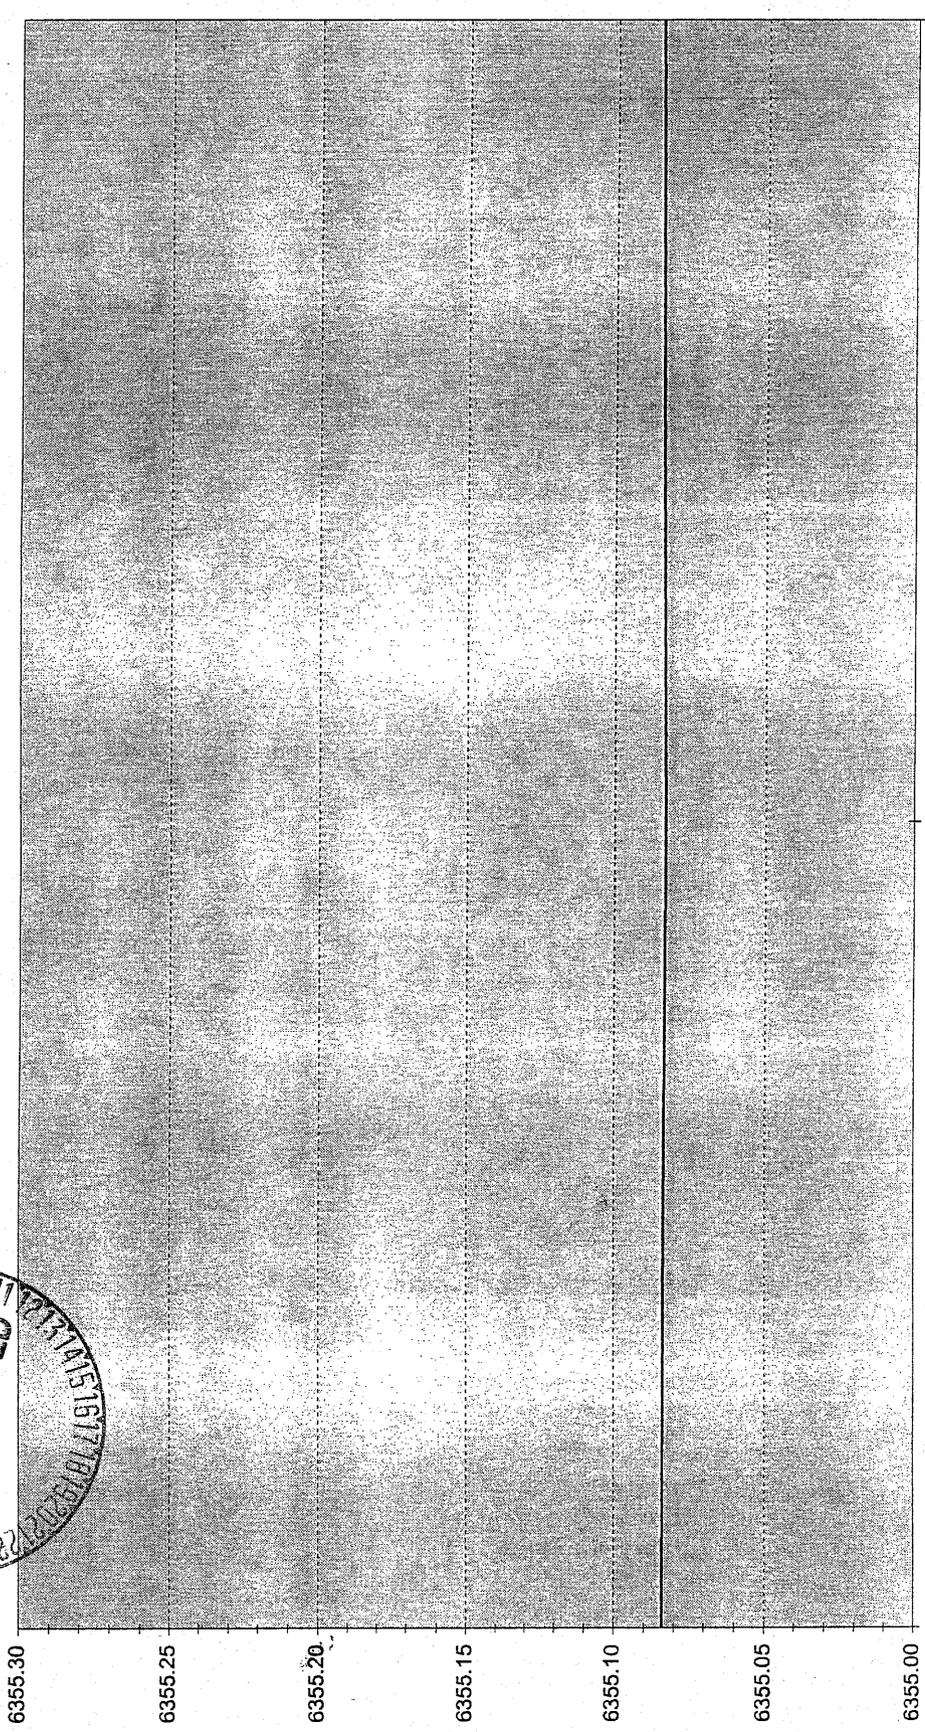
1997-1998 J2-A DAM SETTLEMENT MONUMENT #2

ELEVATION OF MONUMENT (FEET)

6355.30
6355.25
6355.20
6355.15
6355.10
6355.05
6355.00

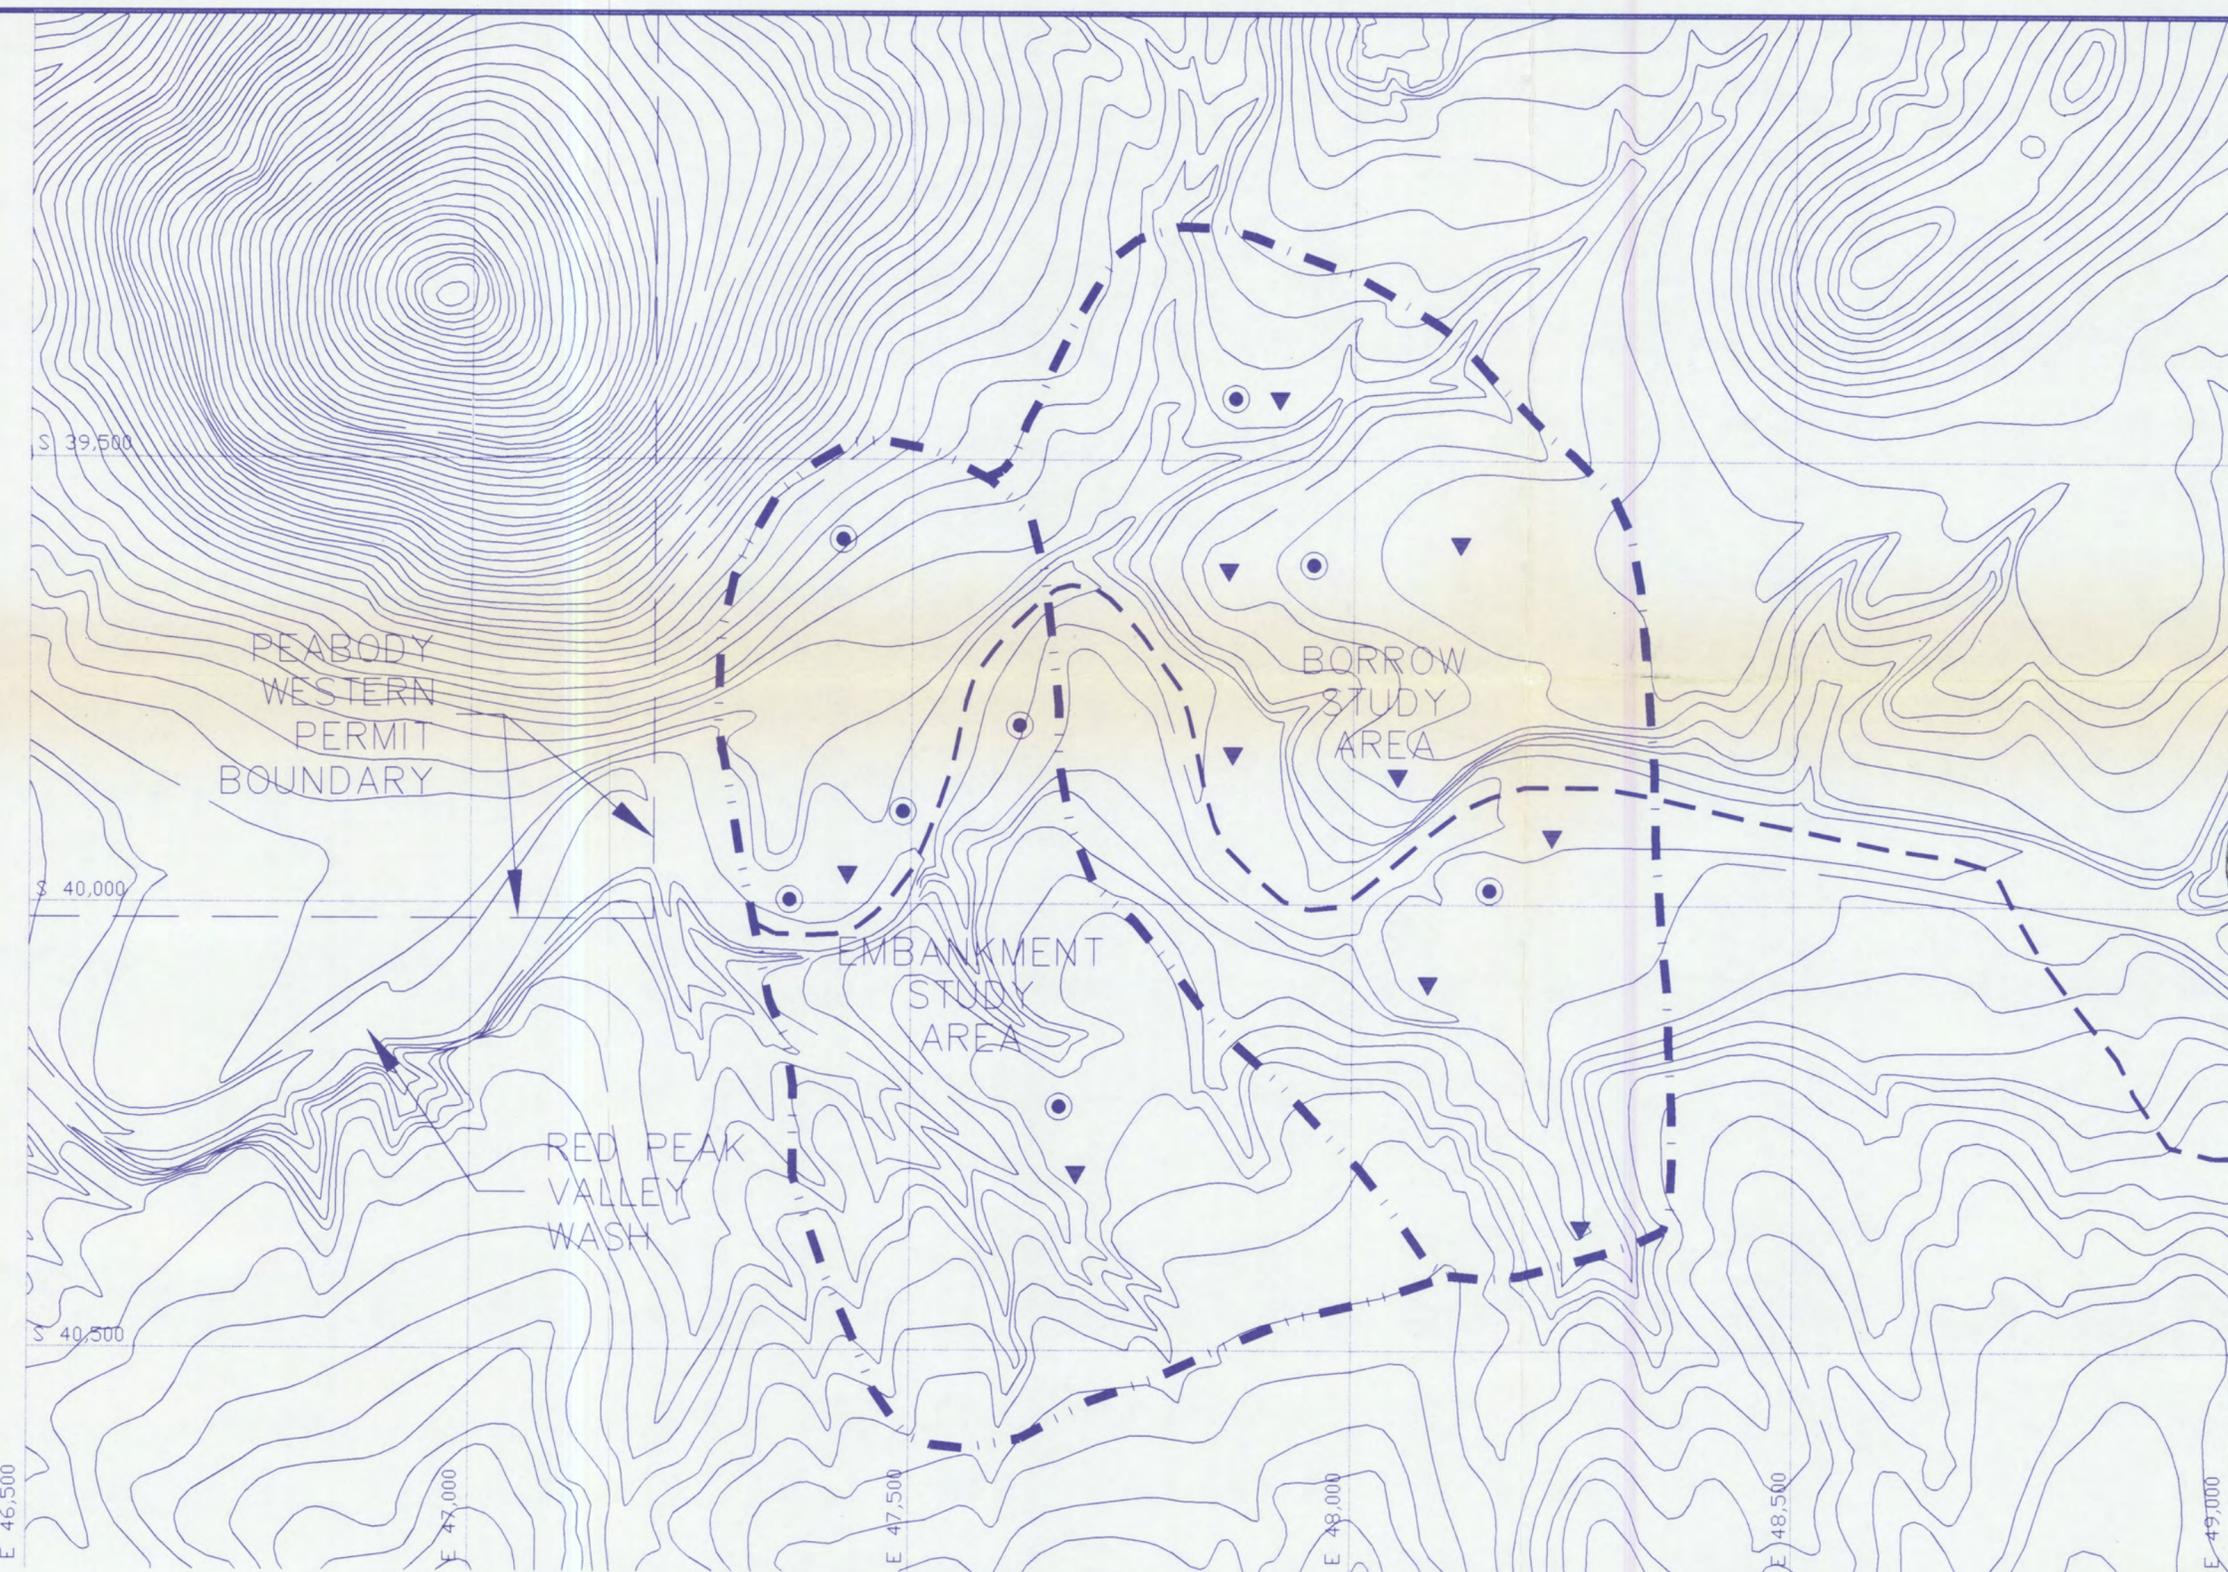
GEOTECH INVESTIGATION AREA
POND J7 JR

NOTE: STUDY AREA AND NUMBER OF DRILL HOLES AND BACKHOE PITS ARE SUBJECT TO CHANGE BASED ON DECISIONS MADE BY THE FIELD ENGINEER.

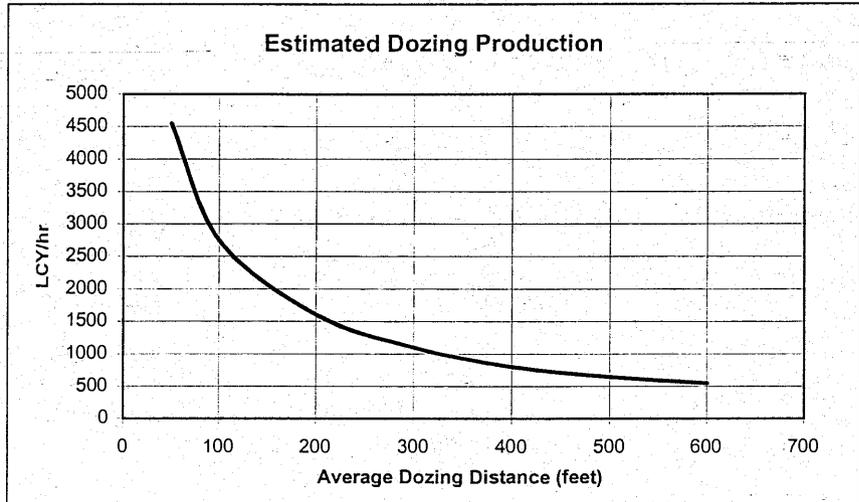
$$\text{Adjustment Factor} = \frac{0.75}{\text{Operating Factor}} \times \frac{1.0}{\text{Material Factor}} \times \frac{1.2}{\text{Grade Factor}} \times \frac{0.82}{\text{Density Correction}}$$

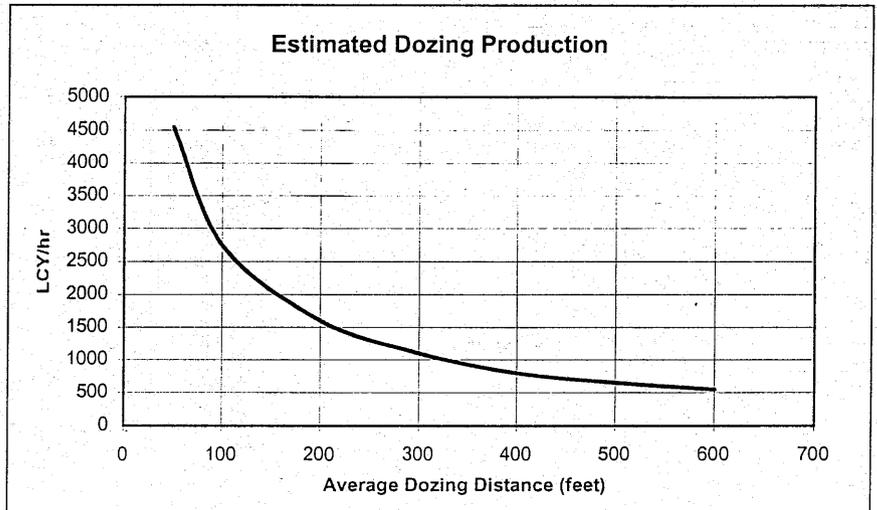
$$\begin{aligned}
 \text{Productivity Adjustment Factor} &= \frac{0.75}{\text{Operating Factor}} \times \frac{1.0}{\text{Material Factor}} \times \frac{1.0}{\text{Grade Factor}} \times \frac{0.82}{\text{Density Correction}} \\
 &\times \frac{1.00}{\text{Production Method}} \times \frac{1.00}{\text{Visibility}} \times \frac{1.00}{\text{Elevation}} \times \frac{1.00}{\text{Direct Drive Trans}} = \boxed{0.62}
 \end{aligned}$$

$$\text{Net Hourly Production} = \frac{1,100}{\text{Normal Hourly Production}} \times \frac{0.62}{\text{Productivity Adjustment Factor}} = \boxed{676.5 \text{ cy/hr}}$$

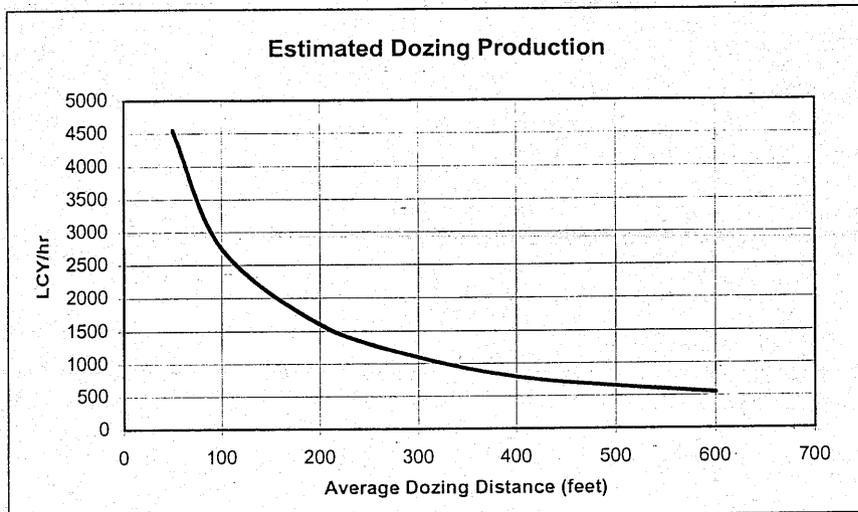
$$\begin{aligned}
 \text{Productivity Adjustment Factor} &= \frac{0.75}{\text{Operating Factor}} \times \frac{0.8}{\text{Material Factor}} \times \frac{1.0}{\text{Grade Factor}} \times \frac{0.82}{\text{Density Correction}} \\
 &\times \frac{1.00}{\text{Production Method}} \times \frac{1.00}{\text{Visibility}} \times \frac{1.00}{\text{Elevation}} \times \frac{1.00}{\text{Direct Drive Trans}} = \boxed{0.49}
 \end{aligned}$$

$$\text{Net Hourly Production} = \frac{4,550}{\text{Normal Hourly Production}} \times \frac{0.49}{\text{Productivity Adjustment Factor}} = \boxed{2238.6 \text{ cy/hr}}$$

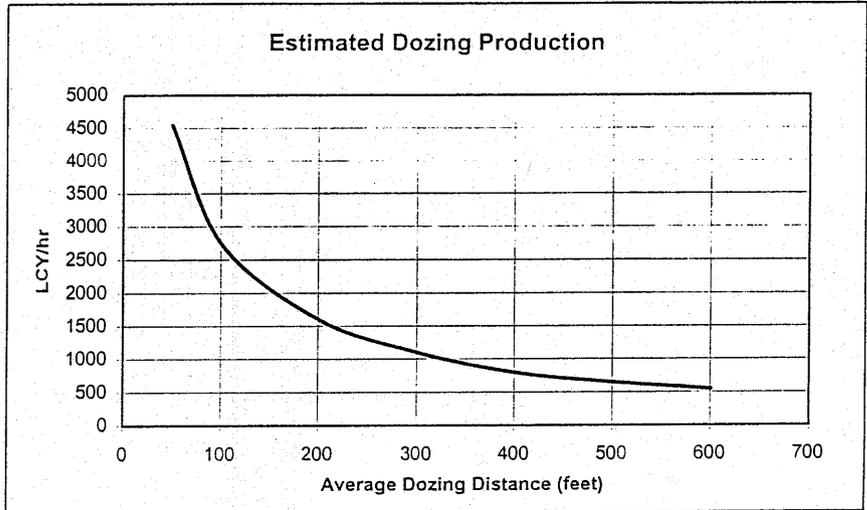
Productivity Adjustment = $\frac{0.75}{\text{Operating Factor}} \times \frac{1.0}{\text{Material Factor}} \times \frac{1.0}{\text{Grade Factor}} \times \frac{0.82}{\text{Density Correction}}$
 $\times \frac{1.00}{\text{Production Method}} \times \frac{1.00}{\text{Visibility}} \times \frac{1.00}{\text{Elevation}} \times \frac{1.00}{\text{Direct Drive Trans}} = 0.62$

Net Hourly Production = $\frac{1,100}{\text{Normal Hourly Production}} \times \frac{0.62}{\text{Productivity Adjustment Factor}} = 676.5 \text{ cy/hr}$
 (see graph above)

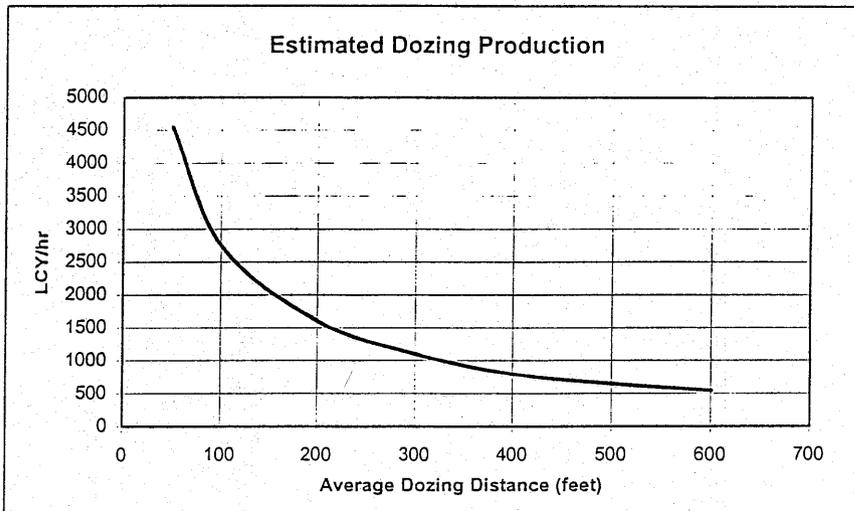
Productivity Adjustment = $\frac{0.75}{\text{Operating Factor}} \times \frac{0.8}{\text{Material Factor}} \times \frac{1.0}{\text{Grade Factor}} \times \frac{0.82}{\text{Density Correction}}$
 $\times \frac{1.00}{\text{Production Method}} \times \frac{1.00}{\text{Visibility}} \times \frac{1.00}{\text{Elevation}} \times \frac{1.00}{\text{Direct Drive Trans}} = \boxed{0.49}$

Net Hourly Production = $\frac{4,550}{\text{Normal Hourly Production}} \times \frac{0.49}{\text{Productivity Adjustment Factor}} = \boxed{2238.6 \text{ cy/hr}}$
 (see graph above)
